EROSION MANAGEMENT PLAN FOR THE BLACK RIVER CORRIDOR

ARCHITECTURE, ENGINEERING & LAND SURVEYING, P.C.

This document was prepared for the New York State Department of State Office of Coastal, Local Government and Community Sustainability with funds provided under Title 11 of the Environmental Protection Fund.

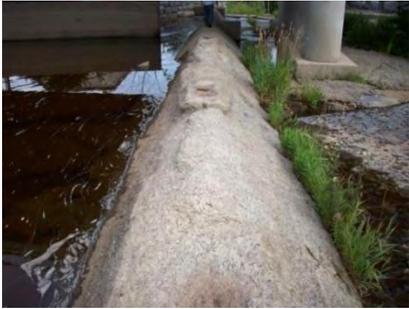
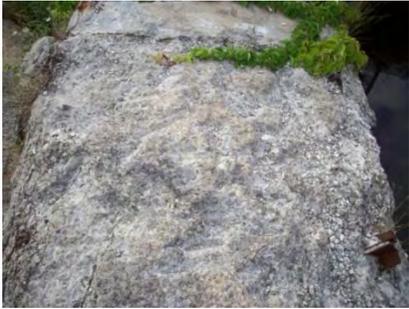
Photos 65 and 66 show the dam itself along Route 3 is deteriorating from age and erosion.

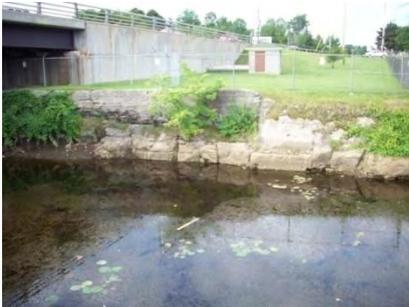
Photos 73-77 were taken of the banks around the Water Filtration Plant. There is noticeable deterioration of the structures in this area. Photo 73 taken near the Water Filtration Plant at the southwestern corner of Huntington Street and Route 3 and shows a retaining wall in poor condition. Photos 75-77 show a failing retaining wall which is directly adjacent to the Water Filtration Plant. Other deteriorating structures are also seen in these photos which will be discussed later in this report.

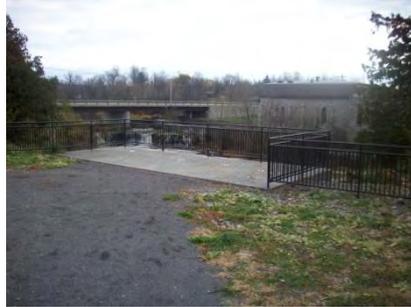
Photo 82 shows the lookout strategically located above the Route 3 wave. Photos 83-85 are of the walkway and bridge that lead patrons down to the water's edge. This area will be discussed in the recommendations section for this portion of the river.

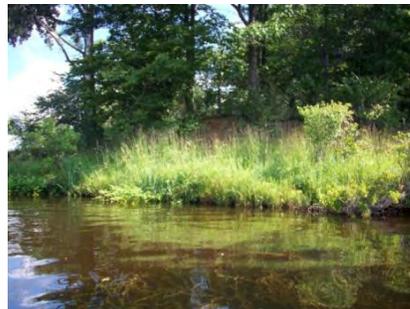
Refer to Photo 125 in which the river bank appears to be in fairly stable condition. Just down river, another section of bank with similar grades is eroding away as shown in Photo 126.

It is easy to see that when vegetation grows on the banks, it greatly mitigates the effects of erosion. This makes it logical that by planting native vegetation along eroded areas of the river would help to keep erosive forces at check. In general, the gradual eroding away of the banks in this area seems to be the most significant form of erosion. It is recommended that vegetation be planted in unstable areas to prevent this from happening. Photo 127 shows a close up shot of the upstream side of Delano Island which is eroding away. Photo 128 shows evidence of some undermining on the banks of Huntington Island which would be difficult to prevent. It has occurred even with the presence of vegetation. It is difficult to determine if this undermining is continuously eating away at the bank material or if it has reached a stable point. These undermined sections should be monitored to see the progression from year to year. If it is determined that this undermining is removing material at a substantial rate and that it needs to be prevented, it may be necessary to install structural measures such as rip-rap or even retaining wall structures. Vegetative options for stabilization are discussed in section I.F.1.

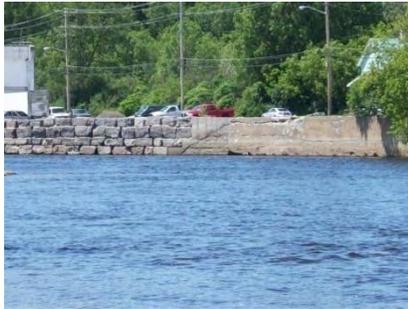
Photo 135

Continuing the inspection just to the northwest of Water Works Park, retaining walls in poor conditions are encountered near the Chapin Watermatics facility as seen in Photo 135. Photo 136 is a close up of the concrete retaining wall which is being eroded away at the normal water elevation.

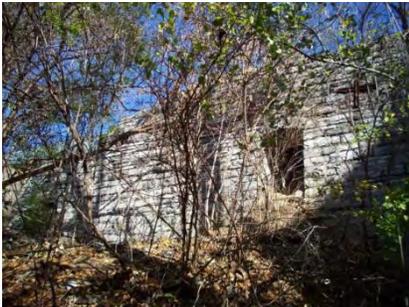
Photos 244-246 are of the deteriorating structures along the southern banks of Beebee Island downstream of the Mill Street Bridge. As can be seen from the site plans, there are buildings which sit very close to the banks in this area. These buildings look to be supported or partially supported by retaining structures which are in questionable condition. Photo 244 was taken from the bottom of the southern Beebee Island bank and shows the structure. Photos 245 and 246 are more detailed photos of these structures. Photo 246 especially shows the deteriorating condition of the retaining structures, as the stones are slowly falling out of the wall.

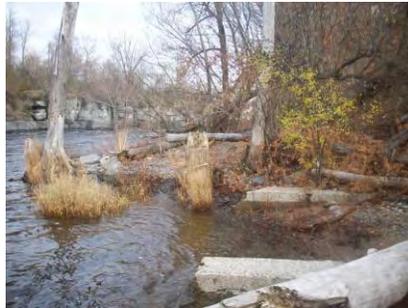
Photo 263

The material that was placed for the pedestrian paths is easily washed away by water which flows to the river as shown in Photo 220 and the area at the bottom of the stairs is eroding away. The brick and mortar structures which are along the stairway are crumbling away. At the bottom of the stairway at the river's edge are abandoned industrial structures which are crumbling as well which could pose a safety hazard to pedestrians which visit. Photos 263 and 264 were taken from the bottom of the stairway and look to the north and northeast, respectively.

It is recommended that the areas at the bottom of the stairs be cleared of debris and the structures either be removed or stabilized. If necessary rip rap could be placed in this area in a strategic stepped fashion which would double as pedestrian sitting areas. These strategically stepped sitting areas could be placed inside the existing concrete remains, if a structural inspection deemed the structures to be safe to do so. If the structures are to remain as a wall along the stairs, the crumbling brick and mortar should be repaired.

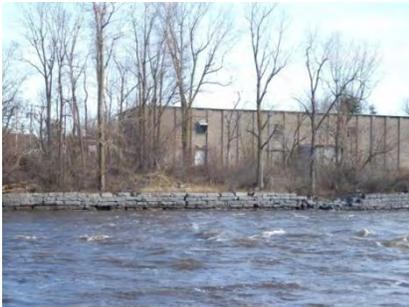
Photo 310

Photos 310-313 pan downriver from the failing retaining wall to the west along the northern banks. Photos 310 and 311 are of smaller rock wall retaining structures which are also failing. Vegetation exists along the banks behind the rock wall. Photos 312 and 313 are of the northern banks of the river upstream of the railroad bridge. Abandoned, crumbling structures are seen in the background. The banks along this area seem to be stabilized by the native vegetation.

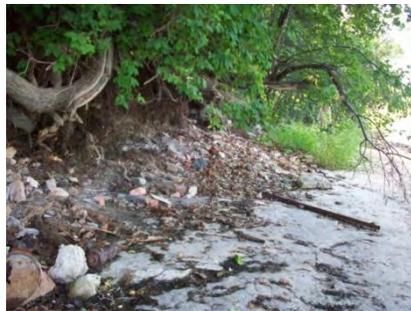
Photos 341-345 are of the waste site that exists on the southern banks of the river, to the northwest of Vanduzee Street Bridge. This area is labeled on the Overall Plan in Appendix A. Photo 341 and 342 show the lower bedrock banks in the area with debris on the higher banks which is washing away during higher flows. Photos 343-345 show closer views of the materials, including broken thermometers.
