FCS
FRANKLIN CONSULTING SERVICES

INSPECTION REPORT

PROJECT: WATERTOWN MUNICIPAL ICE ARENA

INSPECTION #: 3

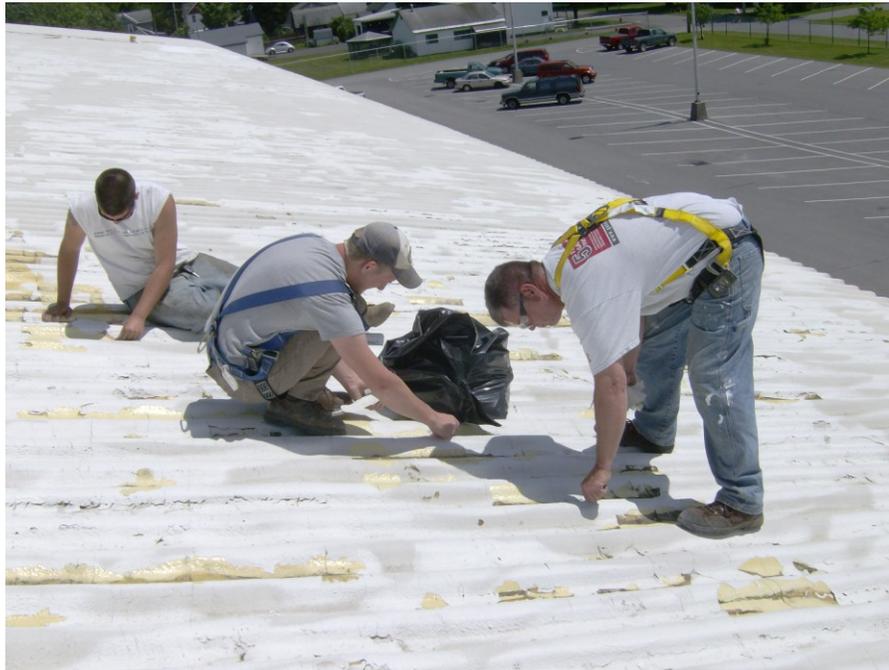
- **PREP WORK OF ROOF SURFACES REQUIRED PEELING BACK CURLED AND DELAMINATED COATING.**
- **EQUIPMENT READIED FOR SPRAY APPLICATION.**

MONOLITHIC HAD BEGUN HIS PREP OF THE SOUTHEAST CORNER OF THE BUILDING PARKING LOT SIDE. IT WAS NOTED THAT REPAIRS COMPLETED DURING LAST YEARS EFFORTS BEFORE BEING SHUT DOWN DUE TO WEATHER CONSTRAINTS WERE ONCE AGAIN FAILING. THOSE AREAS COULD BE PEELED BACK UP ONCE AGAIN. FURTHER REVIEW OF THE PEELED BACK AREAS NOTED EXCESSIVE SPIDER CRACKING OF THE PREVIOUSLY INSTALLED TRUCO COATING THE NOW HAD EXTENDED DOWN AND INTO THE FIRST LAYER OF THE SPRAY FOAM INSULATION.

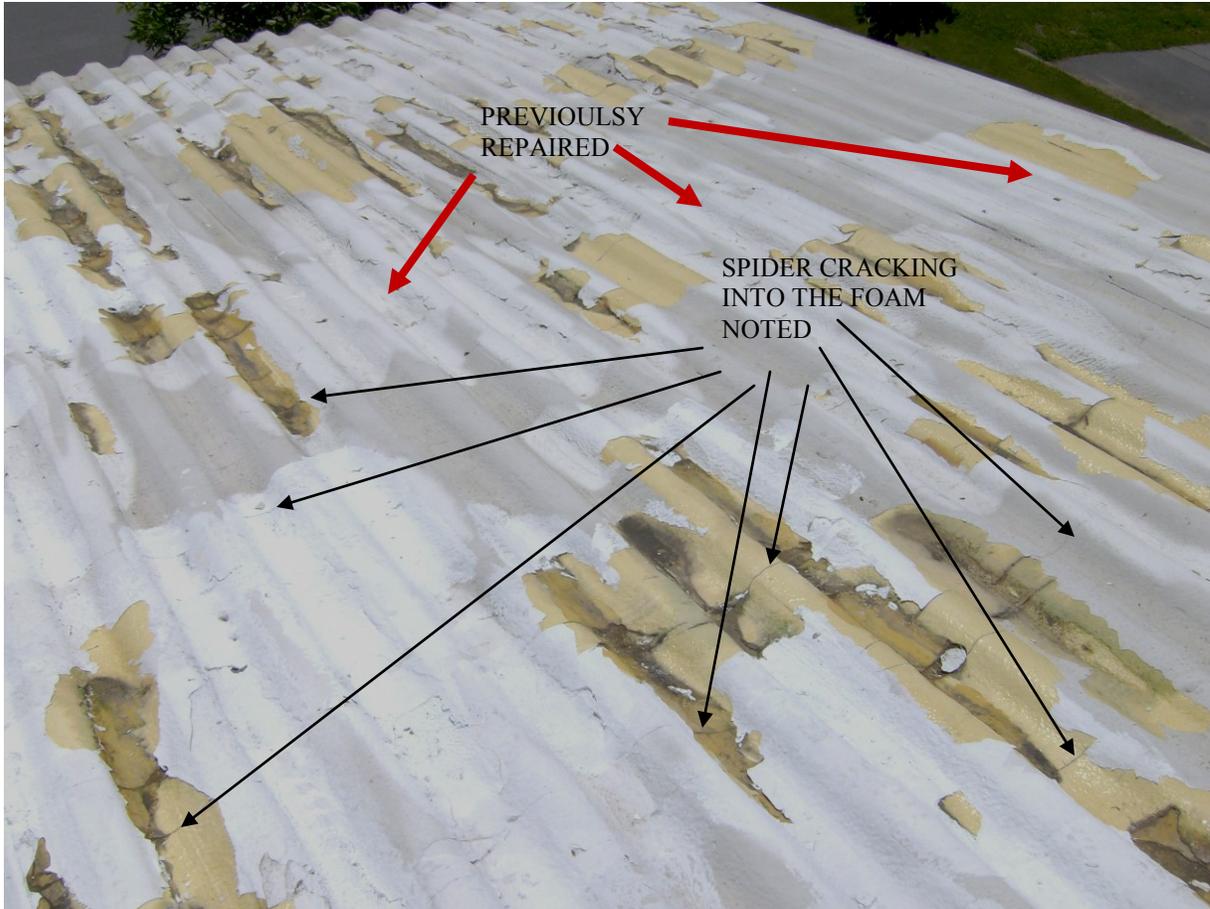
THE CONCLUSION REACHED BETWEEN TOM BOOLUKOS AND RICH FRANKLIN WAS THAT MOISTURE HAD BEEN DRIVEN INTO THE AND UNDER THE INSTALLED COATING DUE TO THE AREAS OF EXPOSED FOAM AND THE CONTINUED SPIDER CRACKING OR SURFACE GRAZZING OF THE PREVIIOULSY INSTALLED TRUCO COATING. WHEN THE ROOF SURFACES HAD HEATED, THE MOISTURE UNDER AND IN THE EXISITNG FOAM GASED OFF AND THE RESULTING VAPOR DRIVE FURTHER DELAMINATED THE INSTALLED AND THE NEWLY INSTALLED COATING.

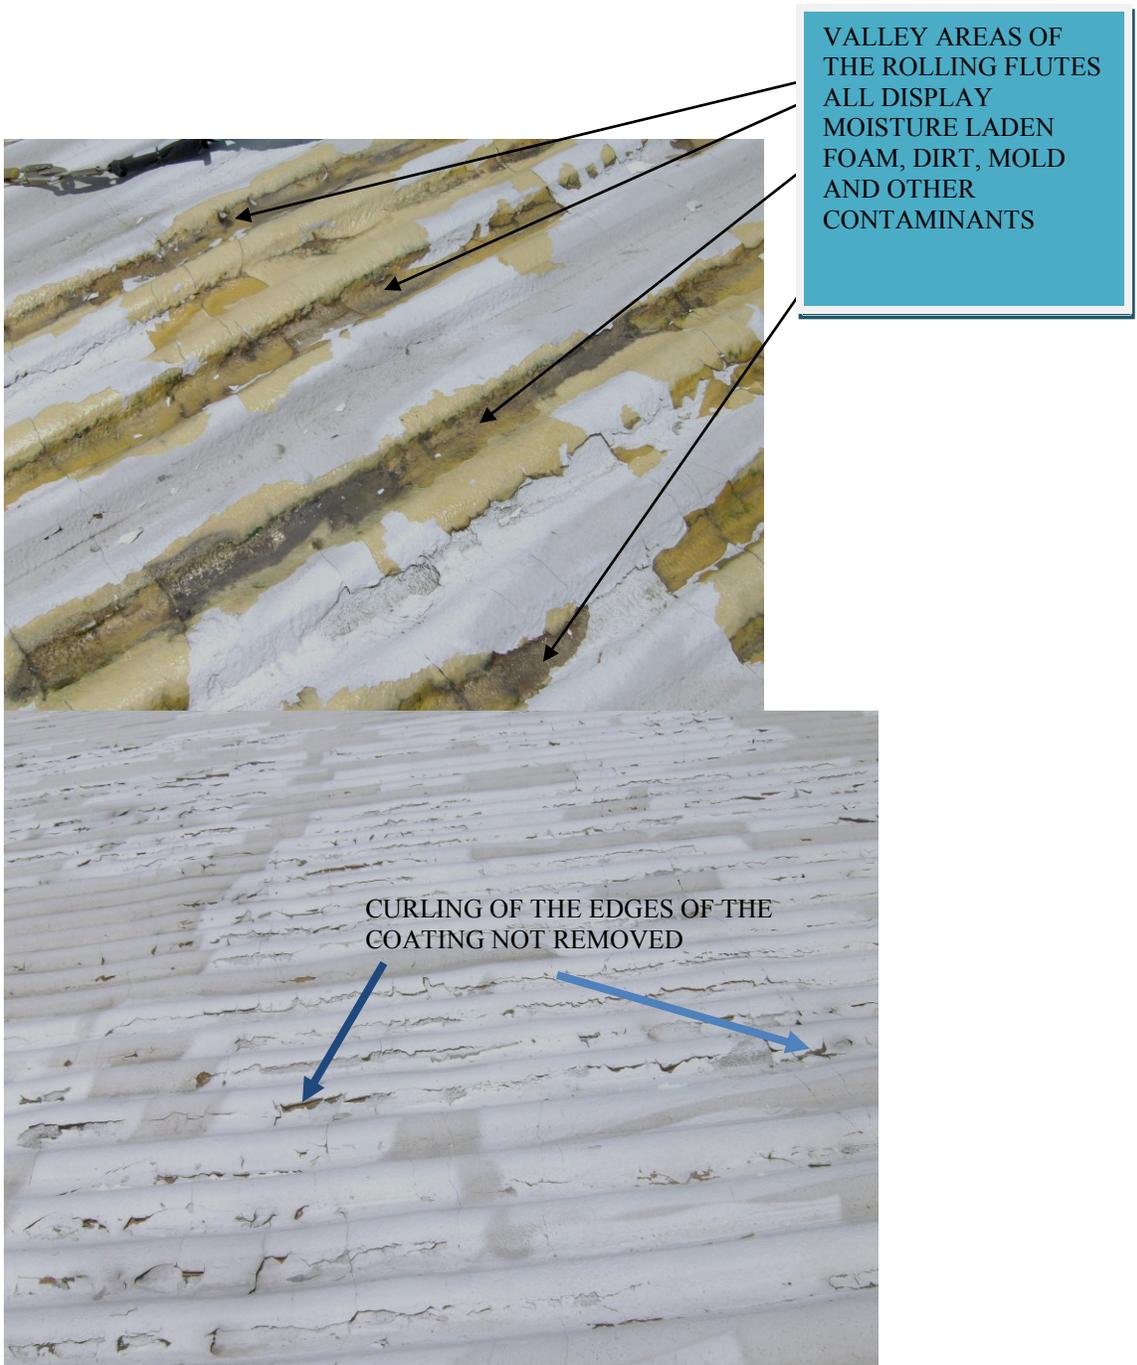
IN ADDITION, THE AREAS PREVIOUSLY PEELED AND RECOATED DISPLAYED CURLING OF THE COATING AT THE EDGES WHERE COATING HAD BEEN REMOVED AND THE ACRYLIC COATING REAPPLIED.
