City Manager's  
Status and Information Update  
October 4, 2019

**INSTUMENTED SURFACE INDENTER TEST REPORT FORM**  
**FIRMNESS AND STABILITY TEST & ACCESSIBILITY EVALUATION**

## Playground Surfacing Evaluation Protocol:

## Impact Test Results

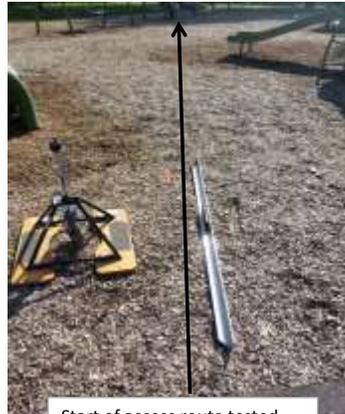
Start of access route tested

Route from pavement to harness swing - Passed					
Date:		09/20/19			
Time:		10:09 AM			
Test Reading	Firm.	Stabl.	Test Reading	Running slope <6%	Cross slope <2%
1	0.34	0.81	1	0.50%	0.35%
2	0.30	1.06	2	2.35%	0.35%
3	0.39	0.69	3	0.60%	1.90%
4	0.29	0.66	4	0.60%	0.20%
5	0.31	1.06	5	4.45%	1.70%
Average	0.326	0.856	Average	1.70%	0.90%
Std.Dev.	0.0361	0.1740	Std.Dev.	1.54%	0.74%

Cross slope on test reading #5 under swing had an original reading of 4.2% but was repaired and brought into compliance. A wear mat is recommended in order to keep clear floor space at less than 2% level.

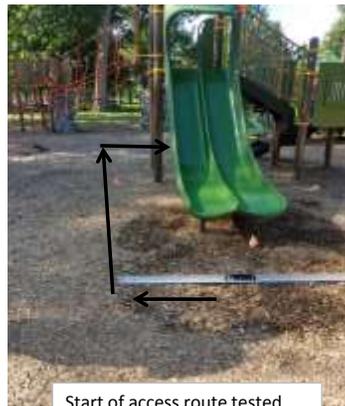
Start of access route tested

Route from transfer platform to double slide exit- Passed					
Date:		09/20/19		Date:	
Time:		10:25 AM		Time:	
Test Reading	Firm.	Stabl.	Test Reading	Running slope <6%	Cross slope <2%
1	0.36	1.20	1	0.80%	1.65%
2	0.25	0.56	2	1.55%	1.50%
3	0.33	0.59	3	1.65%	1.55%
4	0.27	0.76	4	2.90%	1.90%
5	0.28	0.93	5	4.40%	1.75%
Average	0.298	0.808	Average	2.26%	1.67%
Std.Dev.	0.0407	0.2366	Std.Dev.	1.26%	0.14%

Cross slope test spots #2 and #5 originally tested 2.1% and 2.2% in that order but were repaired and brought into compliance. Wear mats are recommended in order to keep clear floor space at <2% level.

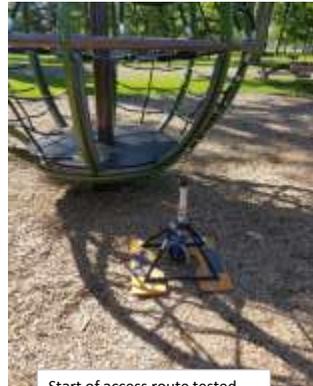
Start of access route tested

Route from harness swing to large spinner toy - Passed					
Date:		09/20/19			
Time:		10:40 AM			
Test Reading	Firm.	Stabl.	Test Reading	Running slope <6%	Cross slope <2%
1	0.34	1.06	1	2.50%	0.45%
2	0.28	0.67	2	0.60%	0.15%
3	0.32	0.66	3	0.25%	0.15%
4	0.30	0.71	4	0.35%	0.60%
5	0.27	0.50	5	2.35%	1.90%
Average	0.302	0.720	Average	1.21%	0.65%
Std.Dev.	0.0256	0.1845	Std.Dev.	1.00%	0.65%

**Notes:** Cross slope on test reading #5 under swing had an original reading of 3.4% but was repaired and brought into compliance.

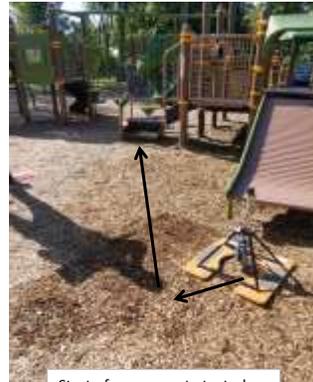
Start of access route tested

Route from roller slide exit to transfer platform - Passed					
Date:		09/20/19			
Time:		10:56 AM			
Test Reading	Firm.	Stabl.	Test Reading	Running slope <6%	Cross slope <2%
1	0.42	0.92	1	3.05%	1.85%
2	0.35	0.96	2	4.55%	0.45%
3	0.36	0.85	3	4.10%	1.85%
4	0.32	0.59	4	4.90%	1.00%
5	n/a	n/a	5	n/a	n/a
Average	0.363	0.830	Average	4.15%	1.29%
Std.Dev.	0.1486	0.3561	Std.Dev.	1.77%	0.74%

**Notes:** Short route so we took 4 readings. Cross slope on test reading #1 under slide exit had an original reading of 2.5% but was repaired and brought into compliance. Wear mat recommended at slide exit to keep in compliance.

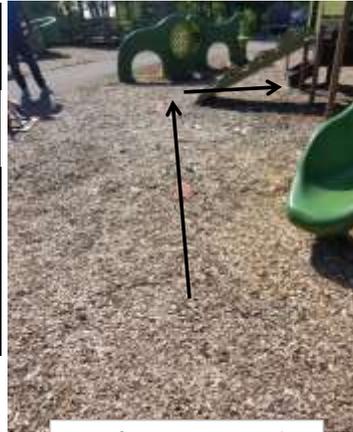
Start of access route tested

Slide exit to transfer platform - Passed					
Date:		09/20/19			
Time:		11:13am			
Test Reading	Firm.	Stabl.	Test Reading	Running slope <6%	Cross slope <2%
1	0.28	0.85	1	3.60%	0.35%
2	0.34	0.70	2	0.80%	0.15%
3	0.32	0.67	3	3.15%	0.10%
4	0.39	0.87	4	0.95%	1.65%
5	0.27	0.72	5	2.50%	0.15%
Average	0.320	0.762	Average	2.20%	0.48%
Std.Dev.	0.0434	0.0818	Std.Dev.	1.14%	0.59%

**Notes:** No repairs needed for this route. Wear mat recommended at slide exit to keep in compliance.

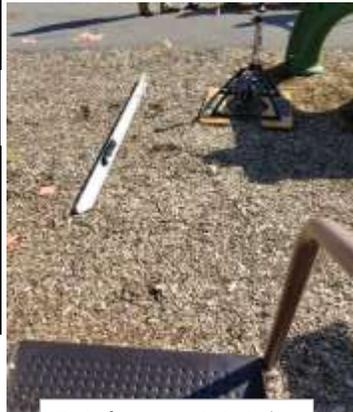
Start of access route tested

Transfer platform to pavement - Passed					
Date:		09/20/19			
Time:		11:21am			
Test Reading	Firm.	Stabl.	Test Reading	Running slope <6%	Cross slope <2%
1	0.28	0.79	1	1.75%	1.30%
2	0.34	0.80	2	1.85%	1.30%
3	0.29	0.71	3	0.25%	1.30%
4			4		
5			5		
Average	0.303	0.767	Average	1.28%	1.30%
Std.Dev.	0.0262	0.0403	Std.Dev.	0.73%	0.00%

**Notes:** Very short pathway. Took 3 readings. Cross slope on test reading #1 under transfer platform had an original reading of 4.25% but was repaired and brought into compliance.

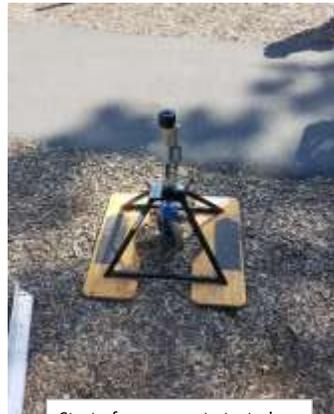
Start of access route tested

Route from pavement to spring rocker - Passed					
Date:		09/20/19			
Time:		10:09 AM			
Test Reading	Firm.	Stabl.	Test Reading	Running slope <6%	Cross slope <2%
1	0.33	0.70	1	2.60%	0.50%
2	0.29	0.64	2	4.20%	0.35%
3	0.31	1.30	3	3.50%	0.25%
4			4		
5			5		
Average	0.310	0.880	Average	3.43%	0.37%
Std.Dev.	0.0163	0.2980	Std.Dev.	0.65%	0.10%

**Notes:** Very short pathway. Took 3 readings. No repairs were made to this route.

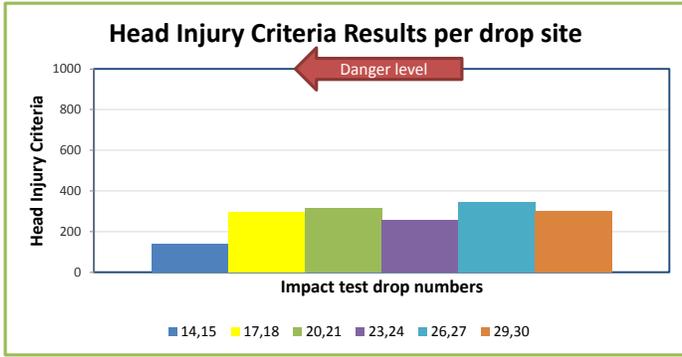
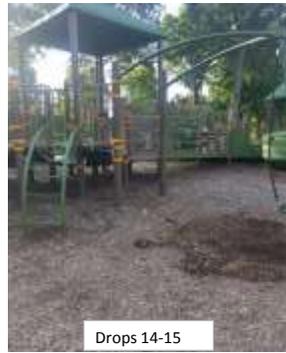
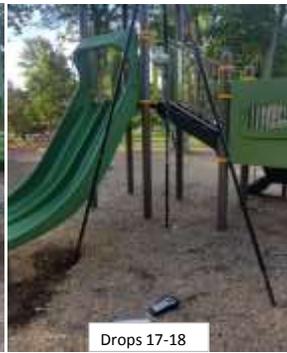
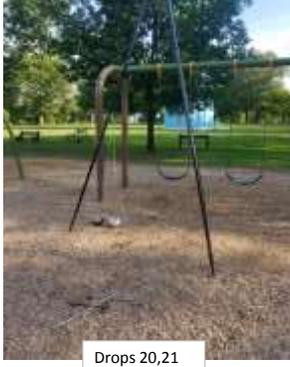
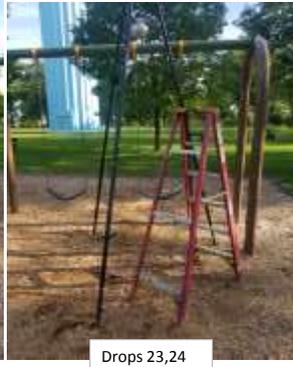
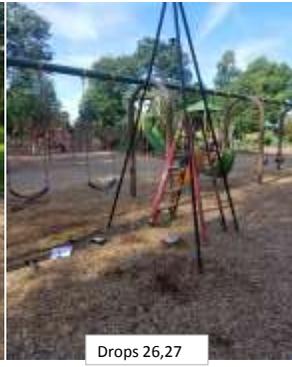
Notes : Surface was installed originally 2 years ago. It has been topped off since then. After getting readings well below the Gmax and HIC limits, and seeing that the thickness of the wood fiber was consistent, we discontinued impact testing all the other pieces of equipment.

The surfacing met the passing criteria of ASTM F3313 (formerly F1292) for impact attenuating surfacing on playgrounds.
