**CITY OF WATERTOWN**  
Ice Arena Study  
Project No. 2008-020

**May 2009**

Ice Arena Study

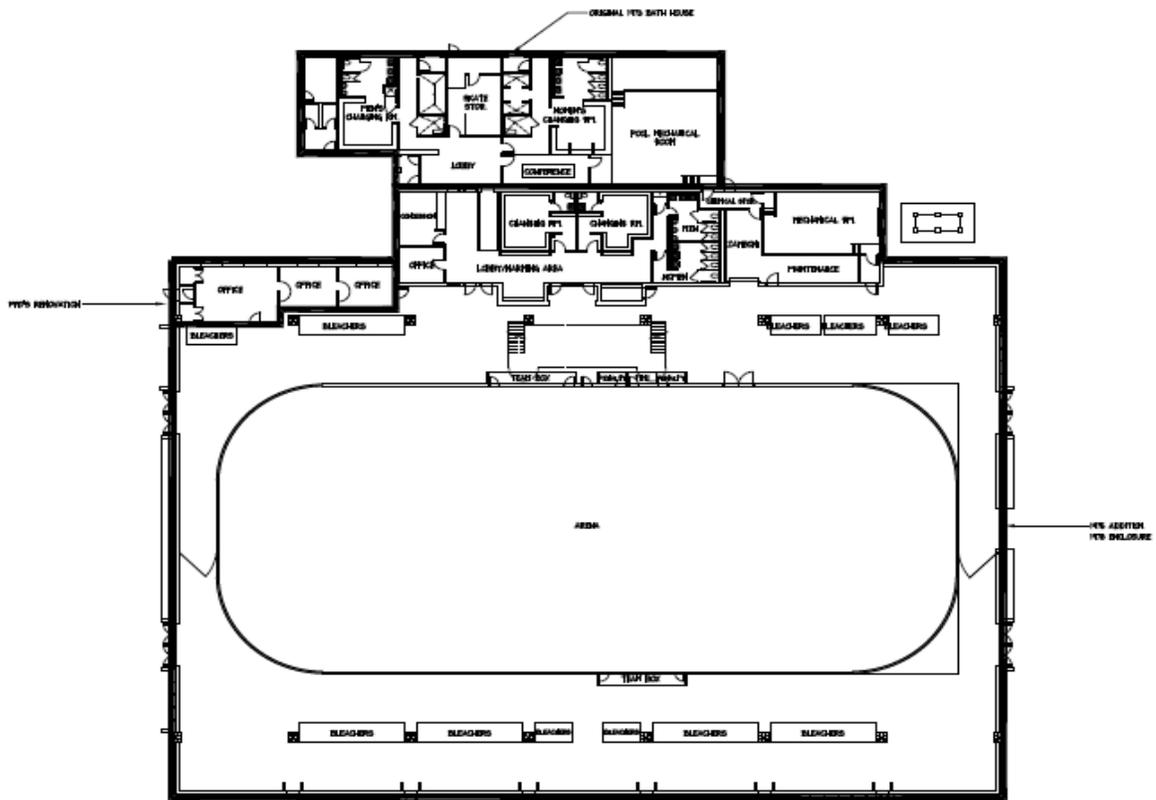
Figure 1 – Floor Plan

The current facility consists of the pool/ice arena and office area areas which are approximately 45,400 square feet of which the arena area is approximately 37,000 square feet and the supporting areas are approximately 8,400 square feet. The current layout of the facility is as shown below in Figure No. 1.

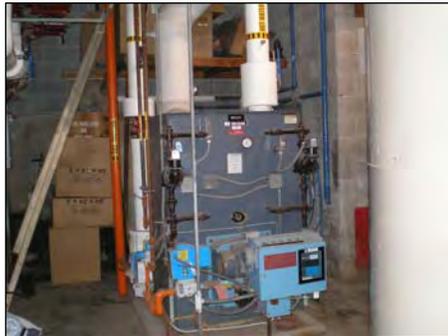
*B1 – Boiler Plant*

The heating system serving the supporting areas of this facility is a hot water hydronic system. This system consists of a central boiler, feed water pumps, hot water supply and return piping, and terminal heating units. The boiler is a natural gas fired, hot water, cast iron sectional, rated at 660 MBH. The feed water pumps are inline centrifugal. The hot water supply and return piping is copper insulated. The terminal heating units consist of ceiling hung unit heaters and fan coil units.

Hot water supply and return piping for heating runs exposed along the ceilings throughout the facility to the terminal heating units located within the individual spaces. The hot water supply and return piping is original except for the piping within the vicinity of the boiler which was replaced when the boiler was replaced in 1999. The feed water pumps were also replaced in 1999. The terminal heating units throughout the facility appear to be original.

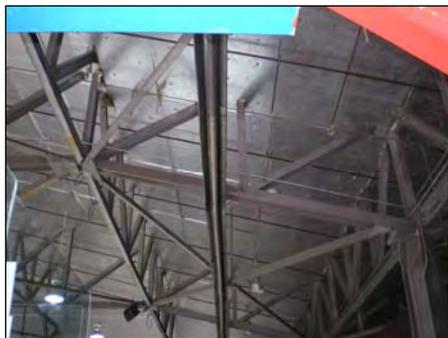
*B7 – Typical Radiant Heating Unit in Arena*

The heating system serving the arena area consists of natural gas fired radiant heating units commonly referred to as co-ray-vac. These units run horizontal along the bottom of the structural steel roof members. These units are located over the spectator areas and ice surface. Radiant heat units were donated by the Watertown Industrial Center in 1996-97 after Car Freshener donated them. Empire Northeast was contracted to install the units for \$16,470 (materials and labor) in 1997. The units were used for early spring and late fall shows as well as during special ice events.

- ♦ Replace radiant heating in ice rink area.
- ♦ Add ventilation and heating to ice rink area.

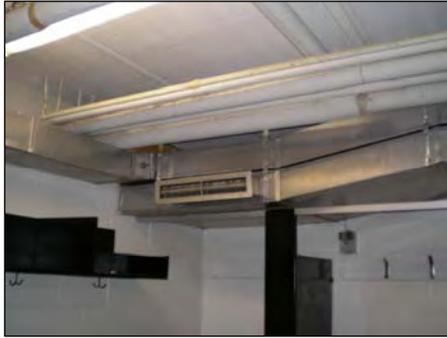
*B9 – Locker Room Ventilation Ductwork*

Mechanical ventilation to the supporting areas is only provided within the men's and women's locker rooms and lobby area outside the locker rooms. Outside ventilation air is introduced to these spaces through a fan coil unit located in the pool mechanical room and supply air ductwork. The ventilation air is exhausted from the locker rooms to the outdoors by means of a power roof exhauster.

The locker rooms were originally designed to have ventilation air provided through a fan coil unit located in the pool mechanical room. This unit provides 100 percent outside tempered air to the locker rooms and lobby through a series of duct work and is 100 percent exhausted. During our investigation, it was noted that this unit has not been operated in a number of years and was not clear if this unit is operable. Other occupied spaces (i.e., changing rooms, conference room, lobby/warming area, office, concession, maintenance room, and arena area) did not appear to have any means of ventilation. Current Building Codes require public occupied spaces to have ventilation air provided to control indoor air quality to the occupants. Toilet rooms, storage, and mechanical rooms are required to be exhausted to eliminate odors within the building.

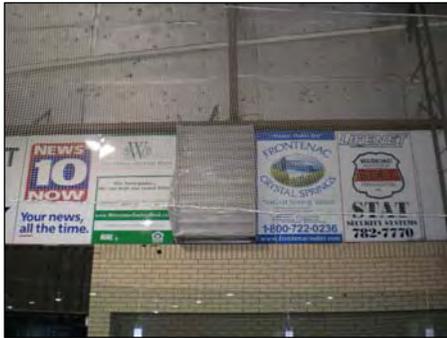
*B11 – Ventilation Supply Air Louver*

Mechanical ventilation to the arena area is provided by means of supply louvers in the end walls of the arena structure and exhausted through an exhaust fan on the opposite end of the structure.

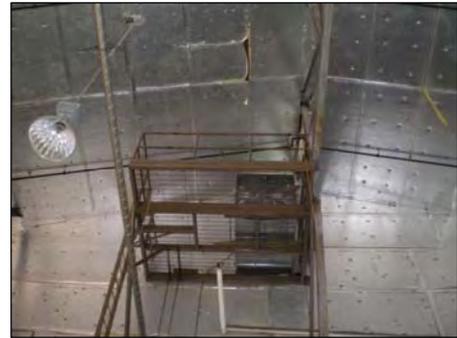
*B12 – Ventilation Exhaust Fan*

During period when the ice sheet is in place, ventilation of the arena area can cause problems. Excessive humidity is a problem with indoor rinks. Humidity causes fog, condensation, mildew, odors, and rust. The optimum moisture content is around 30 to 40 percent RH. A new humidification system was installed to eliminate humidity and moisture problems. The dehumidification unit for the ice arena is located on the east end, exterior of the building. This unit was installed in 2004.

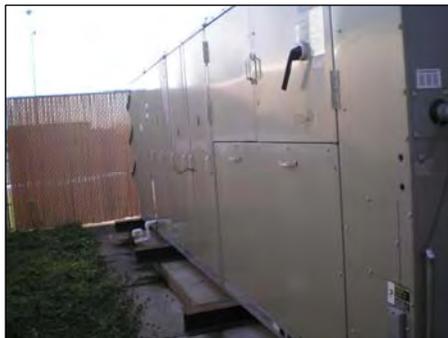
*B15 – Air Conditioning Unit Arena*

Air conditioning is provided in only limited areas of the facility. The office area and arena area have air conditioning. The office area has a condensing unit serving a DX coil in the air handling unit serving the office area, and the arena has a packaged air handling unit serving its area. It is not known when the A/C unit for the office area was installed but assumes in 1998 when the offices were built. The A/C unit for the arena area was installed in 2004. The packaged air handling unit consists of the condensing compressors, DX coils, fans, and motors all in one unit. This unit is located on the east end, exterior of the building.

The air conditioning unit for the arena was installed to provide cooling when necessary during summer events that utilize the facility.

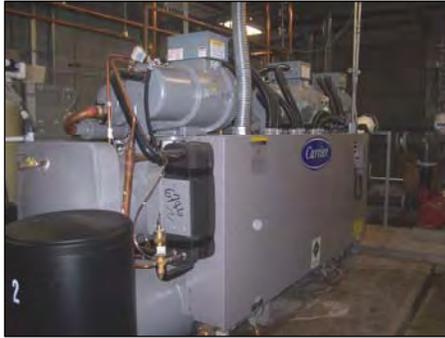
B18 – Arena Chiller

To produce ice in the arena requires the use of mechanical cooling within the floor of the skating rink for the ice to form. Chilled brine is circulated through a series of piping under the floor slab within the rink area. The piping under the slab is original 1975 low density polyethylene piping with steel headers. Over the 34 year life of the system, there have been relatively few leaks and the system has performed well. Some sections of the steel header have been replaced with new flanged sections. This brine is cooled through mechanical cooling via a chiller. The chiller for the arena was replaced in 2007 and is in excellent condition.

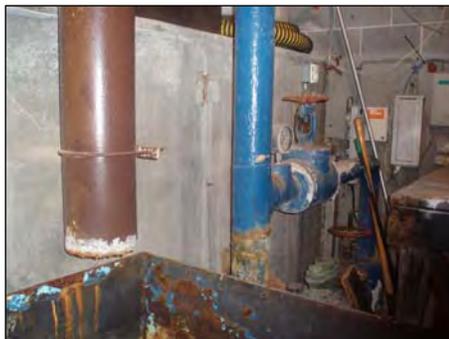
*C1 – Water Entrance*

The domestic water for the facility is from a municipal source. The domestic water enters the building in the pool mechanical room. From there the water is supplied throughout the building to the locker, toilet and other rooms.

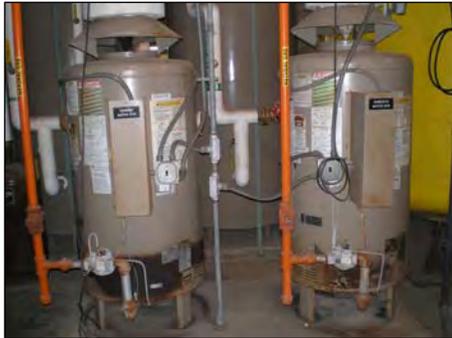
*C2 – Domestic Hot Water Heaters*

The domestic water heaters and storage tanks were replaced in 1992.

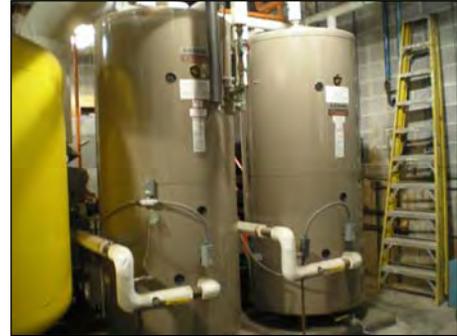
*C3 – Domestic Hot Water Storage*

Hot water is produced in the pool mechanical room by means of gas fired domestic water heaters. There are two (2) water heaters, one (1) for domestic hot water to the toilet rooms, concessions, and locker rooms and one (1) for the hot water to the Zamboni room. From the heaters, the water is stored in tanks ready for usage.

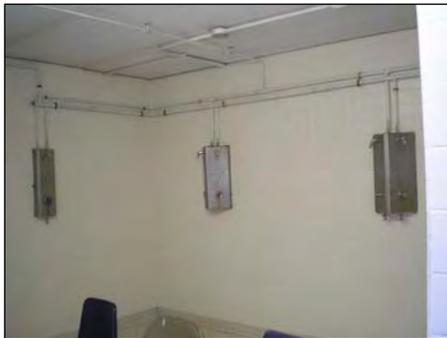
*C4 – Domestic Water Piping Shower Room*

From the pool mechanical room domestic hot and cold water is supplied throughout the building. The supply piping is copper with fiberglass insulation. The supply piping is exposed within the locker rooms and mechanical spaces.

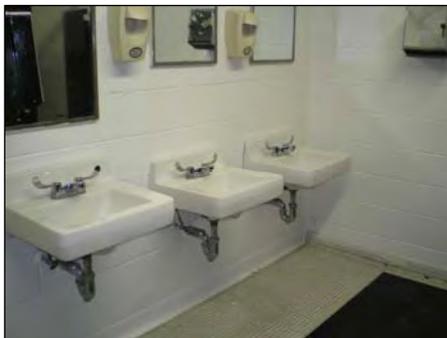
*C6 – Plumbing Fixtures Locker Room*

There are toilet facilities and showers in both the men's and women's locker rooms and men's and Women's public restrooms off the lobby area. The fixtures in all the toilet rooms are not original and the date of replacement is unknown.

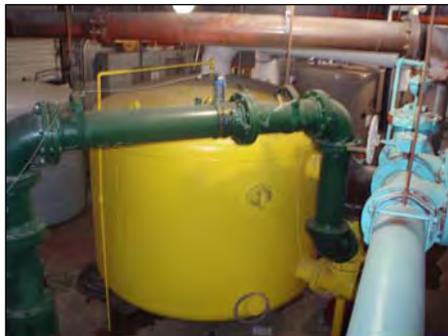
C10 – Pool Filter

The pool filtration system is located in the pool mechanical room. The system consists of filter, strainer, circulation pump, chemical feed, and chemical control, and circulation piping. The filter is pressure sand and appears to be original equipment. The strainer is cast iron and appears to be original equipment. The circulation pump is closed coupled centrifugal end suction and was replaced around 2002. The chemical feed system consists of chemical feed pumps and chemical storage tanks. The age of these components is unknown. The chemical controller consists of sensor probes in the filtered water return to monitor the chlorine residual and PH of the water and a control panel. The control panel is connected to the chemical feed pumps and controls the pumps for chemical feed to the pool water. This system is not original and its age is unknown.

The pool filtration system is in fair condition. The pool filter has been maintained well, yet is outdated and need of replacement. The strainer is outlived it useful life and in need of replacement. The pool pump is relatively new and in good condition. The chemical storage and feed system is relatively new and is functioning properly. Other alternatives to liquid chlorine and acid should be investigated for use as a disinfectant and PH control. The chemical control system appears to be in good condition. There was no indication that this system was not operating properly. The chemical feed and probes were replaced in 1988.

- ♦ Replace water supply piping in pool mechanical room that was not replaced at the time the water heaters were replaced.
- ♦ Replace and repair water supply piping insulation throughout facility.
- ♦ Replace pool filter.
- ♦ Replace strainer.
- ♦ Replace chlorine and acid feed system with alternative system.
- ♦ Construct chemical storage room.

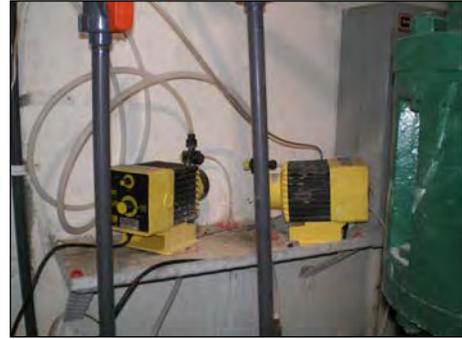
C15 – Chemical Feed Pumps

The chemicals for disinfection and PH control for the pool are stored in the pool mechanical room. The corrosiveness of these chemicals is causing premature deterioration of equipment within this space.

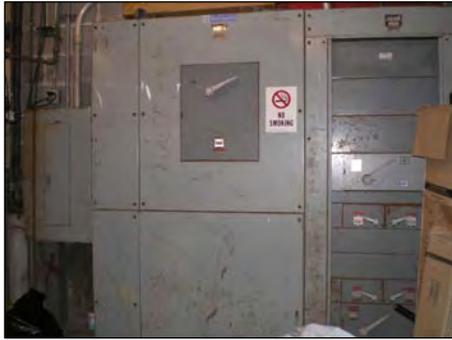
*D1 – Main Disconnect and Distribution Panel*

The electrical service to the pool mechanical room is 120/208 volt three phase. The main disconnect within this room is 400 amp. Adjacent to the main disconnect is the main distribution panel. Located within the pool mechanical room are power and lighting distribution panels. These panels provide the power for lighting and equipment for the pool area and pool mechanical room. These main disconnect main, distribution panel and power and lighting panels are original.

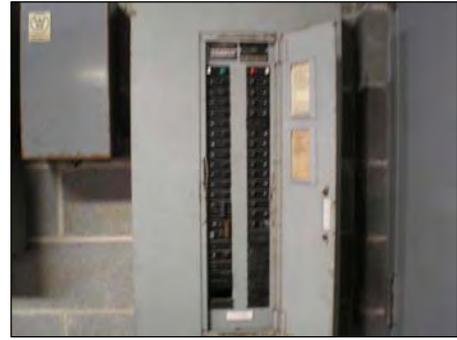
*D2 – Power Distribution Panel*

The main disconnect, main distribution, and power and lighting panels in the pool mechanical room are showing deterioration due to the corrosive environment in this room.

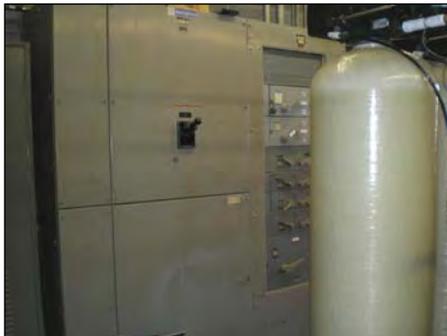
*D3 – Main Disconnect Chiller Mechanical Room*

The electrical service to the chiller mechanical room is 277/480 volt three phase. The main disconnect within this room is 800 amp. Adjacent to the main disconnect is the main distribution panel. Located within the chiller mechanical room are power and lighting panels, 480/208 volt step-down transformers and metering equipment. These main disconnect, distribution panel, power and lighting panels and step-down transformers are original equipment other than a main distribution section that was added during the chiller replacement.

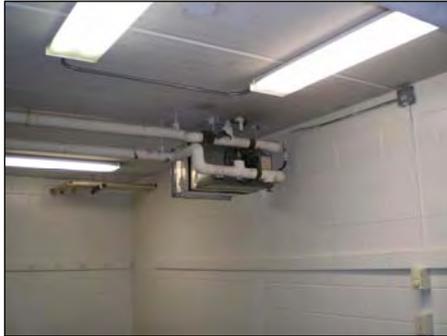
*E1 – Lighting in Conference Room*

The lighting within the arena facility is a combination of surface mounted fluorescents, incandescent and metal halide. The fluorescents and incandescent lighting are in the interior spaces of the facility with the metal halide lighting in the ice rink area. The lighting in the rink area was replaced in 1980's.

There are no deficiencies. The lighting appears to be original, yet in fair to good condition.

- ♦ Replace fixtures utilizing high-efficiency fluorescent fixtures.
- ♦ Replace fixtures within the ice rink utilizing high-efficiency high output fluorescent fixtures.
- ♦ Install occupancy sensors throughout the facility.

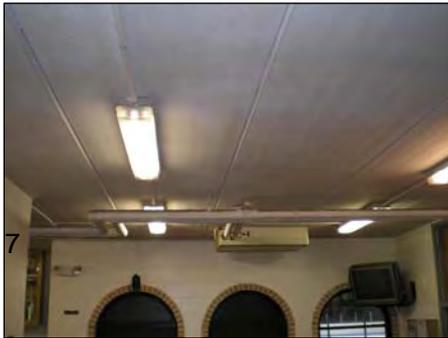
*F1 – Emergency Lighting Lobby*

There is exit lighting and emergency lighting throughout the facility. The majority of areas requiring emergency and exit lighting have adequate coverage. There are areas within the facility that Code prescribed emergency lighting coverage is lacking. The Code requires the means of egress pathway have an average of one (1) foot-candle along the egress path.

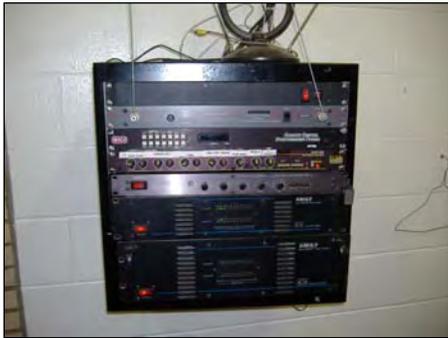
*A1 – Tuner/Amplifier*

The original public address system consists of a tuner with amplification in the office and speakers hung in the middle of the arena for the ability to broadcast music and announcements within the ice rink area. Music was played directly from the tuner with announcements from microphones plugged into wall jacks. With the addition of the viewing booth, portable equipment was added to provide flexibility in the use of the sound system for a number of venues carried out at the arena. The portable equipment is wired into the existing tuner/amplifier through a connect cable strung between the two locations.

The original tuner/amplifier is 1970's vintage. The portable equipment age is unknown. The sound/ public address system has outlived its useful life. A digital system with wireless microphone technology is suggested as replacement of the existing equipment.

The system is currently being replaced by City personnel.

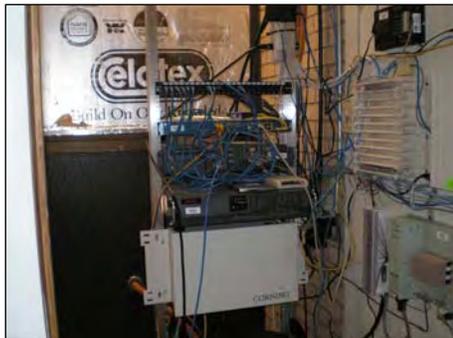
*B1 – Telephone and Data Equipment Rack*

In conjunction with the telephone and data systems installed in 2005, there is an analog Verizon demarcation in the pool mechanical room. This is the land line back-up for the arena, sewer plant, and newer street facility should the data connection to City Hall be disconnected. This system also provides fax service to the Parks & Recreation Offices.

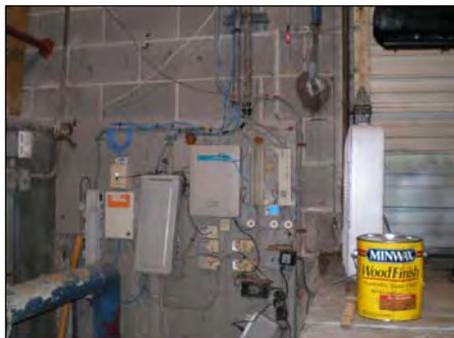
*B3 – Verizon Analog Demarcation in Pool Mechanical Room*

The Verizon analog demarcation and associated equipment in the pool mechanical room is in poor condition due to the corrosive environment within this room.

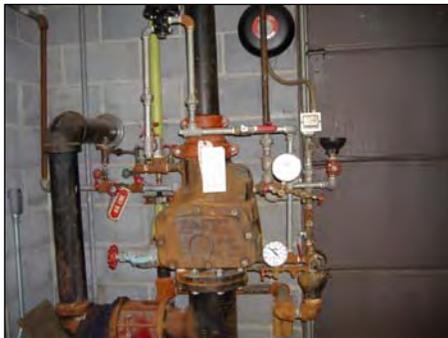
*C1 – Sprinkler System Control Valve*

The fire protection system for the Arena Facility consists of a sprinkler system in the ice rink area. There are no other means of fire protection within this facility.

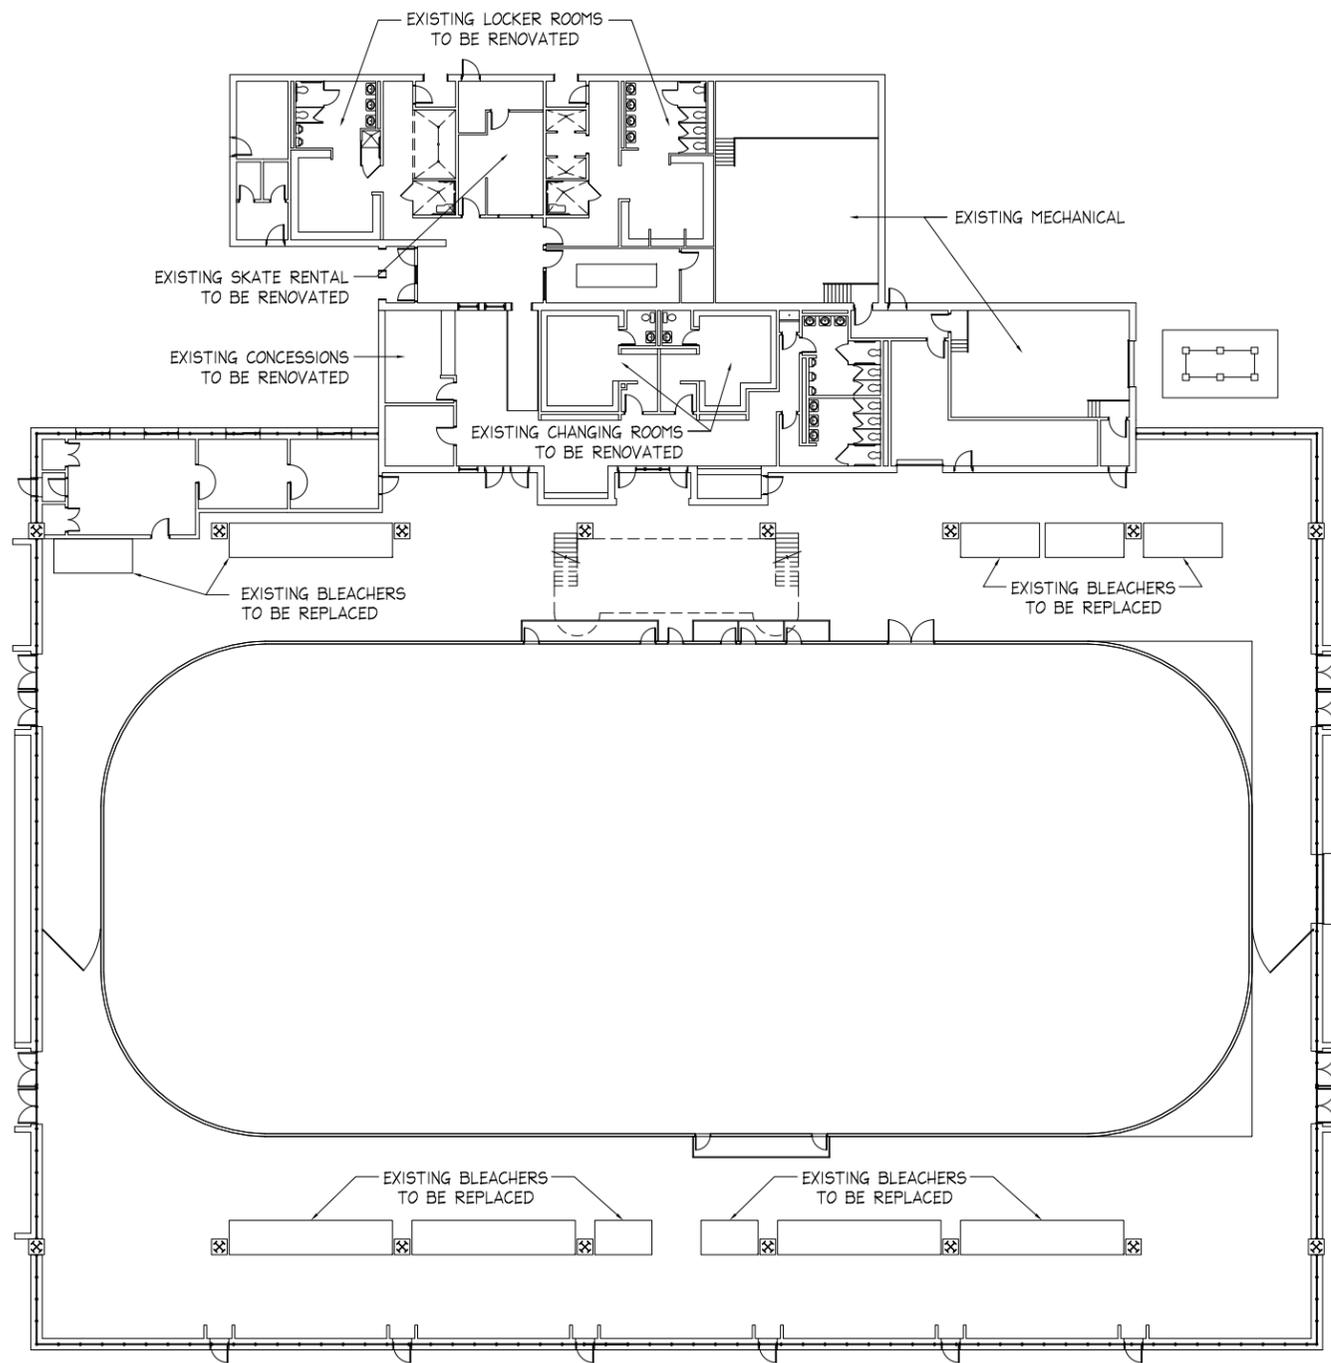
A-001

1. RENOVATION OF EXISTING LOCKER ROOMS (APPROX. 1,500 SF)
2. RENOVATION OF EXISTING CHANGING ROOMS (APPROX. 700 SF)
3. REPLACEMENT OF EXISTING BLEACHERS
4. SOLUTION TO EXISTING EXTERIOR WINDOWS IN ARENA AREA (APPROX. 4,600 SF)
5. NEW LOCKER ROOMS (APPROX 530 SF EACH)
6. NEW OFFICE CONFIGURATION (800 SF)
7. NEW ARCADE
8. NEW CONCESSIONS
11. NEW ENTRY
12. NEW STORAGE SPACE
13. NEW STAGE 2,400 SF +/-

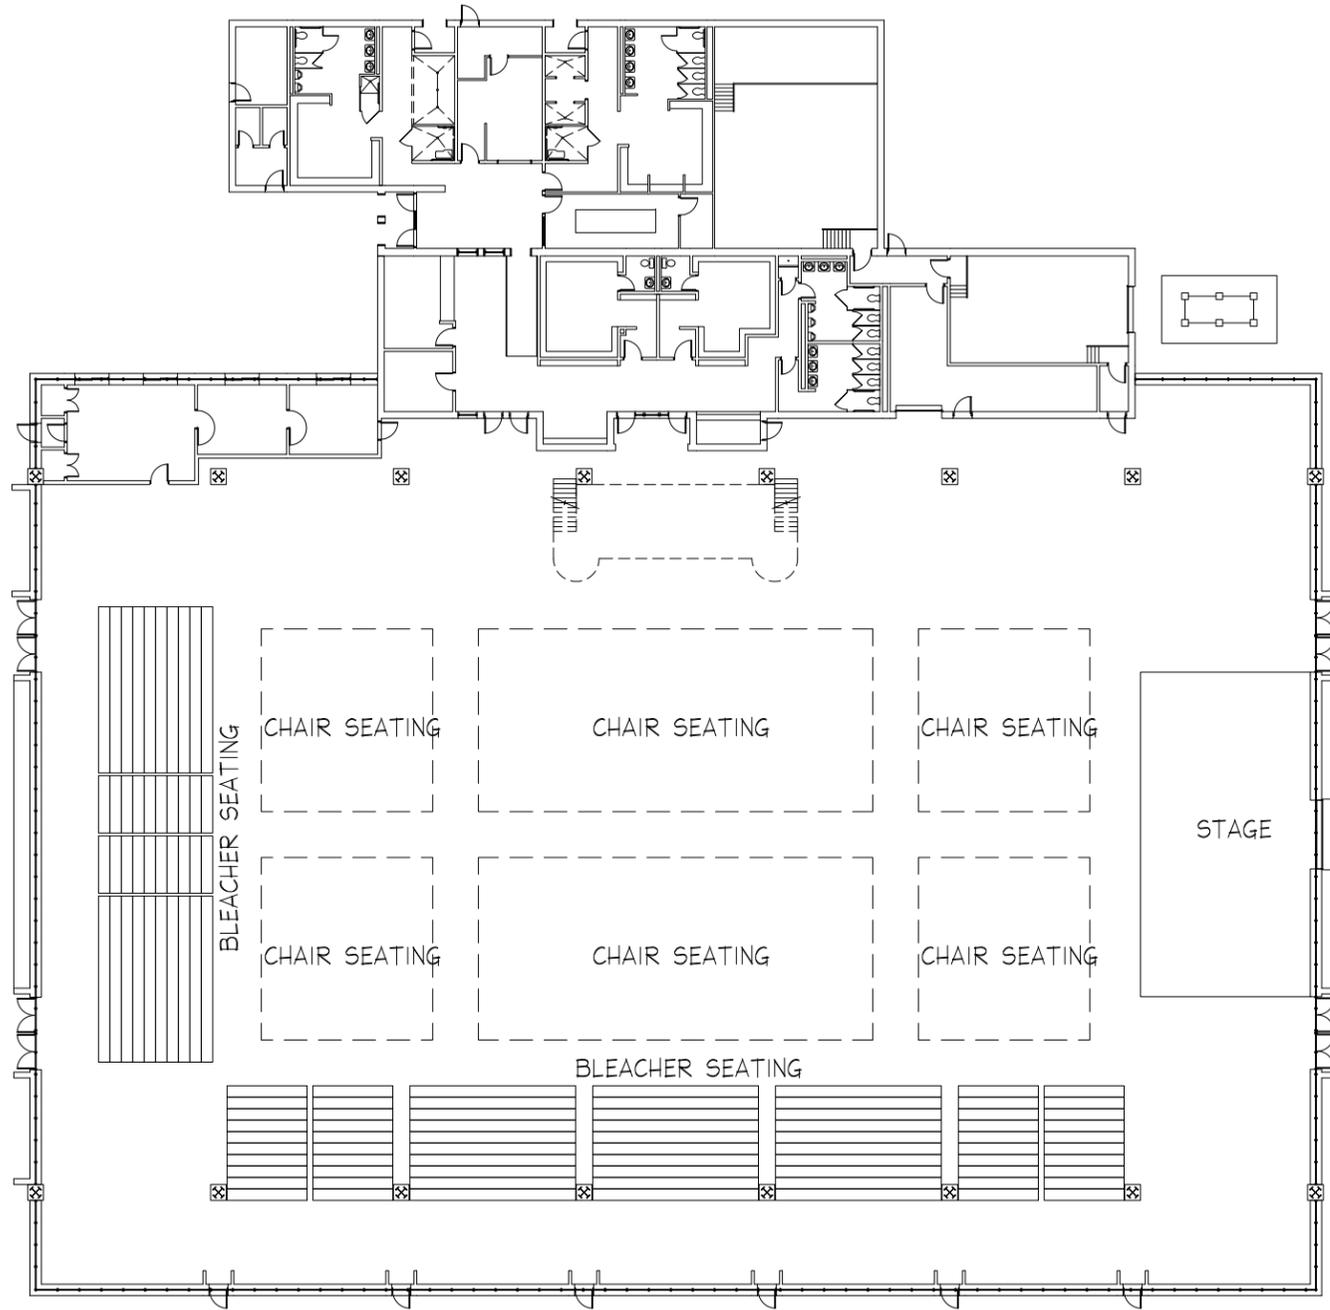
# A-003

ARENA OCCUPANCY AND EGRESS:  
 MAX. OCCUPANCY +/- 3,000 PEOPLE  
 14 EXITS PROVIDED  
 66' OF EXIT WIDTH TOTAL

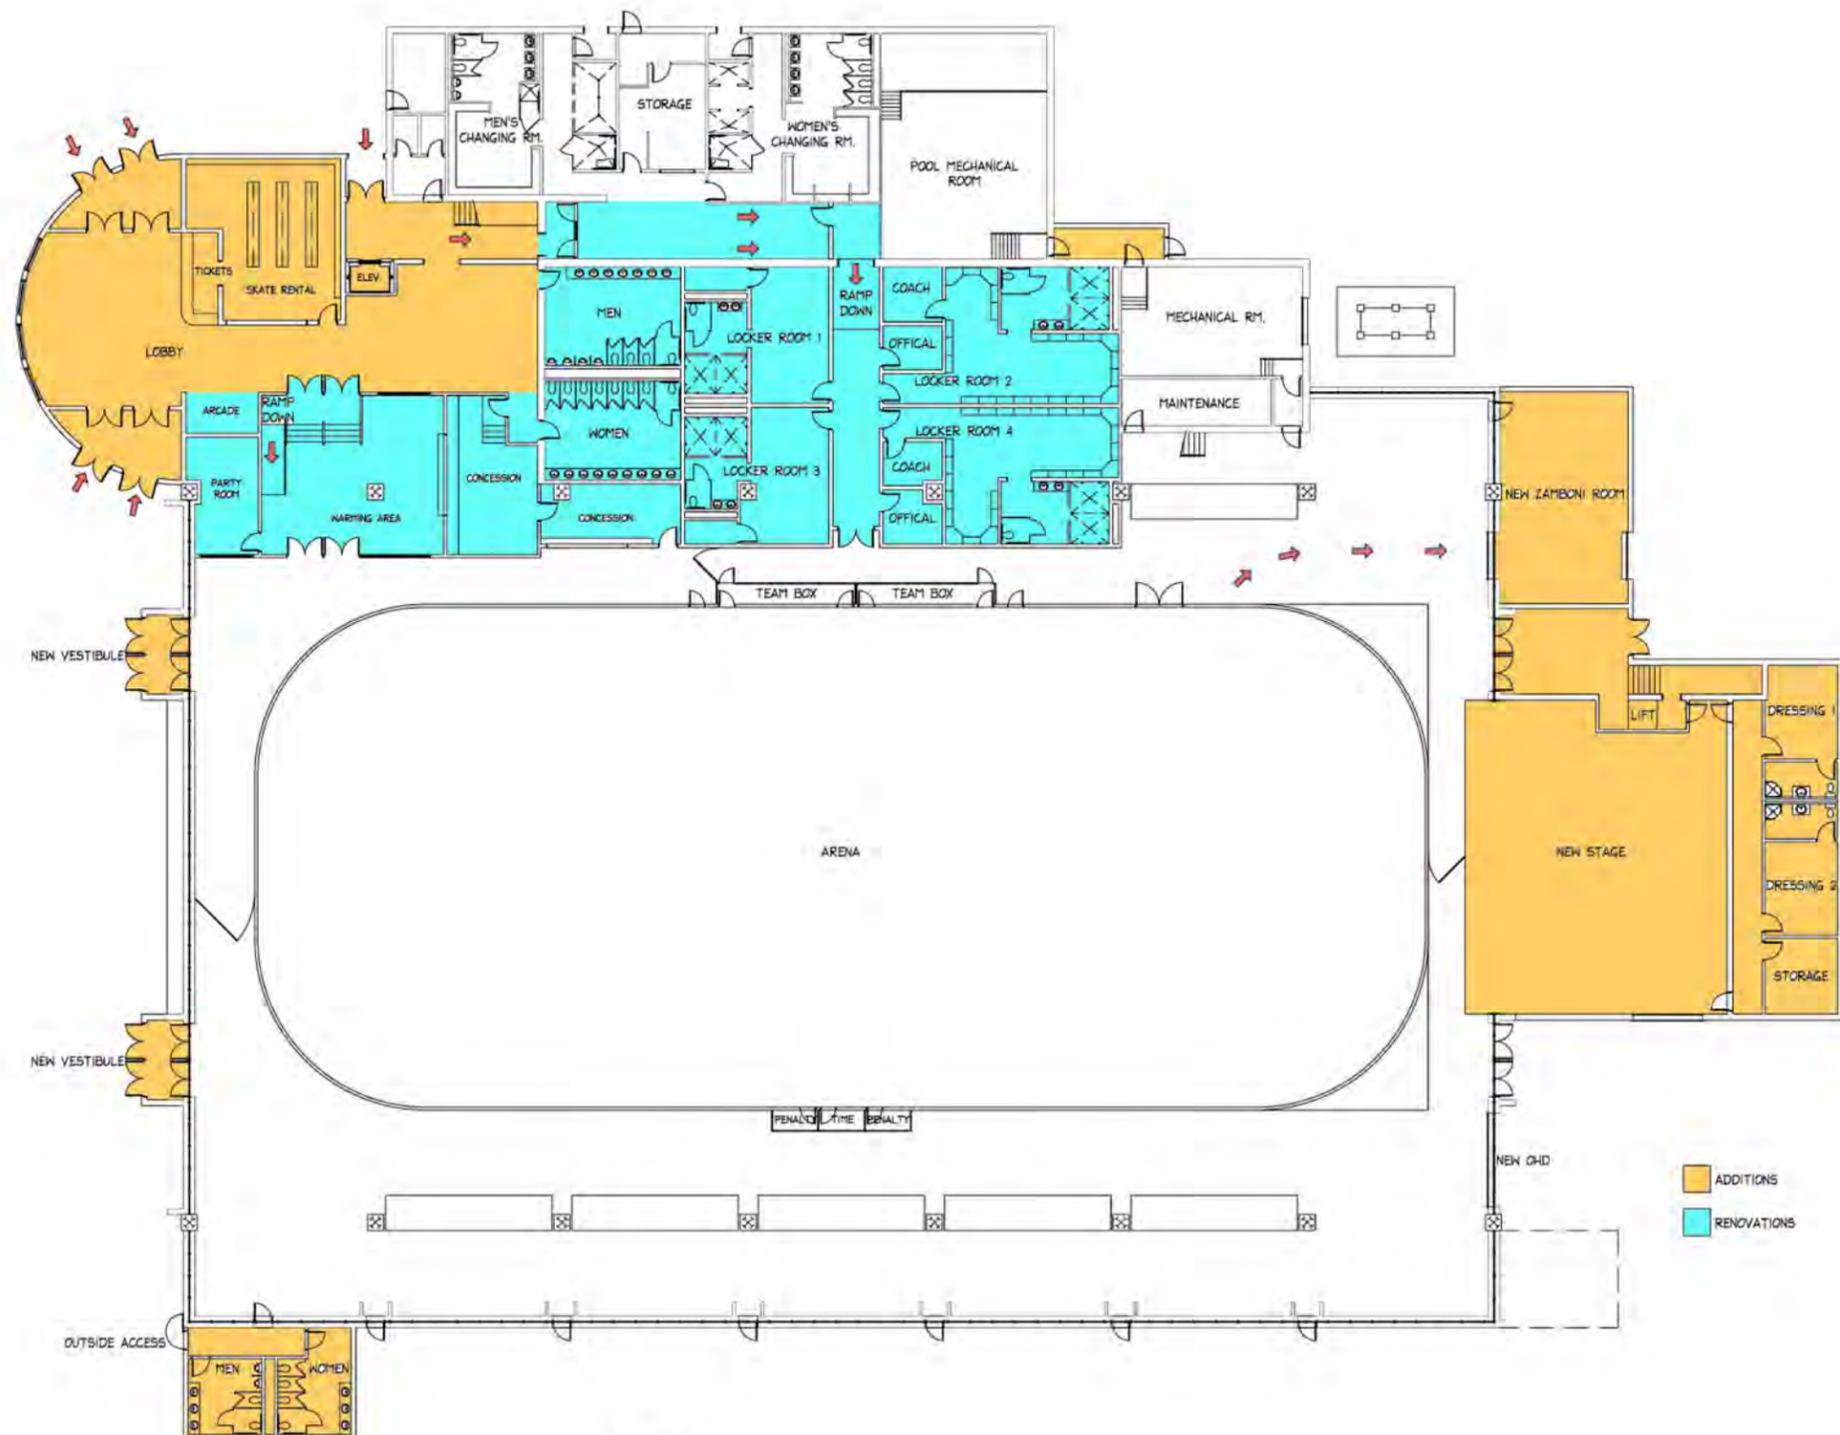
**A-100**

**PROPOSED FIRST FLOOR ADDITIONS AND RENOVATIONS**

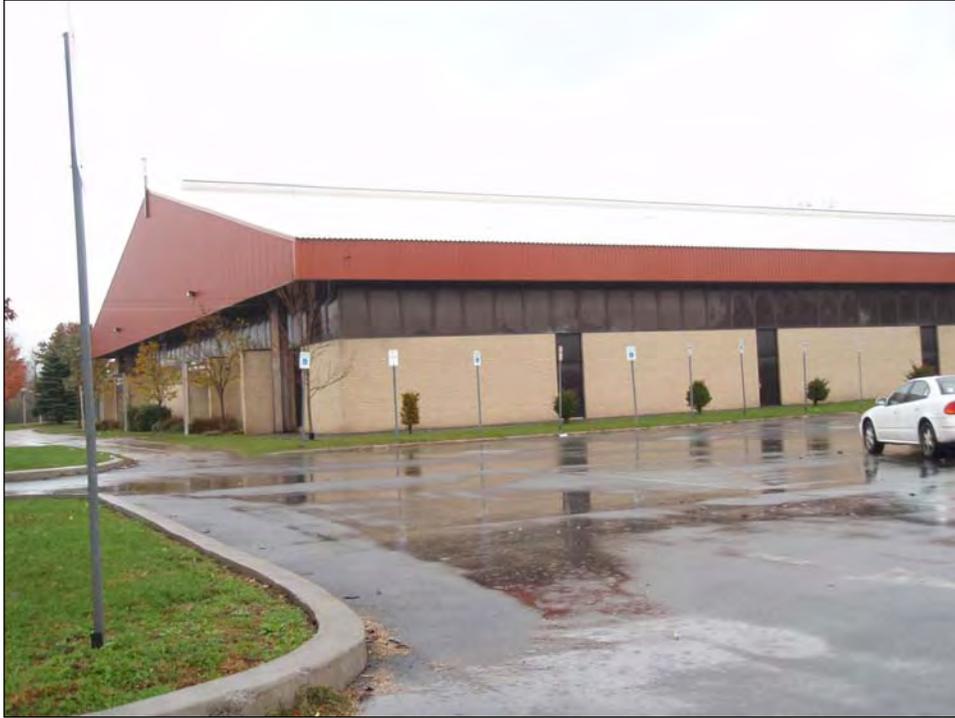
Photo 7 – Arena, Southwest Corner Showing Glazing Strip

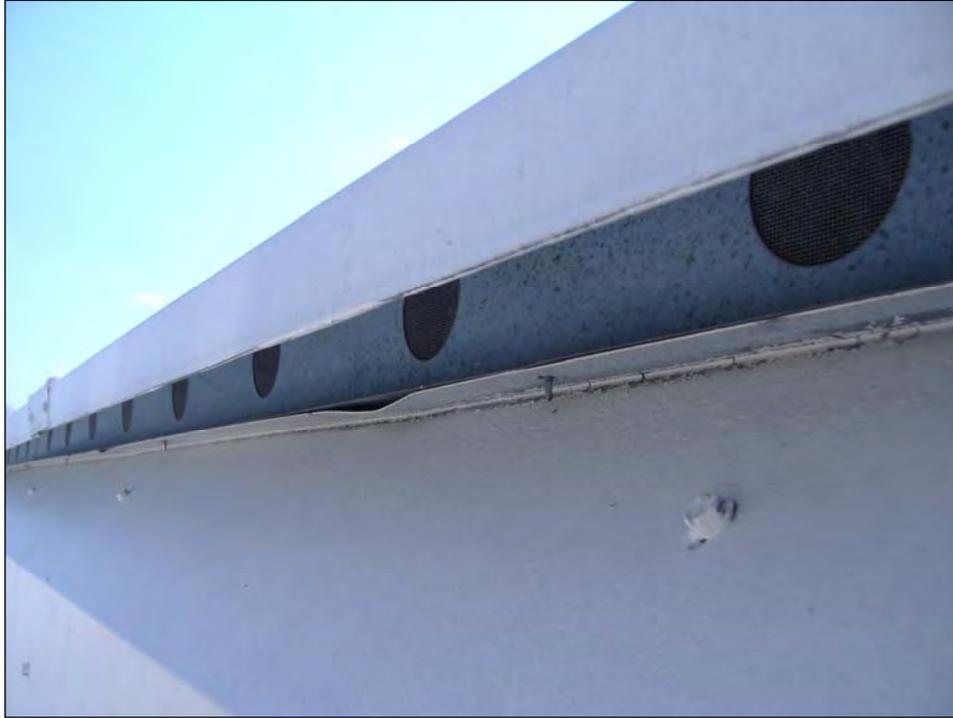
Photo 9 – Roof Vent Showing Separation

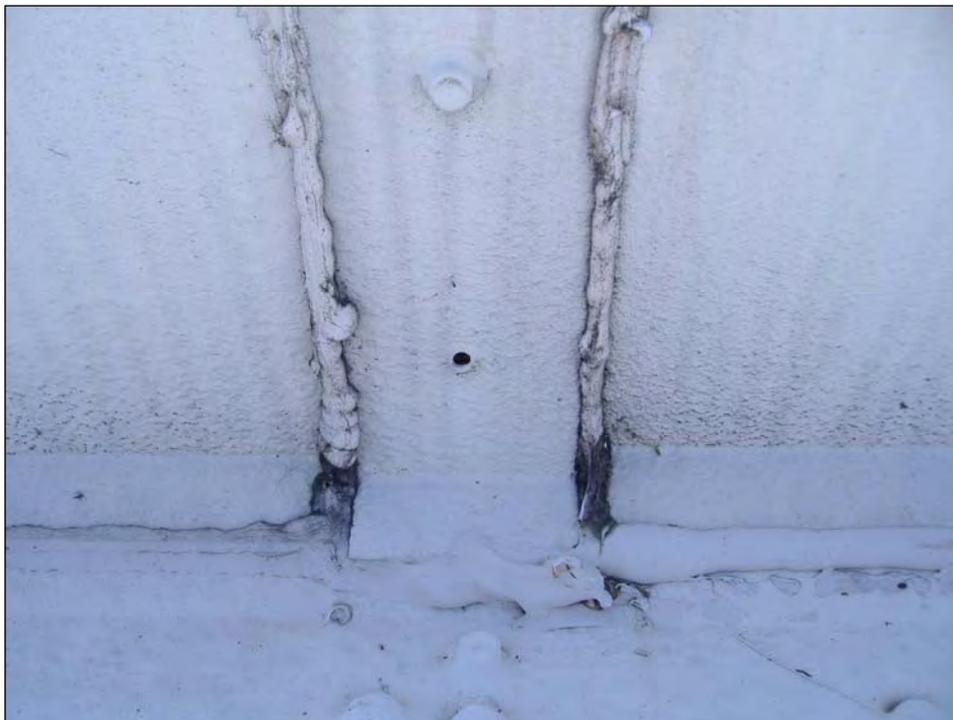
Photo 10 – Missing and Loosened Roof Fasteners

In 2004, a proposal was received from Monolithic Coatings to re-coat the roof for \$8,640. However, that proposal was not accepted. An inspection of the roof in March 2009 showed that the roof coating continues to deteriorate, and there is surface rusting on the roof edges in some locations. Also in 2004, the roof vent cover was replaced by Allside Roofing. There have been reported periodic instances of the roof leaking. Inspection of the roof vent in March 2009 showed that there were gaps where the top and sides fasten as well as gaps in the caulking on the west end.

We would recommend that the arena structure be further evaluated for the installation of a retrofit roofing system over the existing roofing system. This evaluation will include inspecting the underside of the existing roofing panel for corrosion, conduct fastener pull out tests, and evaluate the top of purlins for corrosion and the ability to support a new roofing system. This would involve accessing the underside of the roofing system with a personnel lift from the interior, removing the rigid insulation in place on the underside of the deck, and visually inspect the underside of the deck and the top flange of the roof purlins.

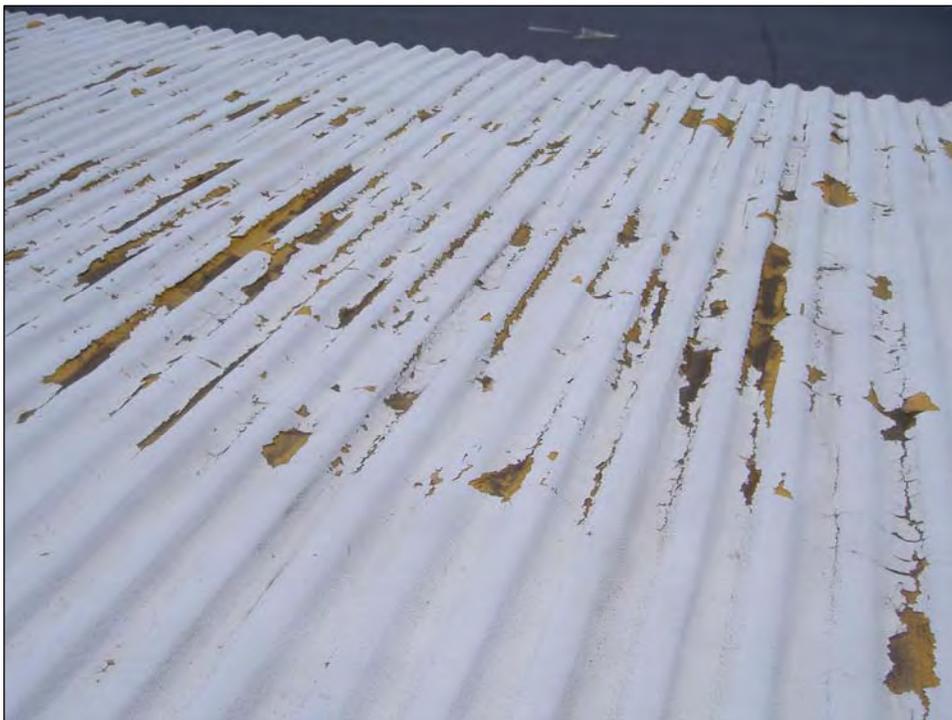
Photo 12 – Peeling Roof Coating

In 2000, the City installed a spray applied polyurethane foam retrofit system over the existing steel roof. The City received bids for two (2) alternatives; the first a spray system applied directly to the steel for approximately \$ 117,000, and a second alternative to include a one inch layer of spray applied insulation, for a total installed cost of \$ 177,000. It is our understanding the basic coating only option was selected. This coating system was installed by A to Z Coatings, Inc., of Orangeburg, NY. The product used was manufactured by Truco Inc., and began showing signs of failure in 2004. Efforts to enforce the warranty have been unsuccessful. Since that time, the roof coating has continued to delaminate.

**Option 1 – Remove and Replace Existing Metal Roofing System.** This would include complete removal of the existing metal roofing and insulation below, and replacement with an insulated roofing system. The system types could range from a batt fiberglass insulated system, to a rigid foam “sandwich panel”, to an insulated single ply EPDM system over rigid insulation and metal deck as follows:

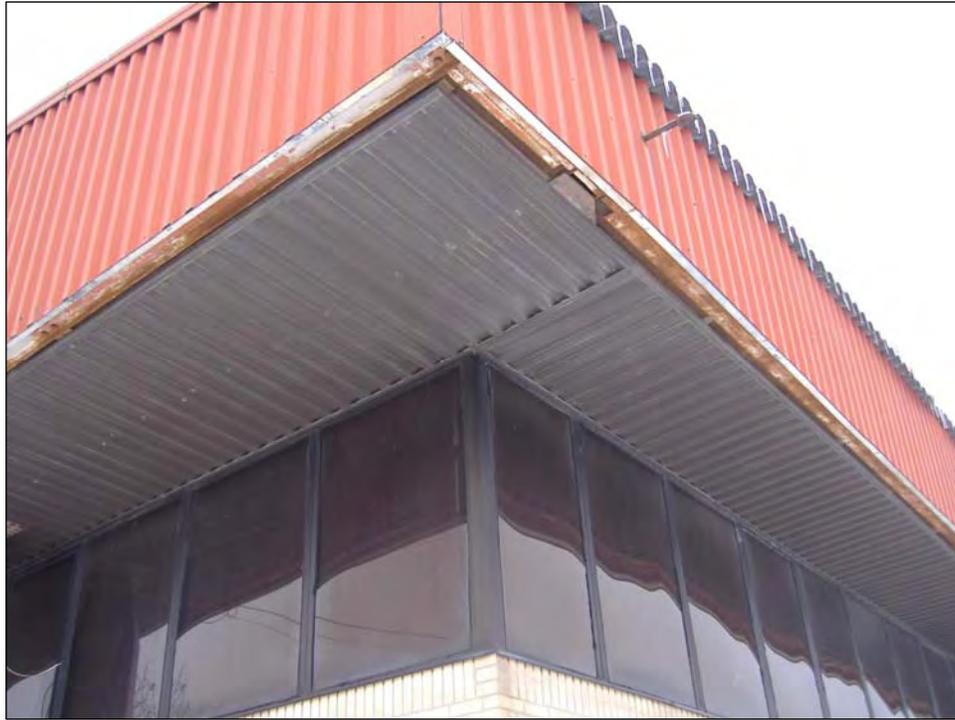
Photo 13 – Arena Glazing Strip Detail

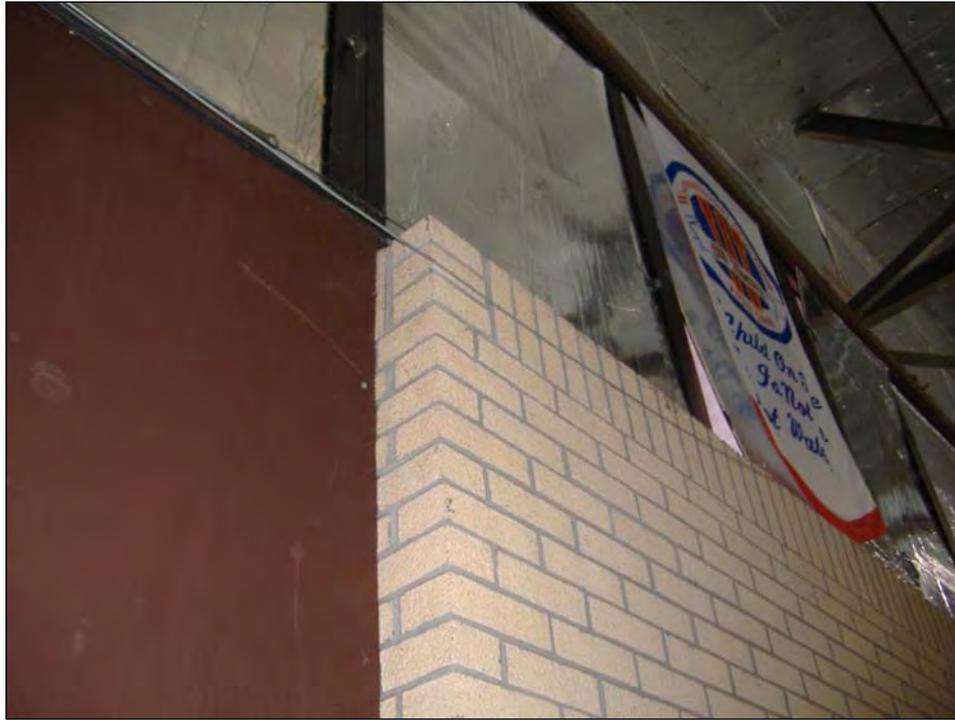
Photo 15 – Arena Glazing Strip, Interior

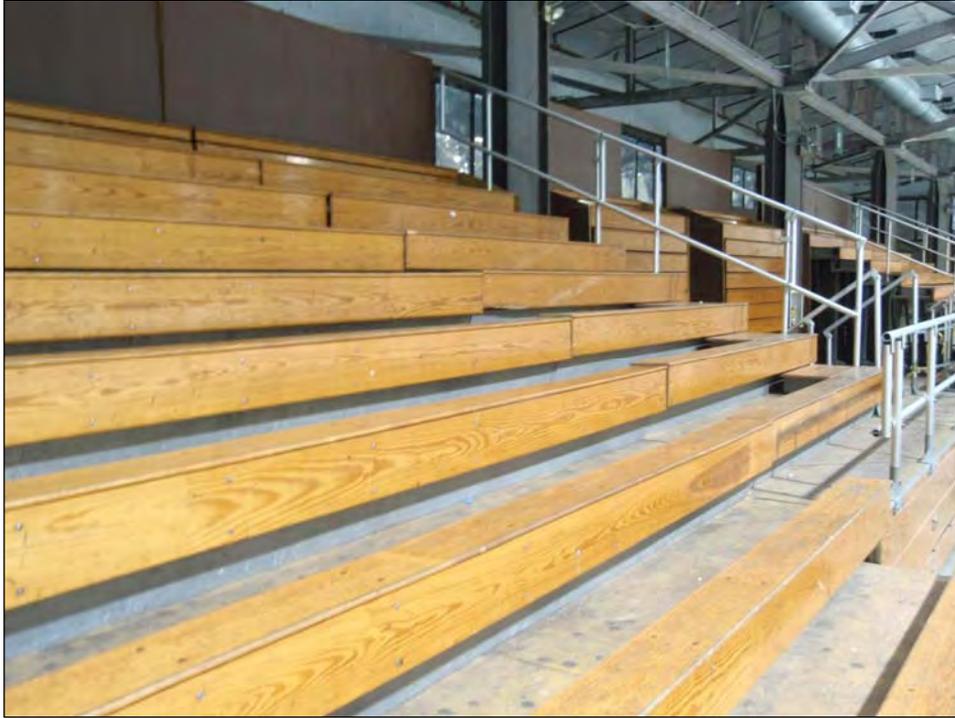
Photo 21 – Existing Wood Bleachers

- a.     The existing moveable wood bleachers are in fair condition.
- b.     The bleachers do not meet current safety and accessibility standards.
- c.     Recommend that the City consider phasing out the existing bleachers and buying new movable units to meet the current standards.

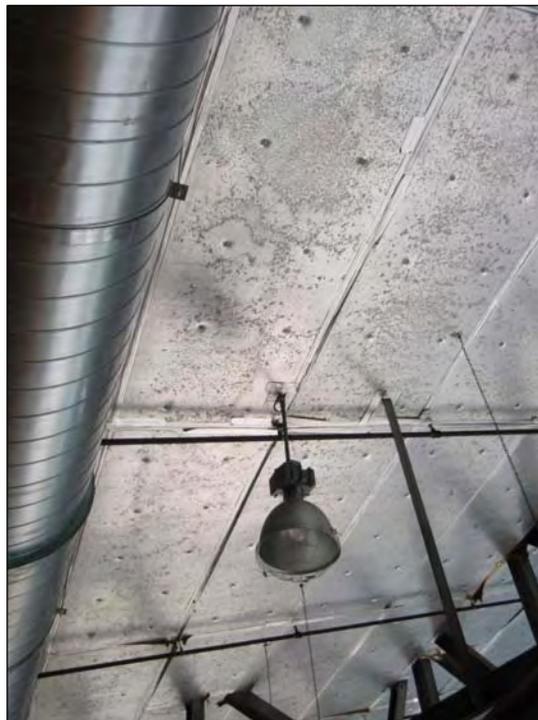
Photo 22 – Arena Ceiling Insulation

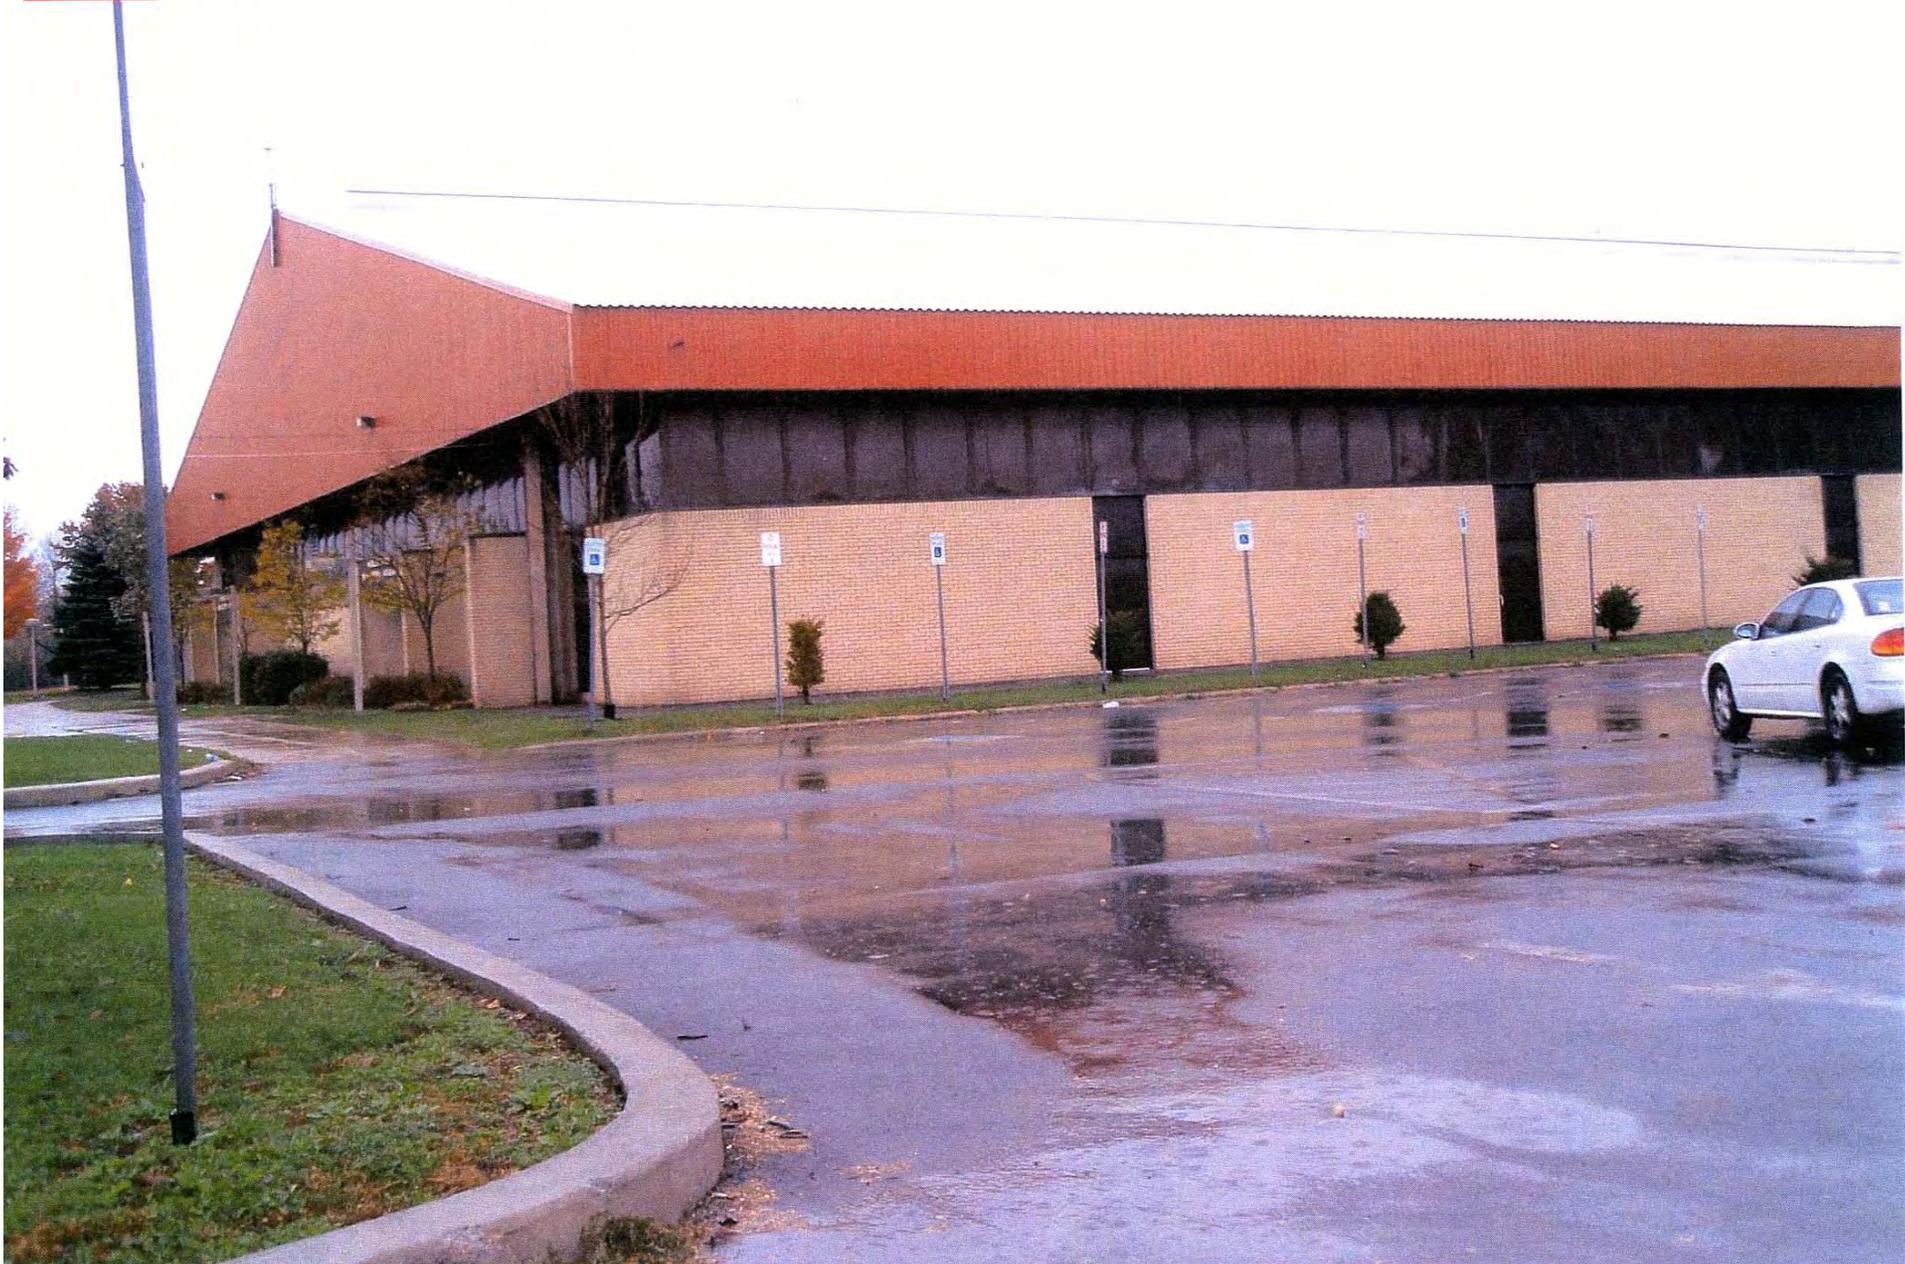
**b  
& a** METAL SIDING  
OPTION C
