**CITY OF WATERTOWN**  
Ice Arena Study  
Project No. 2008-020

**May 2009**

Ice Arena Study

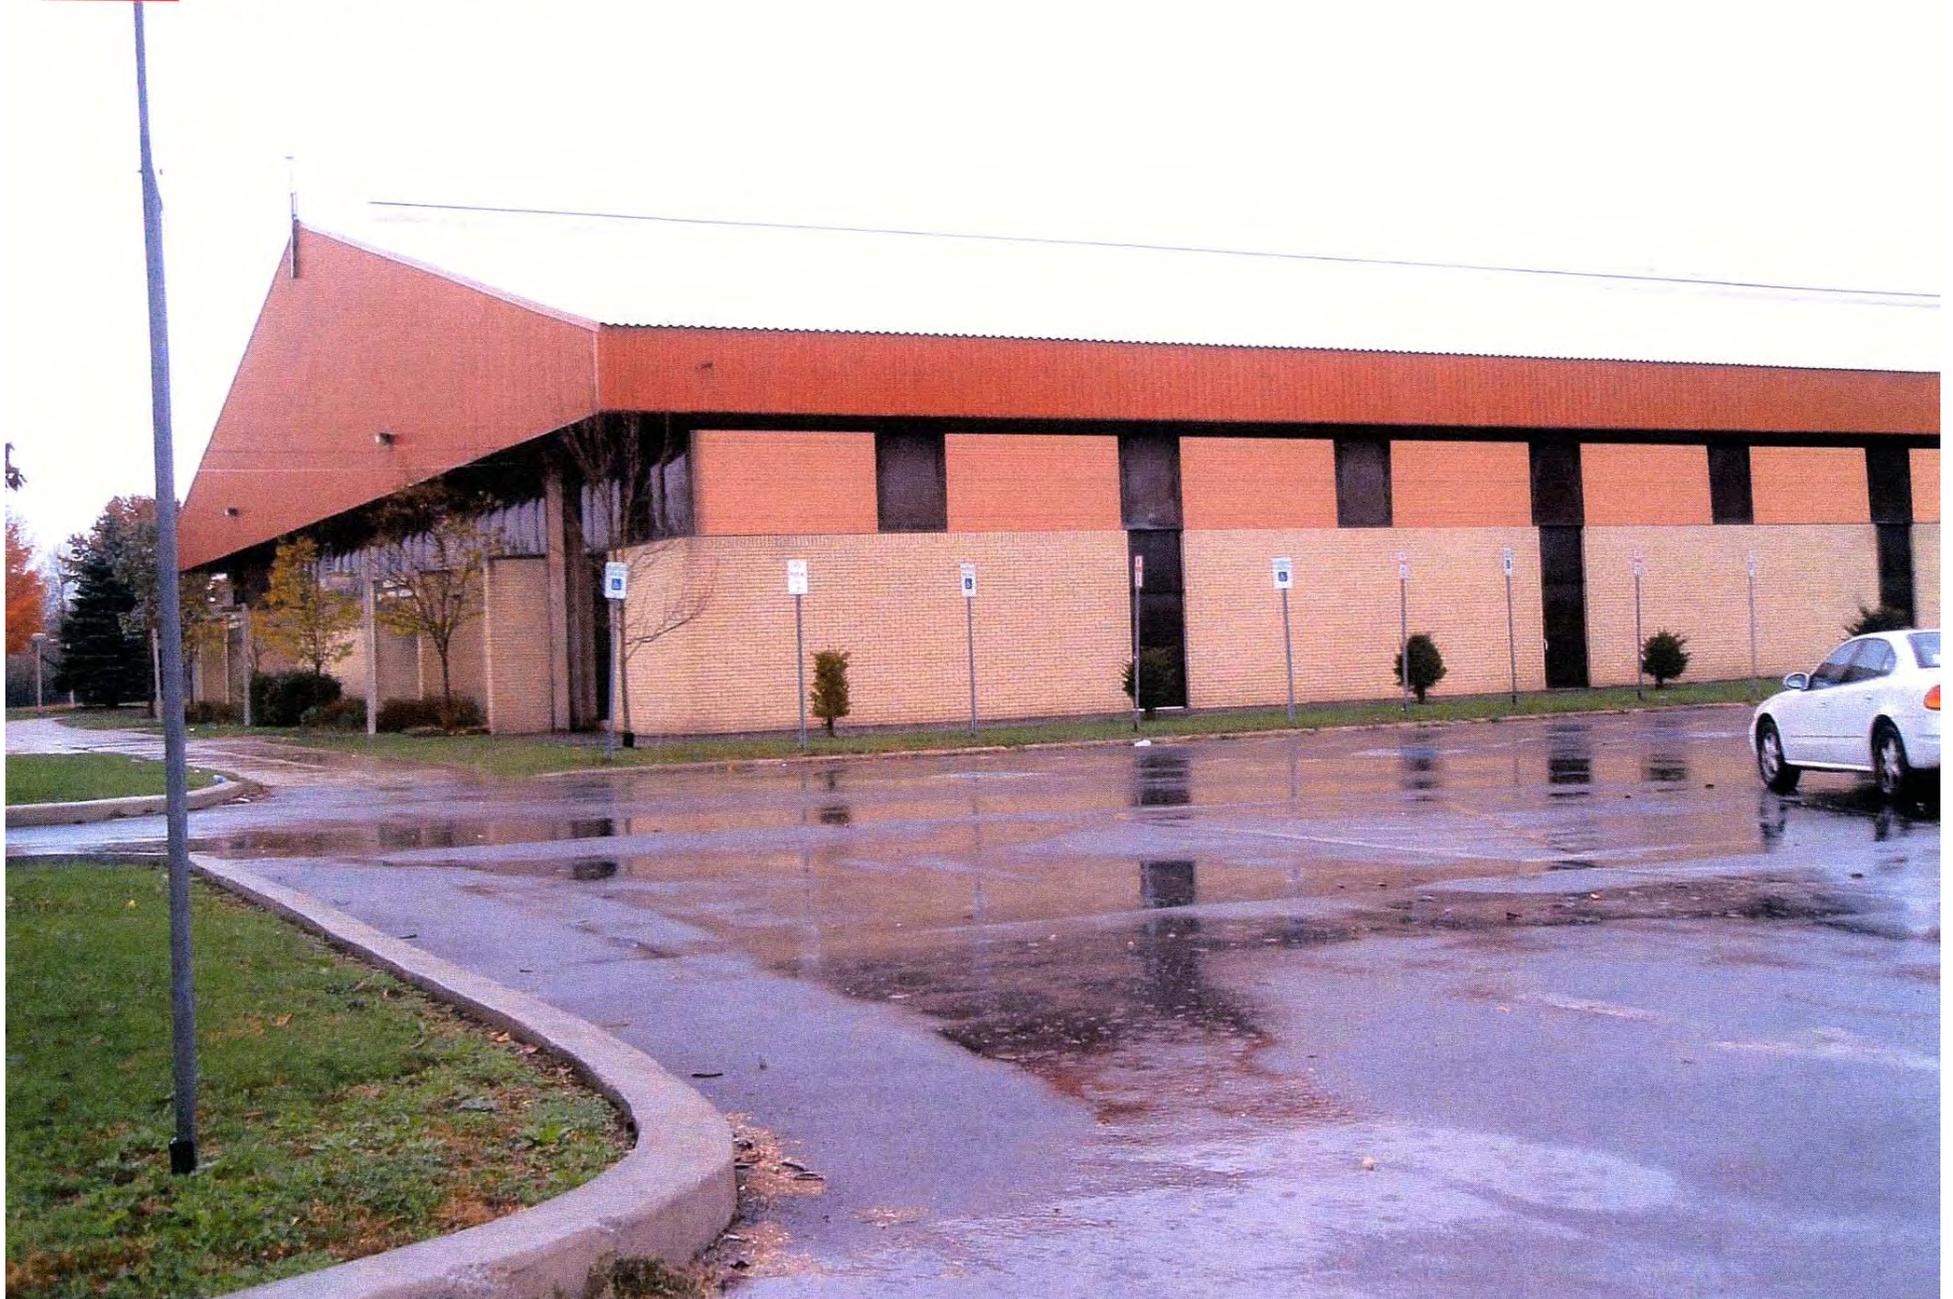
ADVERTISING SCREEN  
OPTION B

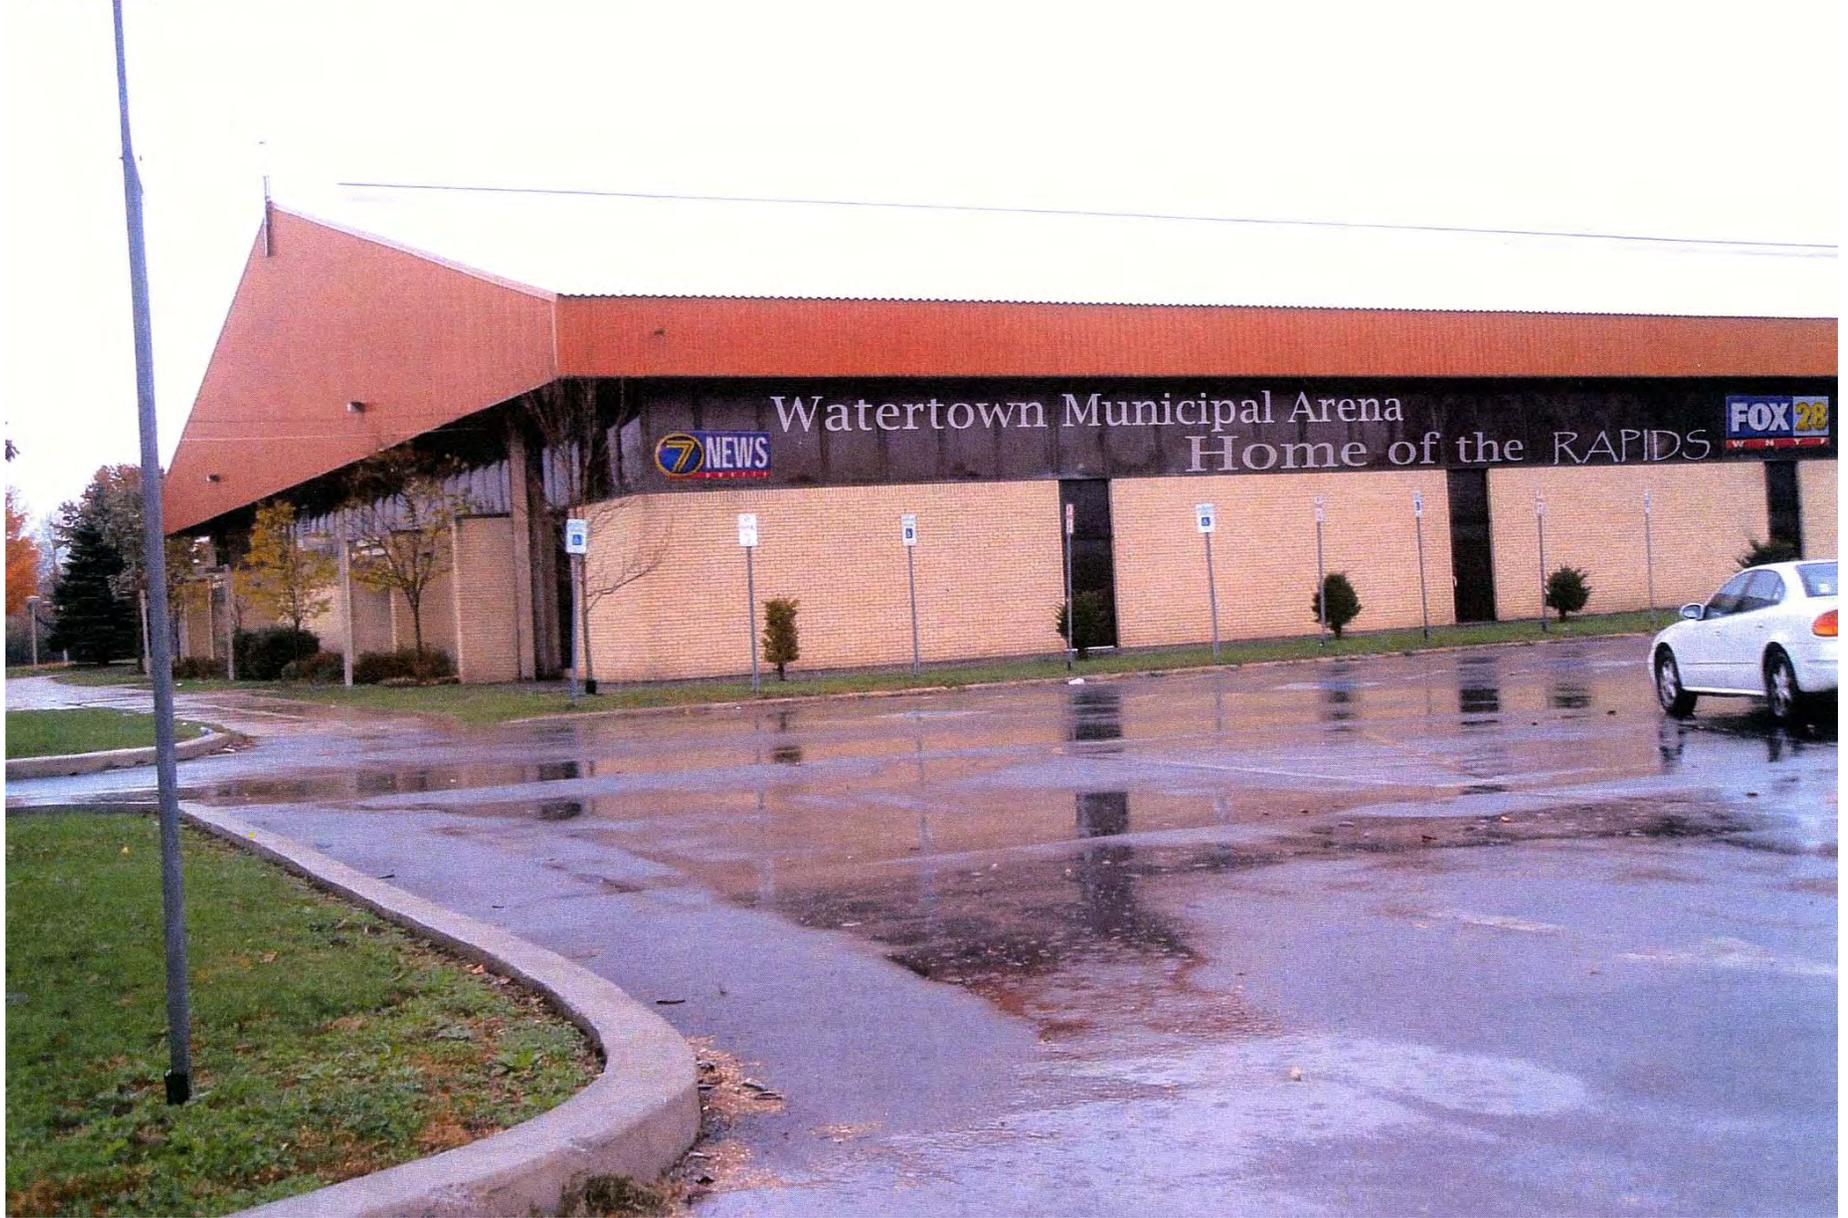
INSULATED PANEL  
OPTION A
