1. William J. Flynn Pool and Bathhouse Report

- Facility Assessment
- Feasibility Study
- Cost Estimate

**City of Watertown New York**  
**FACILITY ASSESSMENT and FEASIBILITY STUDY**  
**William J. Flynn Municipal Swimming Pool**

C&S Project No.: 129.108.001  
Date Issue            07/05/2022

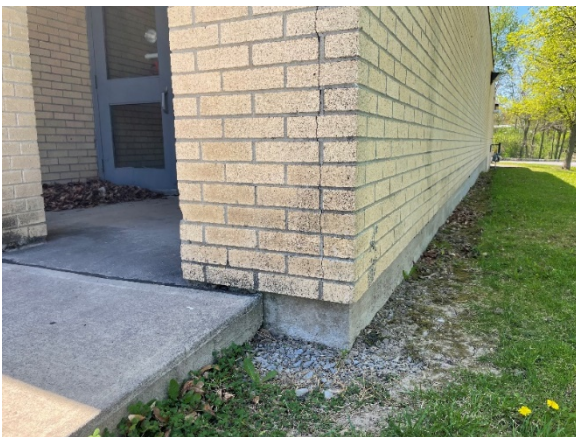
The clay brick veneer has several cracks in different locations at corners and openings. This appears to have been caused by water infiltration at the exterior wall ledge just below the top of the roof. This is not a good detail for the North country area and requires a lot of maintenance at the joints of the metal shelf flashing. To compound the matter there is no sub-flashing below the counterflashing at the shelf.

Vertical Crack in Brick Veneer

6. Replace existing toilet room partitions in the bathroom and changing room areas.
7. Provide epoxy paint finish on all of the walls.
8. Remove and replace 600 s.f. of brick veneer in areas of cracks and tooth in new brick to match existing.

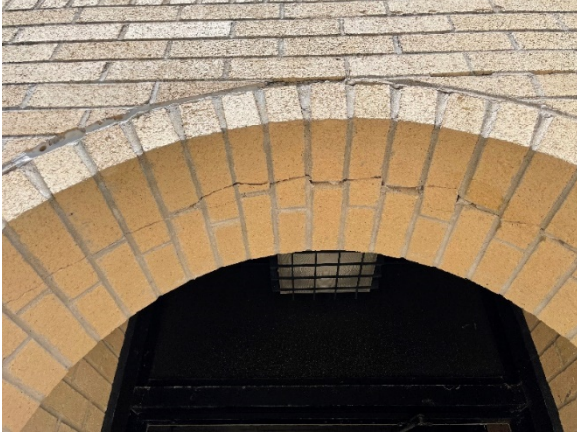
Crack in Brick Veneer

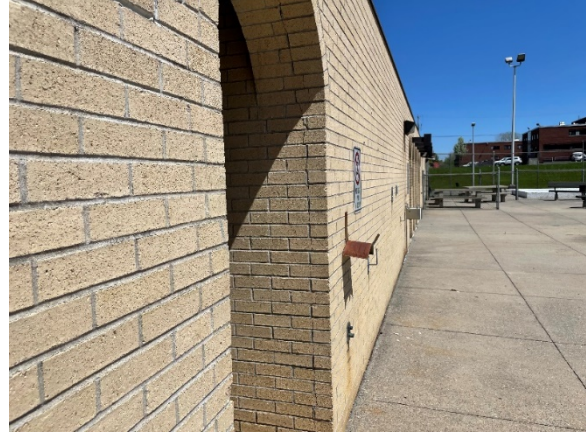
Vertical Crack in Brick Veneer

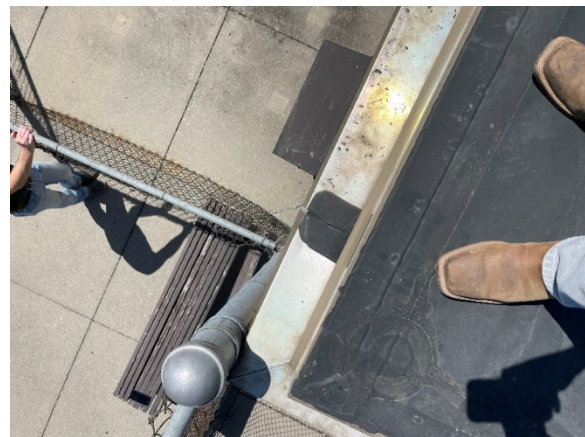
The roof structure is of precast concrete planks and the bottom is only 8'-8" above finish floor. The low roof height and exposed electrical conduits, mechanical systems, plumbing, and control valves are unsightly and accessible to tampering. The Roofing is EPDM and is believed to be original. The majority of the roof area is experiencing standing water. Most of the flashings have failed.

Split Rubber Flashing on Edge (Typical)

1. Replace existing roofing with new fully adhered tapered insulation and EPDM.
2. Replace all existing doors and frames with new FRP doors and frames.
3. Replace all existing Exit lights and install new emergency lighting.

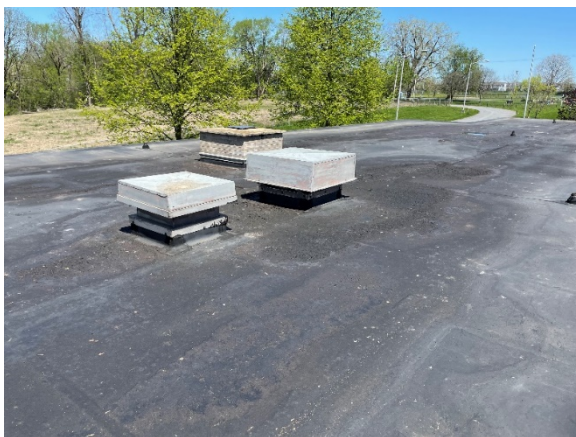
EPDM Roof Looking East

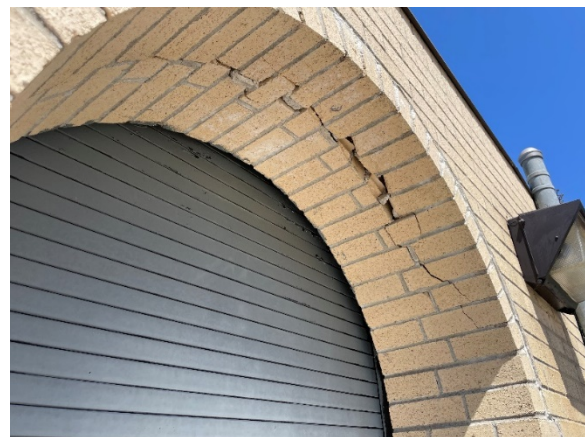
Brick Veneer at Concession Window

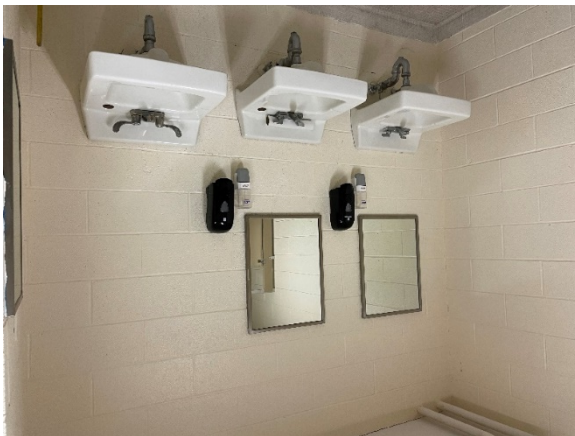
Men's Changing Area

The toilet room accessories, partitions, tile work and fixtures have exceeded their useful life and should be replaced. Toilet stalls and showers as well as the approach to the doors entering the Locker rooms and accessing the pool area are not fully compliant with current NYS and federal accessibility codes and standards. Lockers have been removed from both changing rooms and a make shift bench covers the concrete locker bases.

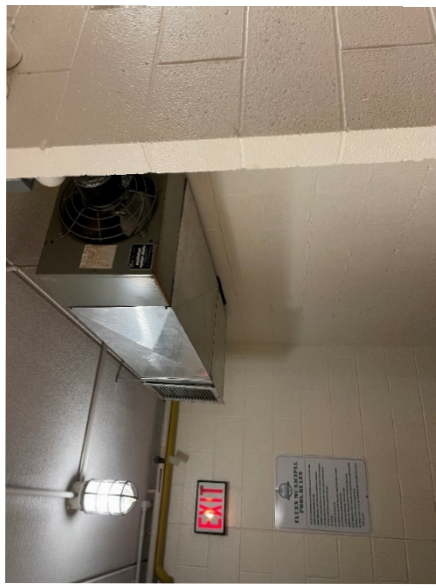
Exposed Mech Equipment

10. Raise the existing roof system (approximately 24") over the bathhouse (excluding the Mechanical Room) as required to conceal all of the Mechanical and Electrical equipment. Provide concrete masonry units and brick veneer on the extended wall. Replace existing roofing with new fully adhered tapered insulation and EPDM. Install a new 2'x2' acoustical tile ceiling system at 9'-0" above finish floor throughout.

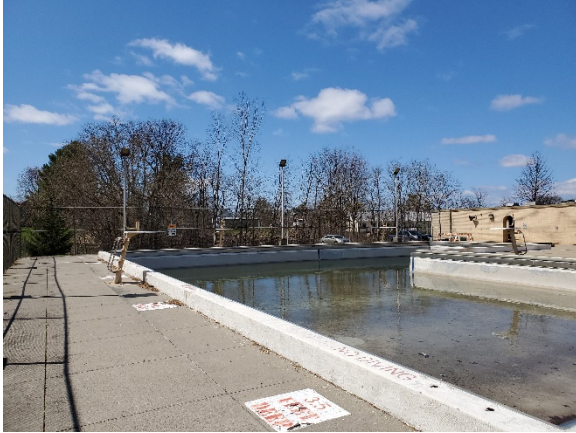
City staff reports that the existing pool structural shell is cracked in several locations and leaks excessively. The existing stainless steel gutter system no longer effectively distributes clean water along the perimeter of the pool nor collects overflow water for return to the filtration system. The main drains are also leaking into the subsoil below the pool and may be not be complaint with NYS pool drain safety requirements. Furthermore, the original configuration of the pool edge features a 12-inch high curb where the pool deck meets the pool gutter. This type of design is no longer considered desirable because it presents a tripping hazard.

Pool and Deck Looking Northwest

**New Gutter System** - The top of the existing pool wall, including the stainless steel gutter system, will be demolished and replaced with a new top of wall and gutter system. The top of the pool will be lowered to be flush with the existing pool deck. Any required swim lane and pool section divider anchorages will be part of the gutter system.

**Pool Deck Repairs** – The existing concrete pool deck is generally in good condition, however the work to remove and replace the top of the pool wall will require the removal of a significant portion of the deck, therefore complete replacement is recommended. Any issues with storm drainage on the pool deck will be addressed during the deck replacement.

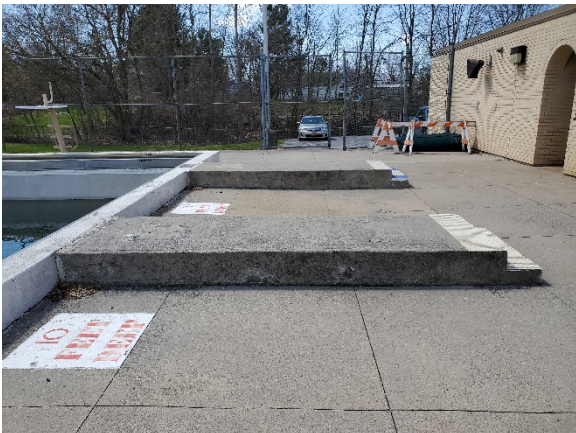
The Main Swimming Pool was designed by Sargent, Webster, Crenshaw and Foley Engineers and was constructed in 1978. The 4,900 SF pool has a 10-inch thick hand molded gunnite structure with steel reinforcement which ranges in depth from 3.5 to 10 feet. The original gunite pool surface was coated with a layer of marcite and features a stainless steel gutter system and one set of marcite-coated gunite stairs. The pool, originally featured two diving boards.

Former Diving Board Foundations

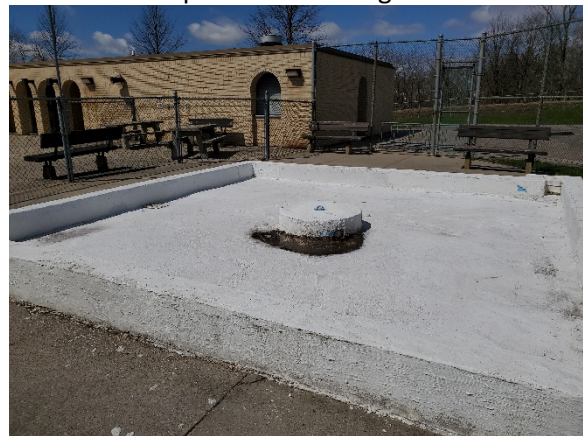
Kiddie Splash Pool

The existing kiddie splash pool and fencing will be removed. New concrete will be placed to provide a picnic / eating area in the current location.

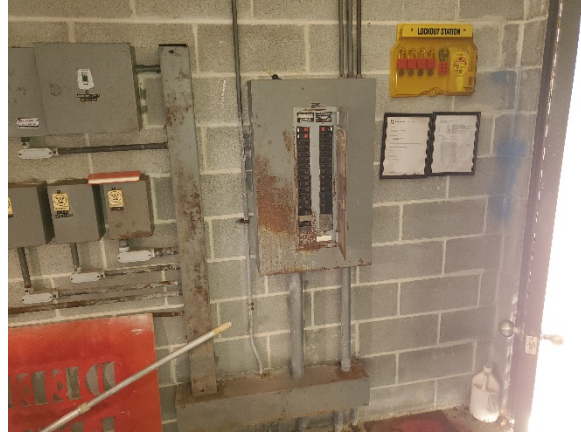
All of the existing electrical panels and conduit in the Filter / Chemical Feed Room are heavily corroded. The operating status of the room ventilation is not known; however, all ducts and ventilation controls are heavily corroded.

Filter Room Power Panel

- A new 120 / 208 Vac, 3 Phase power panel will be provided.
- New rapid sand filters in horizontal FRP tanks will be provided. All piping within the building and the existing penetrations through the existing concrete foundation walls will be replaced.

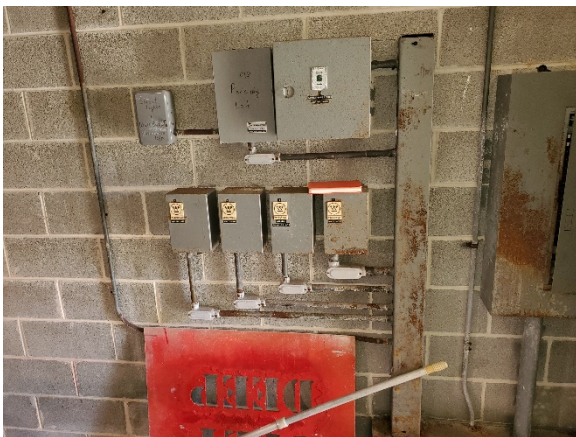
Filter Room - Electrical Switch Gear

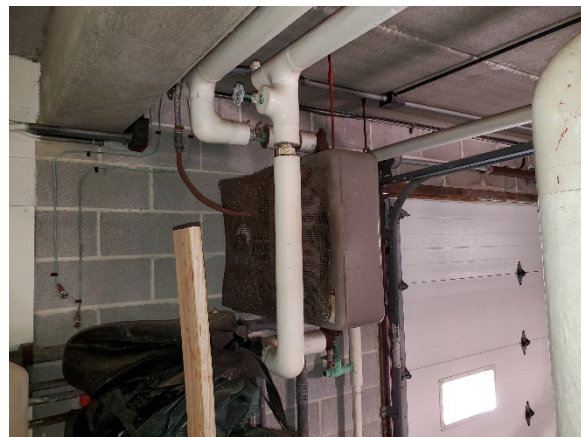
Filter Room Heater

- New electric unit heaters will be provided.
- The interior CMU walls will be repainted.
- New LED light fixtures, exit signs and emergency lighting will be provided.

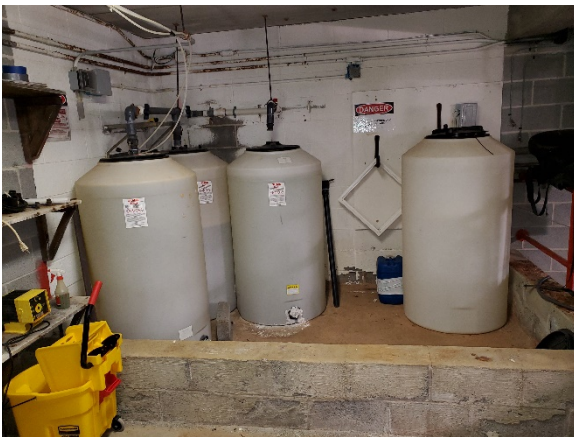
**Filter / Chemical Feed Room** – Most of the equipment in the existing filter and chemical feed room has been removed. Only miscellaneous piping, some small plastic tanks and the supporting electrical systems remain.

Disinfectant Tanks

- New chemical systems for disinfection and pH adjustment will be provided. The walking surface above the abandoned surge tank will be improved so that this area of the room be used for storage and pumping of sodium hypochlorite and carbon dioxide.

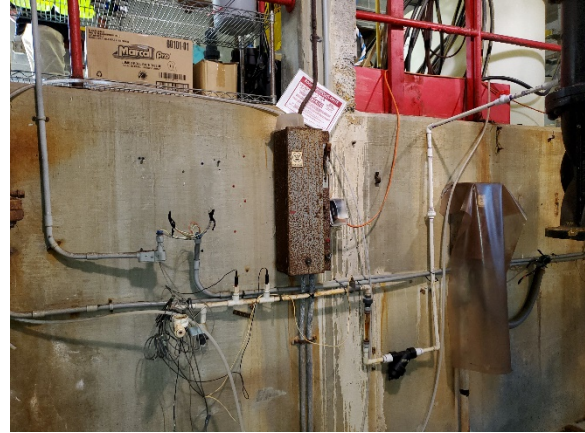
The City staff reports that the existing surge tank, which is part of the building substructure is cracked and has leaks.

Surge Tank Wall

- The existing surge tank will be abandoned and replaced with a pre-cast concrete surge tank. It is likely that repairs to the existing surge tank would cost more than providing and new pre-cast tank. Therefore, the existing tank will be filled with flowable fill. The new surge tank will be located below the pool deck between the pool and the filter building.

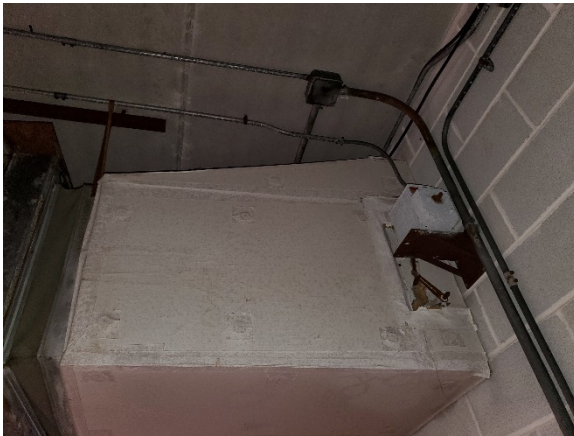
Filter Room Ventilation Unit

- All remaining mechanical, electrical, heat and ventilation equipment will be removed from the room.
- Replace two man doors and the overhead door.
- A new forced air wall ventilator and ducting will be provided.
