EROSION MANAGEMENT PLAN FOR THE BLACK RIVER CORRIDOR

ARCHITECTURE, ENGINEERING & LAND SURVEYING, P.C.

This document was prepared for the New York State Department of State Office of Coastal, Local Government and Community Sustainability with funds provided under Title 11 of the Environmental Protection Fund.

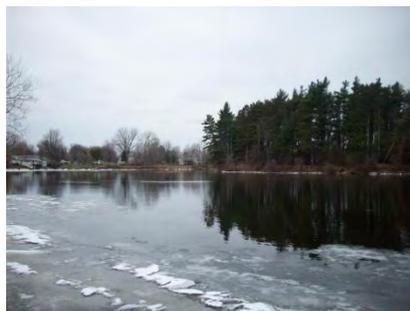
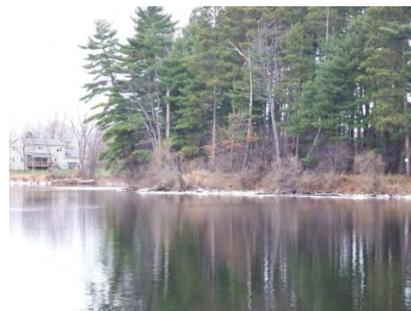
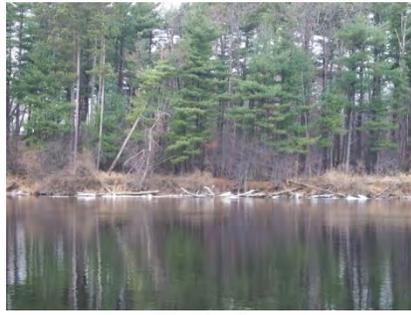
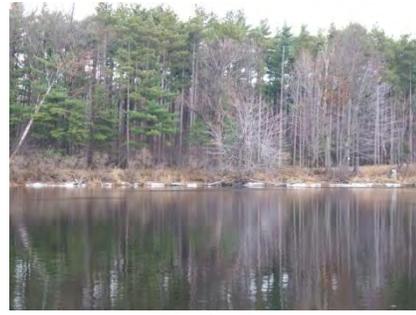
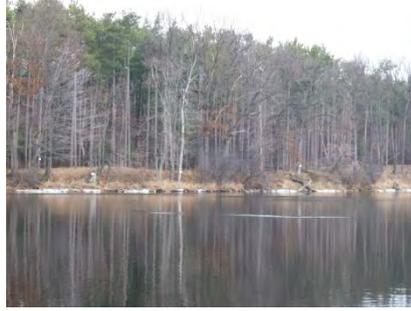
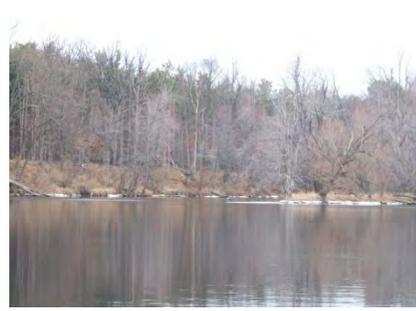
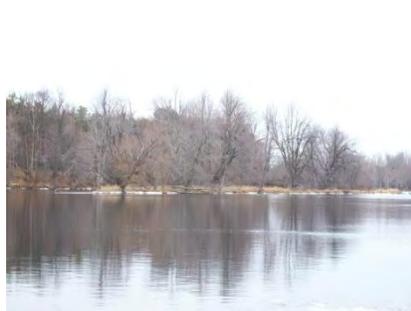
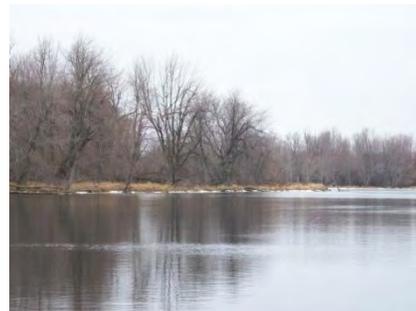
The inspection started by taking photographs from the southern banks of the river, near Ridge Road in the Town of Watertown along the Black River trail system. Photos 1-8 were taken in late Fall 2008 from the trails and look in the northerly direction towards Huntington Island. They pan from west to east along the Huntington Island banks. It is difficult to see, but there is evidence of minor erosion along the southern banks of Huntington Island in the vicinity of the small island just to the north of it.

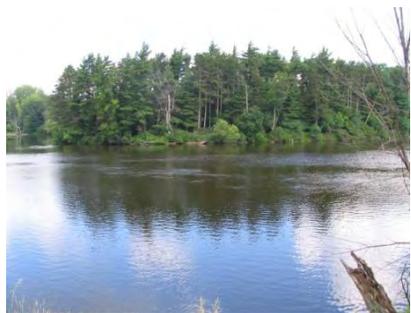
Photos 9 and 10 were taken from Ridge Road, downstream from the previous photos. Photo 9 is looking north at Huntington Island and shows the heavy vegetation which exists here. Photo 10 is looking northeast up the river.

As can be seen from viewing Photos 1-10, Huntington Island is heavily vegetated with trees and brush. This helps in some bank areas to prevent significant erosion from occurring. At these heavily vegetated banks, when the water moves at higher velocities, the vegetation will tend to keep the bank material in place.

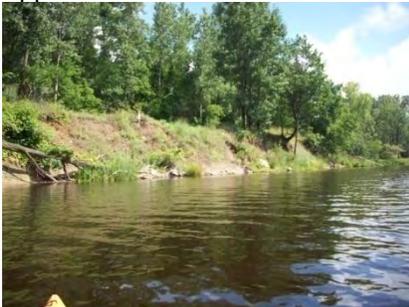
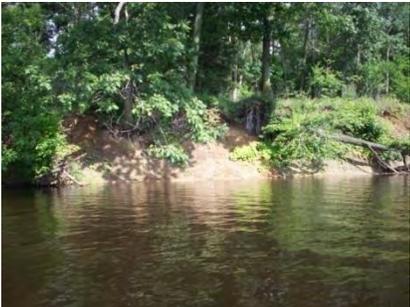
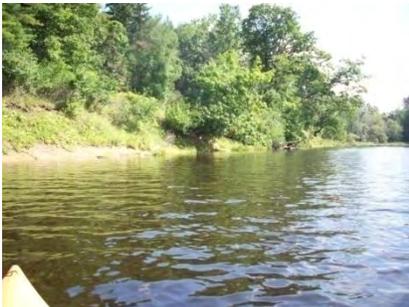
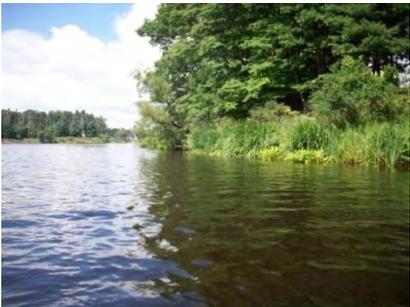
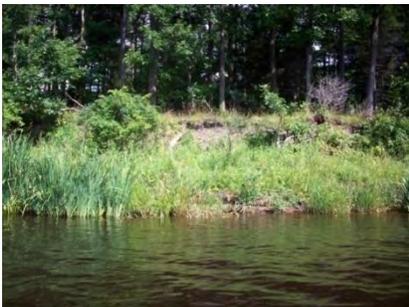
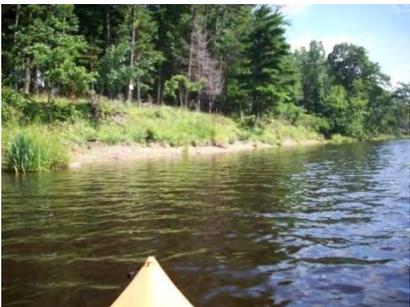
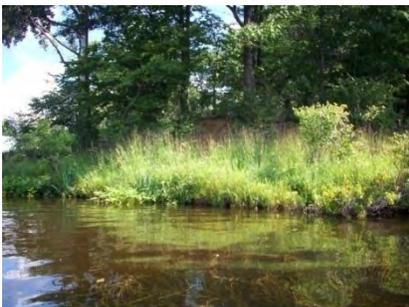
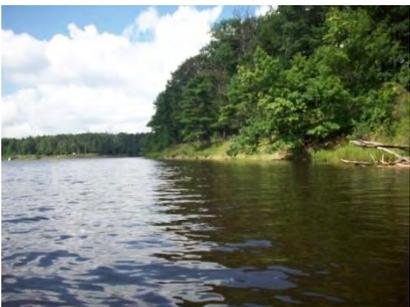
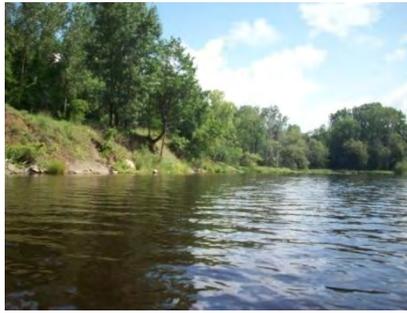
Although velocities are normally low in this area, there still is evidence of gradual erosion in areas where there is no vegetation. This is likely because as the water flows past the banks and fluctuates in level, it slowly eats away at the material. In addition to this, the water velocity does become higher and more erosive when storms occur and during the annual spring melt. Photos 11-19 below show pictures of the southern shore of Huntington Island near the Route 3 Fishing Access Area and Car-Top Launch. These photos were taken from kayaks. These areas are indicated in the plan included in Appendix B.

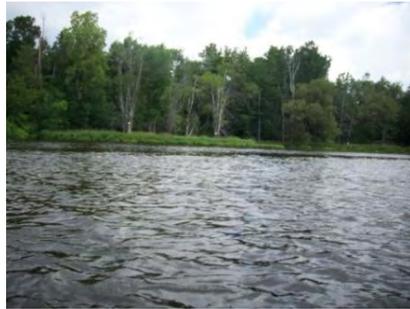
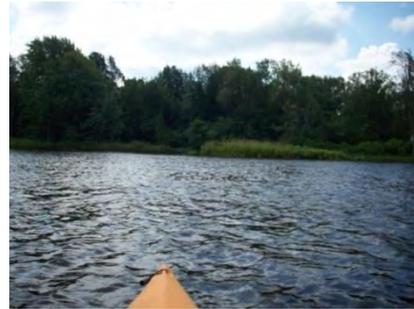
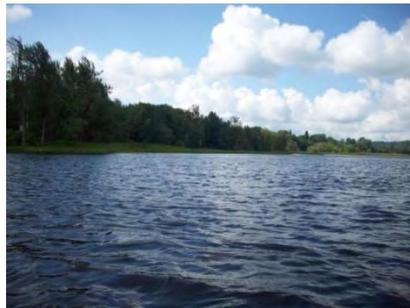
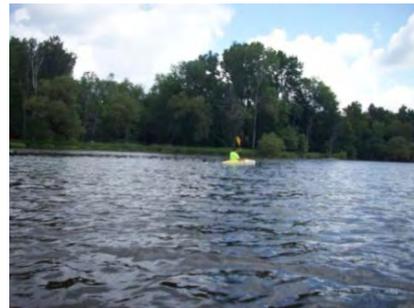
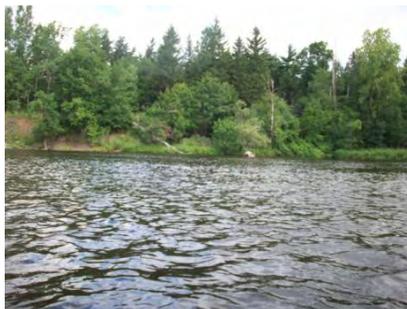
The southern banks of the river along Ridge Road seem to be fairly stable. Photos 20-24 show portions of this shoreline.

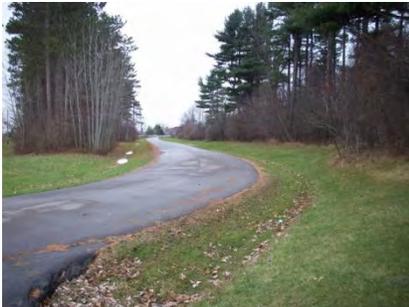
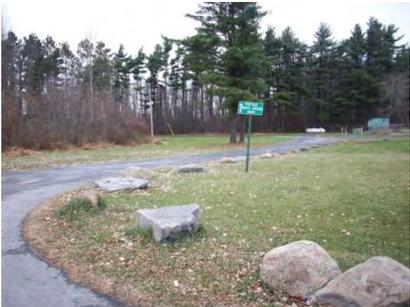
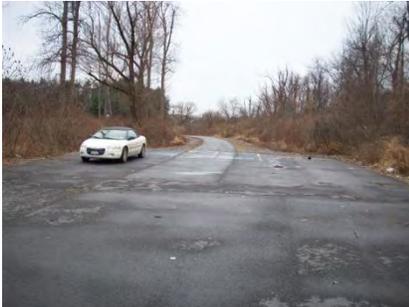
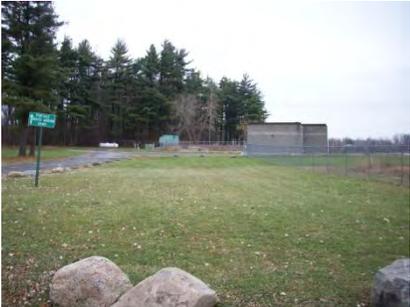
The Route 3 Fishing Access and Car-Top Launch was visited and used as an area to take photos. It was used as one of the critical vantage points for the EMP because of its openness and opportunity for views. Photos 25-28 were taken of the access area itself. Photo 25 is looking west towards the main entrance off NYS Route 3. Photo 26 is looking northeast from the boat launch area. Photo 27 is taken from the boat launch area and looks southwest towards the parking area and access to the deck area. Photo 28 looks in the northeastern direction towards the Water Filtration Plant's reservoir.

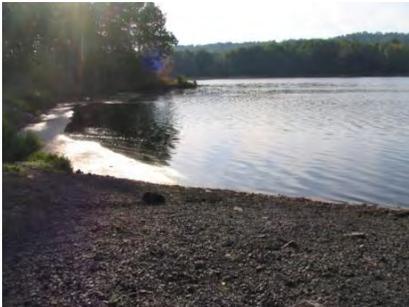
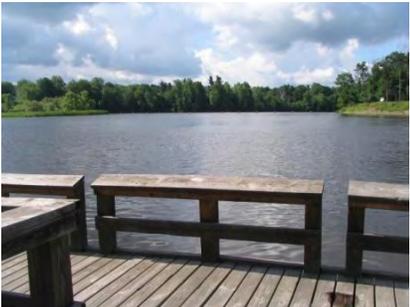
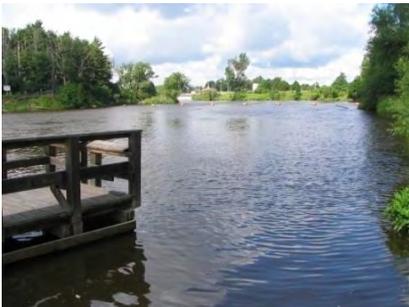
Photos 29-31 were taken looking southerly from the access area. A large portion of the southern riverbank can be seen from here in addition to parts of Delano Island. These southern banks are generally stable. Delano Island has some erosion issues which will be focused on.

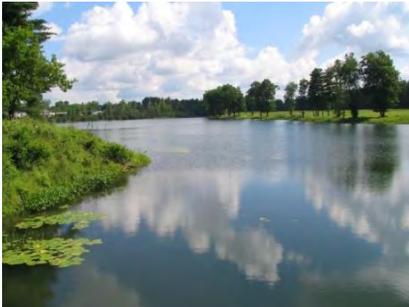
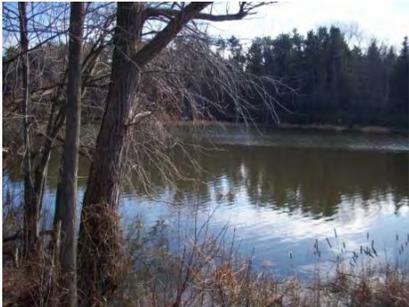
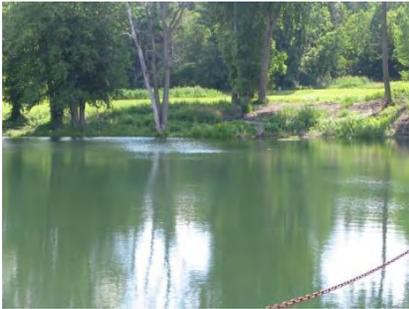
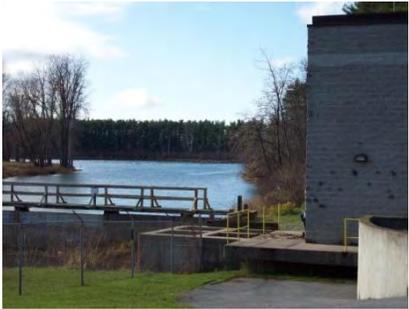
Photos 32 and 33 were taken from the northern side of the Route 3 Fishing Access Area and Car-Top Launch area and overlook the reservoir for the water filtration plant. Sludge is stored in basins on the northwestern side of Huntington Island in this vicinity. Since this area receives a generally consistent amount of water, the erosion is very limited. It is reported that approximately every 3-4 years it is required to clean the reservoir of sludge and deposit it in the basins directly to the east. This is the only time when erosion is really a factor and even then it is minor. Photographs for Photos 34 and 35 were taken near the facility at the northern end of the reservoir looking to the south.

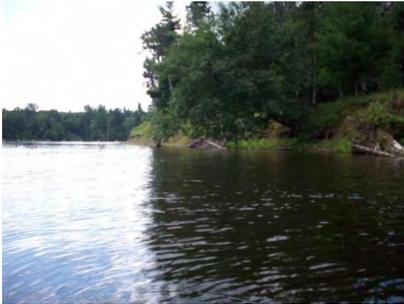
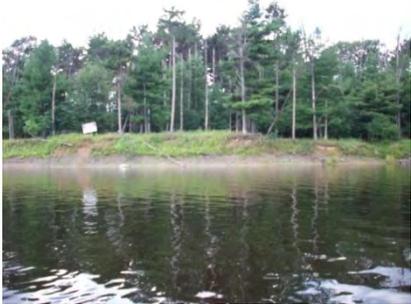
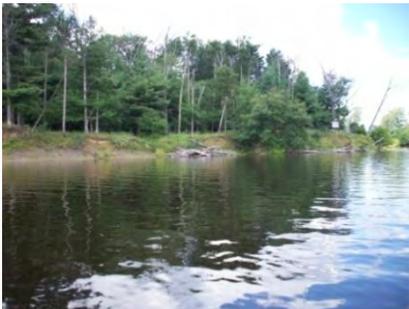
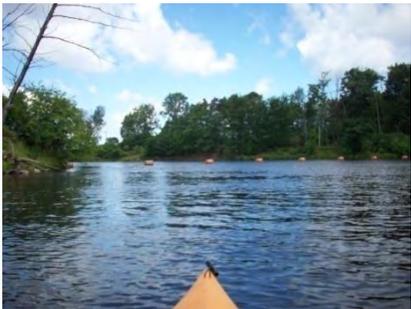
Delano Island, which is just above the Route 3 Bridge and dam was inspected on the eastern side from kayaks. The other sides were inspected from afar by taking photos. The eastern side appears to have the most significant erosion, as it opposes the current. Photos 36-40 show the eastern side of the Island and the eroded areas.

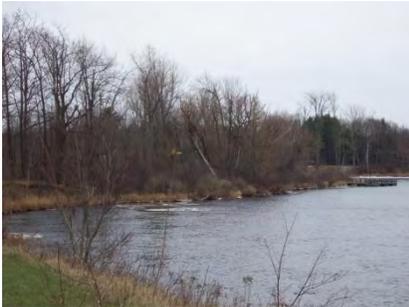
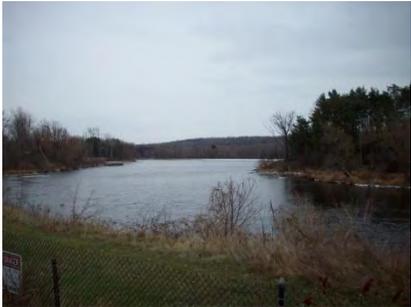
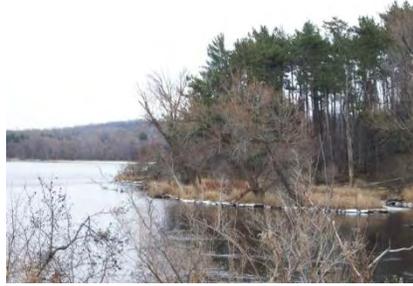
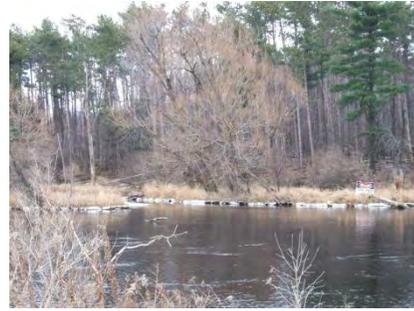
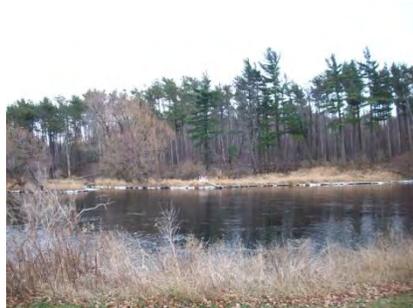
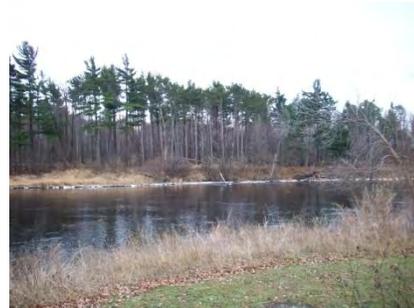
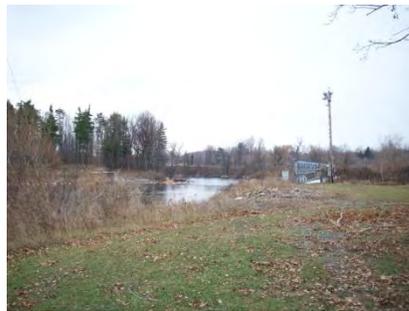
Photos 41-47 were taken from a maintenance access area to the northeast of the Route 3 Bridge. The western and northern sides of Delano Island were able to be seen from here. The photos pan from north to south from looking at the Route 3 Fishing Access and Car-Top Launch Area to the western side of Delano Island. There was no significant erosion visible from here.

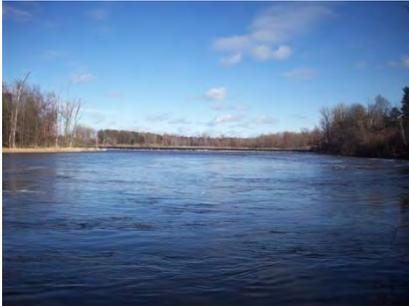
By utilizing the fishing access area on Huntington Street just outside the City limits, inspections were able to be performed on the southern banks of Delano Island and the southern banks of the river. The photo in Photo 48 is looking northeast from the aforementioned fishing access area towards the dam which stretches from Delano Island to the southern bank of the river. Photos 49-52 are of the southern banks of Delano Island, panning from the east to the west and ultimately looking at the Route 3 Bridge in Photo 52. Photos 53 and 54 are of the southern bank of the river along Huntington Street. Photo 55 shows a discharge culvert to the river near the fishing access area. There does not appear to be any significant erosion issues in this area.

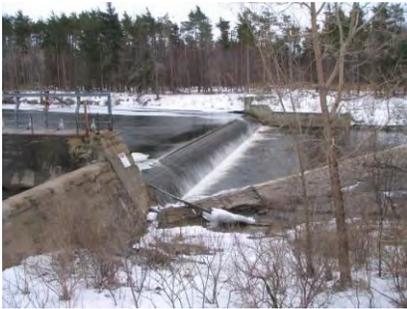
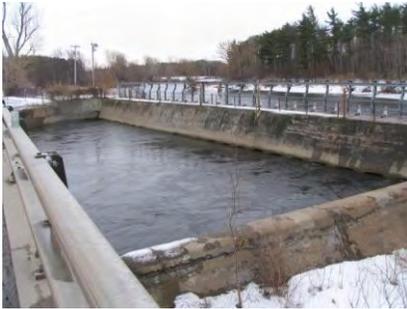
Photos were taken around the vicinity of the Route 3 Bridge. Views of the western side of Delano Island, the hydroelectric facility dam, Horseshoe Dam and the Route 3 Wave were able to be captured. Photos 56 and 57 were taken from the Route 3 Bridge and offer a view of the hydroelectric facility dam. The structure seems to be in safe operating condition.

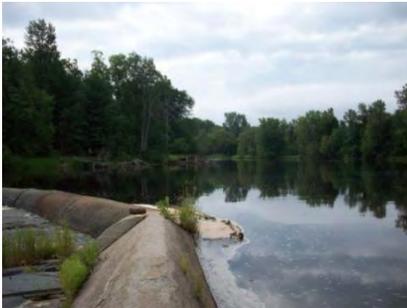
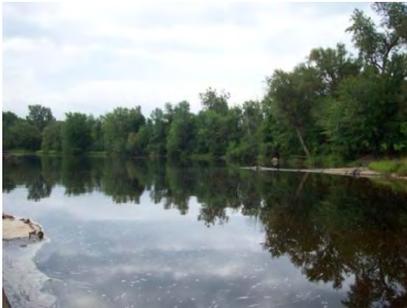
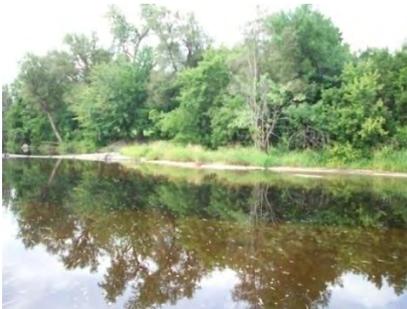
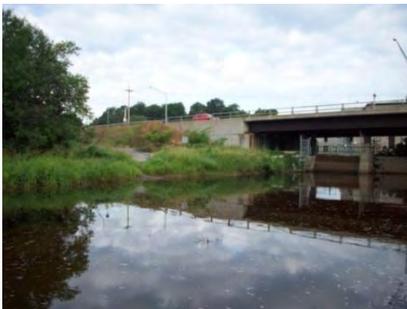
Photos 58-61 were taken from the Horseshoe Dam and show portions of the southern river bank along Huntington Street. Photo 58 shows a portion of the dam structure itself. In general, these areas had no significant erosion problem areas as the shores are in many cases right on bedrock. Note that although Horseshoe Dam is no longer operational, it is important to monitor its condition to anticipate the effects of further deterioration.

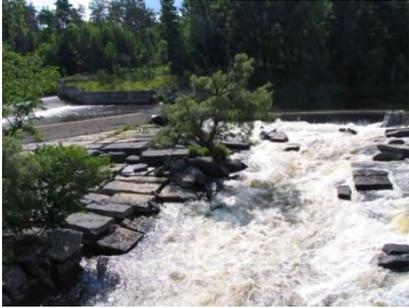
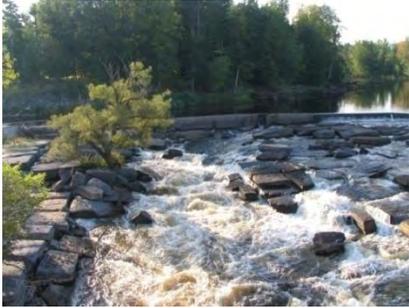
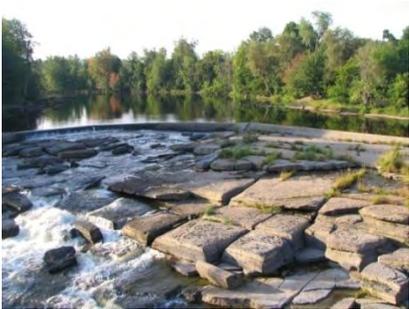
Photos 62-64 were taken from the eastern side of the Route 3 Bridge and showcase the power of the river as it comes over the Horseshoe Dam and into the Route 3 wave area. Only large, heavy boulders are able to remain in this area as the smaller ones wash away.

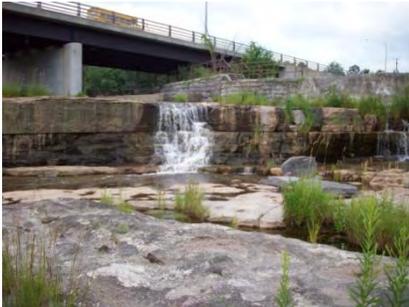
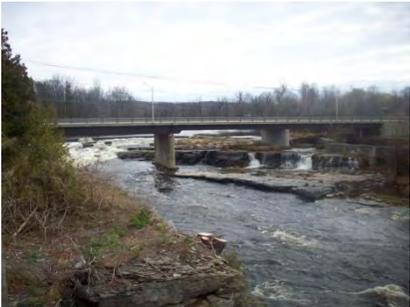
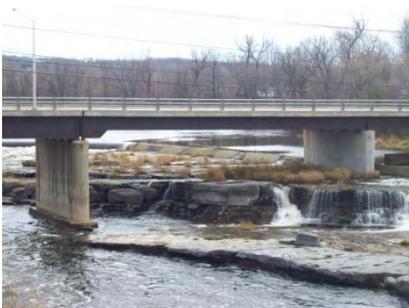
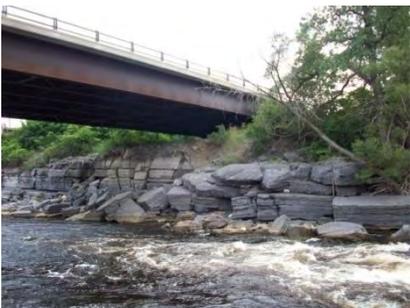
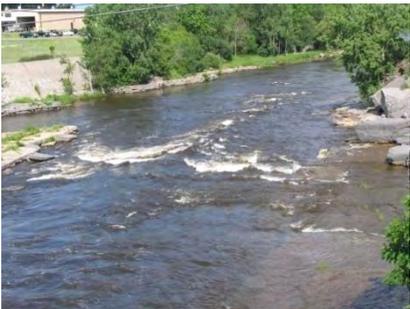
Photos 67 through 72 were taken to show the immediate areas beneath and downstream of the Route 3 bridge, including the Route 3 Wave in Photos 71 and 72. Although the river flows along bedrock, some issues have progressed to a point where the bedrock shelf is falling into the river and creating a safety hazard. It is a safety issue, as the pictures from the Marble Street Access Area and from Mr. Norman Wayte's field report entitled "Erosion on the North Shore Route 3 Access" will show. The areas directly under the Route 3 bridge where some vegetation is growing, is slowly eroding away. Although, this doesn't seem to be cause for concern.

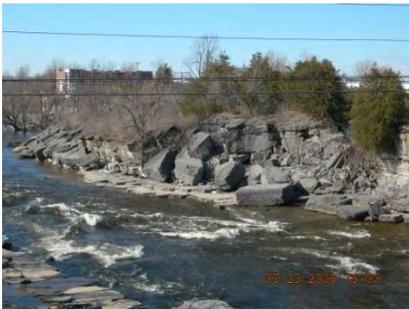
Photo 71

Possibly the most serious erosion that is occurring in this area is of the banks in this area as seen in Photos 71, and 85-90. These unstable areas put the safety of the pedestrians at risk. Refer to Mr. Norman Wayte's field report entitled "Erosion on the North Shore Route 3 Access" dated 14 July 2008 and attached as Appendix C. Mr. Wayte's report, it's photos, and Photos 78-90 of this document show Marble Street access and its unstable areas. It is generally suggested that the unstable boulders, trees and other materials be removed. It may be helpful to introduce vegetation in this area to help stabilize soil on the banks. Although, there are not many areas here that this would be effective, as it is mostly rock.

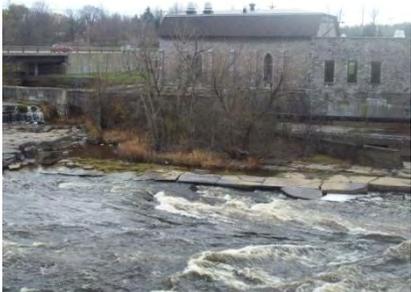
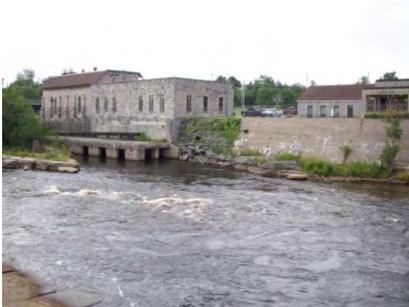
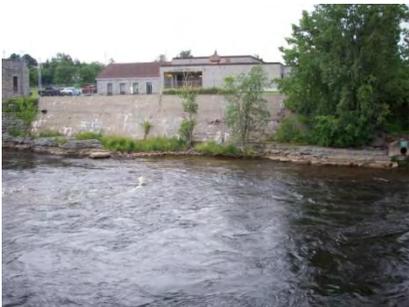
Photos 73-77 were taken of the banks around the Water Filtration Plant. There is noticeable deterioration of the structures in this area. Photo 73 taken near the Water Filtration Plant at the southwestern corner of Huntington Street and Route 3 and shows a retaining wall in poor condition. Photos 75-77 show a failing retaining wall which is directly adjacent to the Water Filtration Plant. Other deteriorating structures are also seen in these photos which will be discussed later in this report.

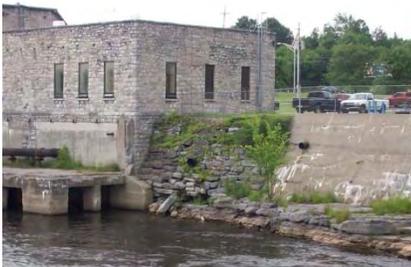
As indicated in the inspection portion of this report, the Water Filtration Plant has several deteriorating structures nearby which should be monitored and/or repaired. Photo 76 shows a retaining wall which is failing. This wall should be repaired in the near future as it will only continue to get worse. Other structures exist around the filtration plant which are starting to show their age. Photo 98 shows the retaining walls and structures in the water which are deteriorating. Photos 129-132 show the cracks which are developing in the concrete retaining wall near the plant. All of these structures around the plant should be included in the inspection program to periodically evaluate them and determine if repairs are necessary.

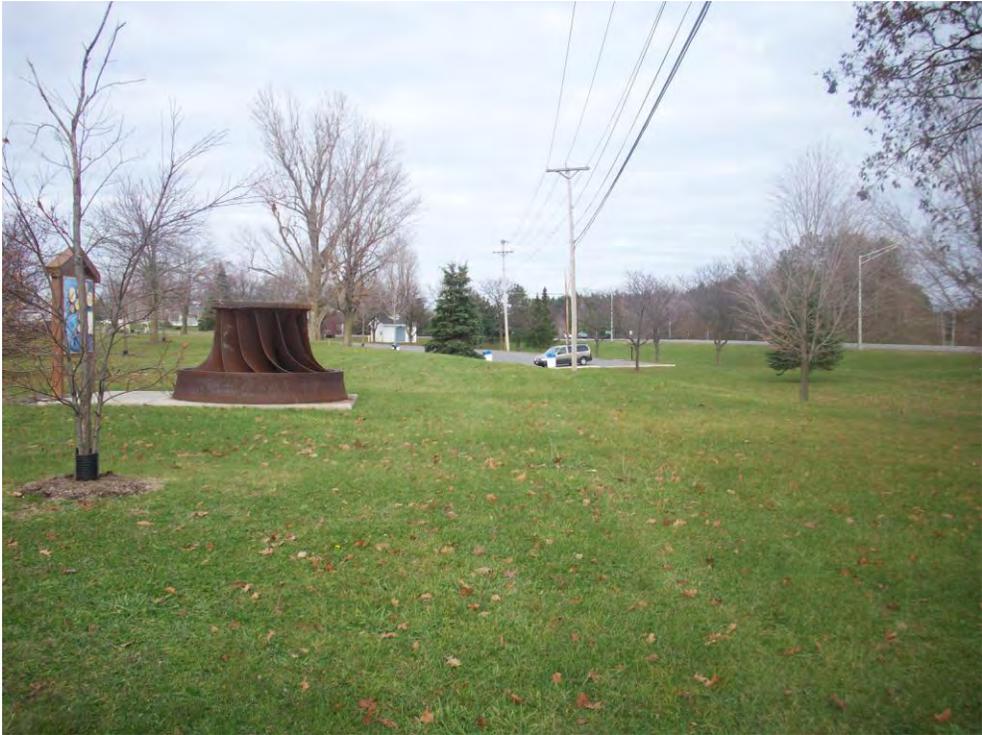
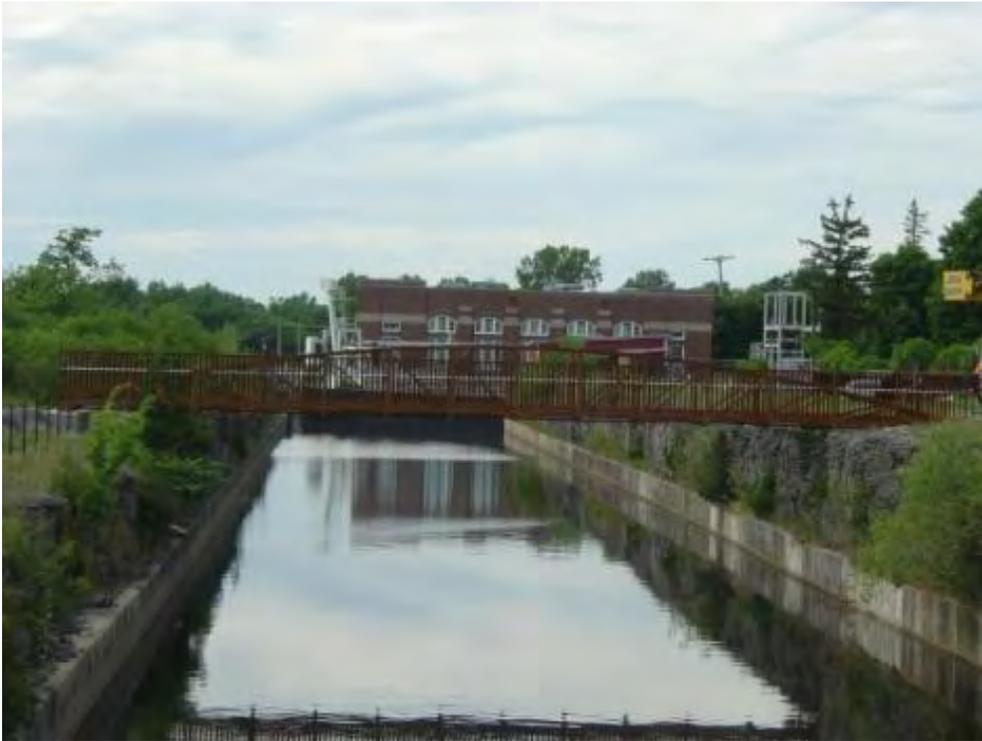
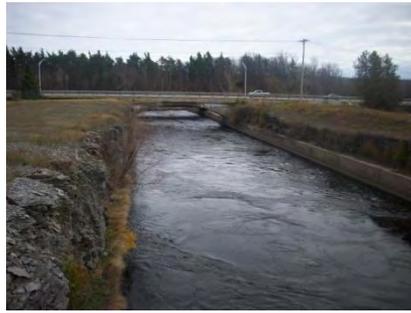
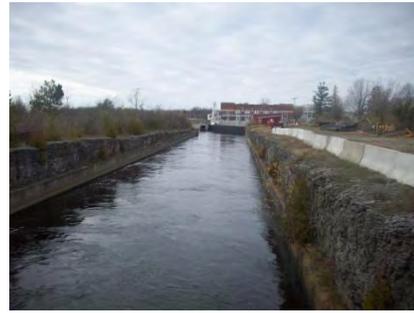
Photos 78-81 were all taken from the Marble Street Park, which allows access to the banks just to the north of the Route 3 wave. Photo 78 shows the parking and lawn areas. The steel pedestrian bridge which allows access over the hydroelectric plant canal is shown in Photo 79. Photos 80 and 81 were taken from the pedestrian bridge looking east and west, respectively. The canal is carved out of rock and the erosion is minimal.

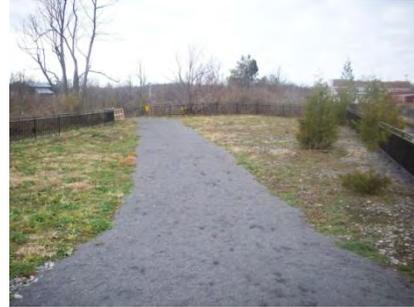
Photo 83

Photo 82 shows the lookout strategically located above the Route 3 wave. Photos 83-85 are of the walkway and bridge that lead patrons down to the water's edge. This area will be discussed in the recommendations section for this portion of the river.

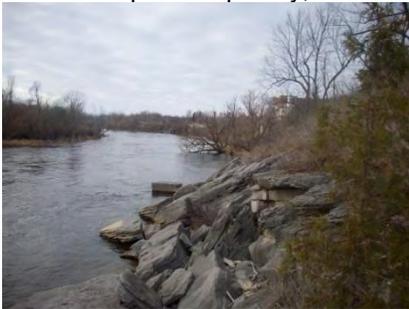
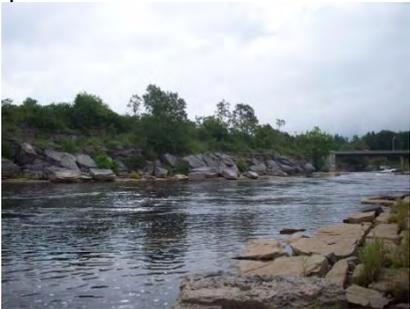
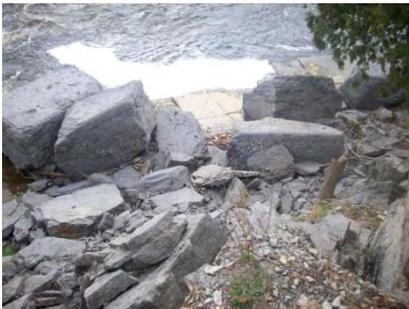
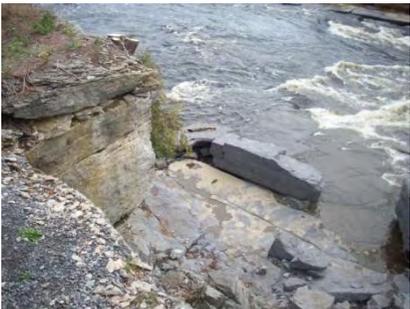
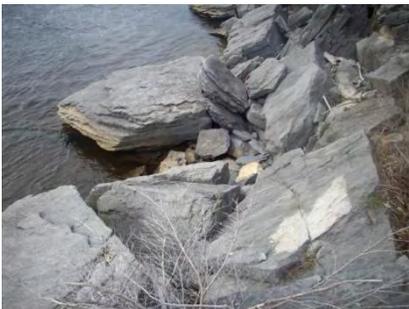
Photos 86-90 are of the banks of the river in the vicinity of the Route 3 Wave. Photos 86 and 87 show the general condition of the bank from afar, while Photos 88-90 show closer views of some of the erosion that has occurred in this area. In general, all sizes of stones line the bank. From smaller stones to huge boulders, these rocks have been deposited here for years and could present hazards to patrons. Now that this area is being accessed quite frequently, it is becoming more important to remove these hazards.

Plans beyond this, future plans likely include trails down to and along the river in this area. As discussed in previous sections, it is first recommended that the large and unstable cobbles and boulders be removed from this area as they are a safety hazard. It is also recommended that the trails in this area be made of more stable materials similar to the paths that were constructed from the pedestrian bridge down to the Route 3 Wave Area.

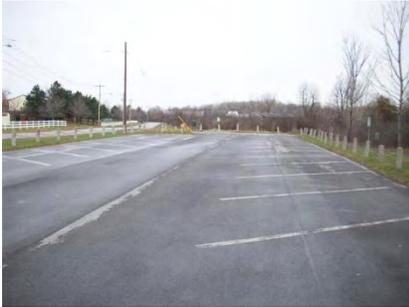
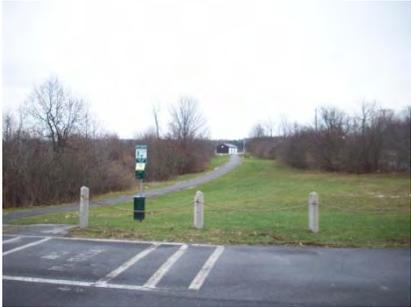
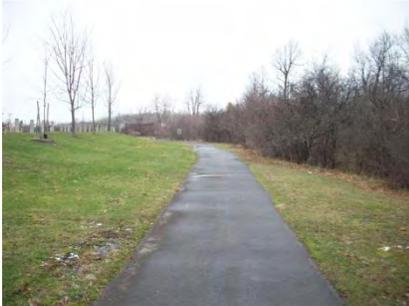
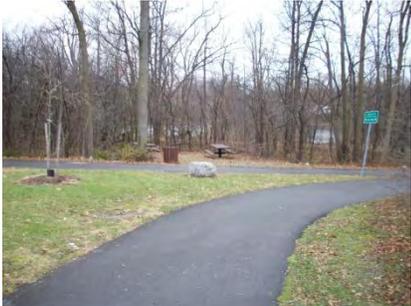
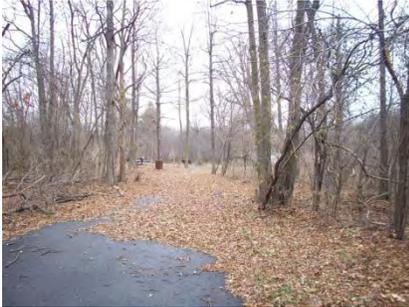
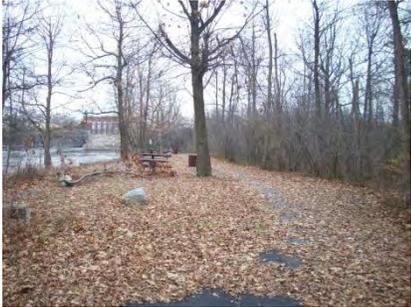
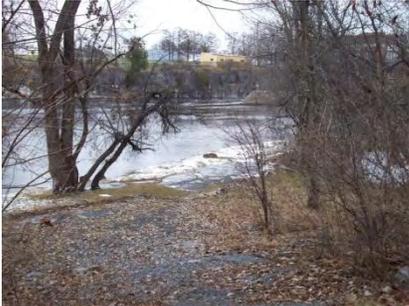
Photos 91-97 are taken of the Water Works Park Access area itself. Photos 91-94 were taken near the parking area. Photos 95-97 were taken farther into the park and closer to the river.

Some areas of the Water Works Park trail system show evidence of erosion from heavy pedestrian traffic. These areas should be included as part of the inspections. It is recommended that larger crushed stone be placed along eroding areas of the pedestrian trails. The stone that is laid down originally for these trails is of smaller aggregate size.

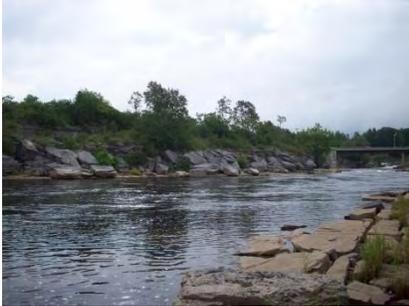
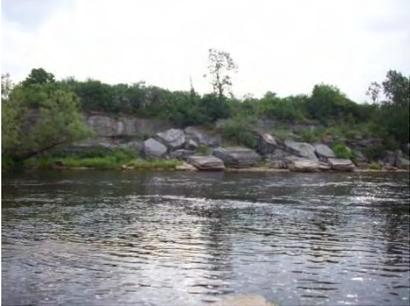
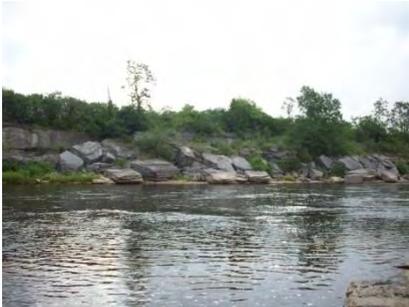
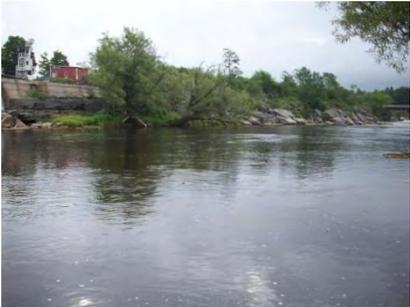
Photos 98-107 were taken in the general vicinity of Water Works Park Public Launch, off Huntington Street. A large portion of both the southern and northern river banks are visible from this area. Photos 98-101 include the eroding banks directly to the south and southeast which were discussed in the previous section.

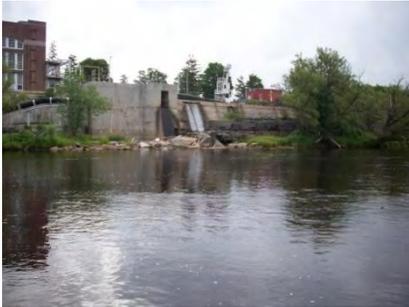
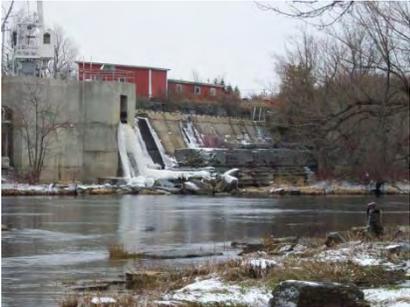
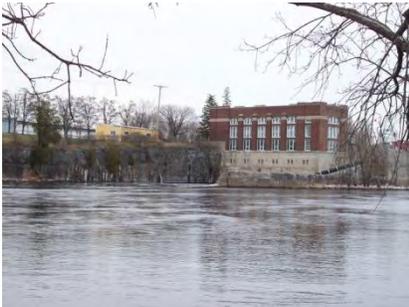
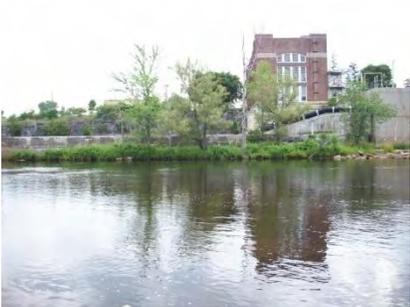
The municipal hydroelectric plant can be seen in Photos 102-105. There didn't appear to be any significant erosion issues around the plant.

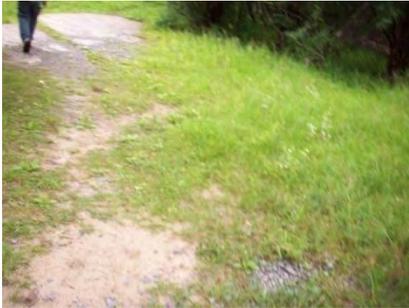
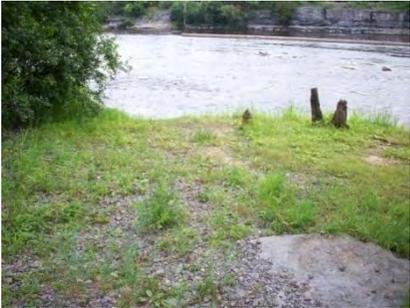
Photos 106 and 107 show some minor erosion that is occurring at the launch area from pedestrian traffic.

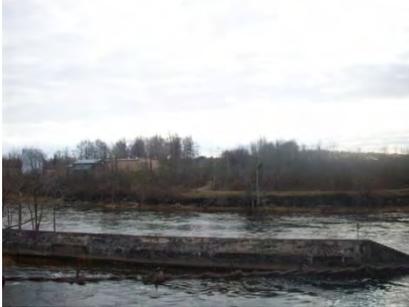
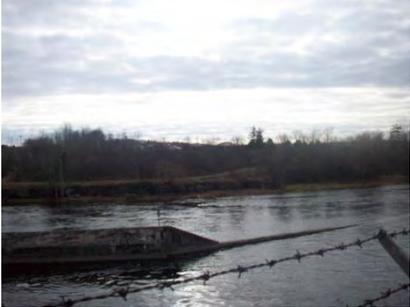
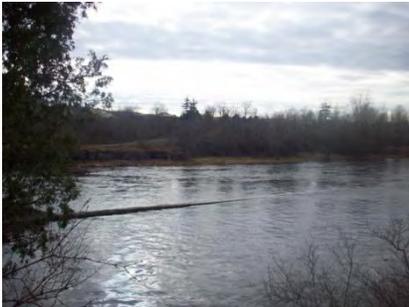
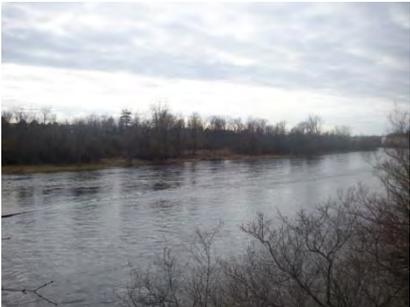
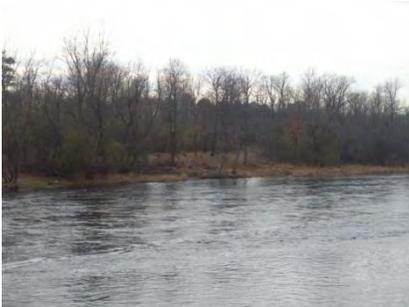
Photos 108-112 are of the Water Works Park and were taken from the northern banks of the river near the municipal hydroelectric plant. A concrete divider for the power plant can also be seen.

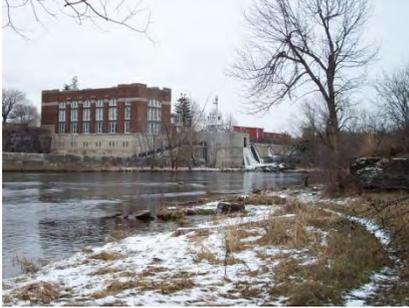
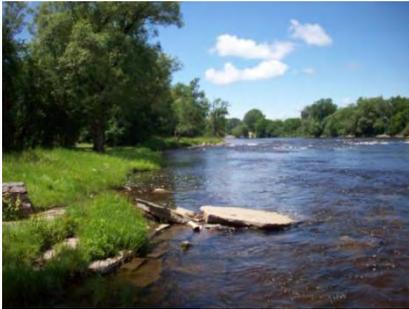
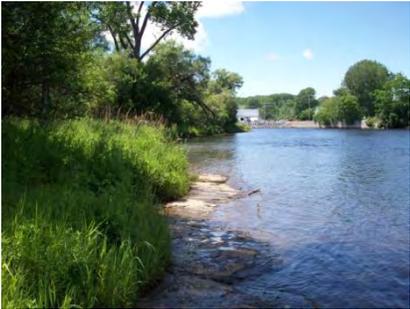
Photos 113-116 were taken along the banks of the Water Works Park to show the condition of the shoreline on the south side of the river in this area. In general bedrock is at or close to the surface. This along with the dense vegetation that has established itself along the shore has made for only minor erosion issues in this area.

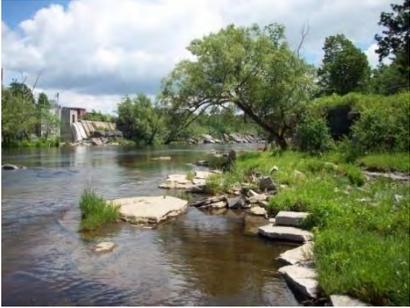
Photo 114

Along the shores of the river adjacent to the Water Works Park there were little to no signs of erosion. In general, this area has thick vegetation growing up to the banks which inhibits erosion quite well. There are a few scattered areas where erosion has caused some cobbles to break loose and remain at the shore as seen in Photo 114. These do not seem to be causing any trouble at this time.

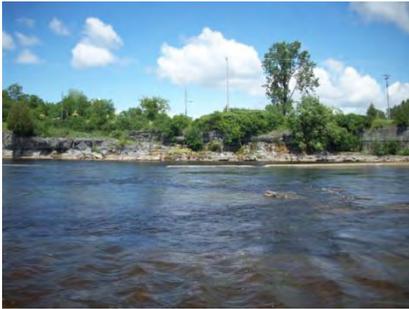
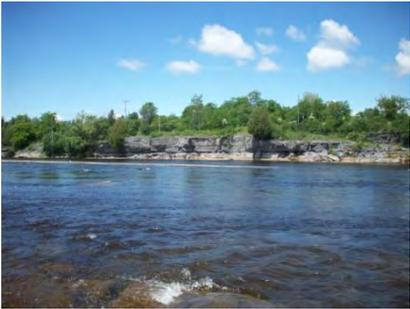
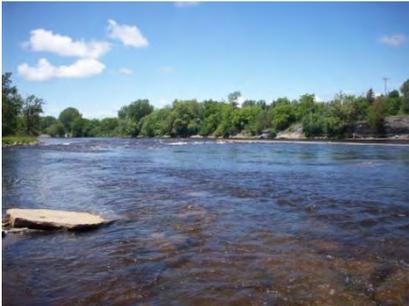
Photos 117-119 were taken from Water Works Park, near the easterly launch area. These photos show the banks directly across to the north which are mainly limestone. This rock bank prevents significant erosion from occurring here.

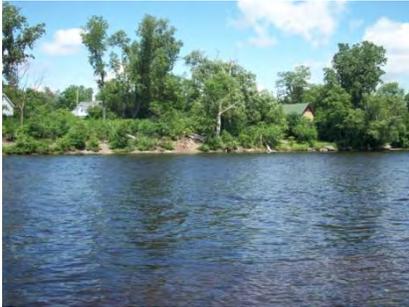
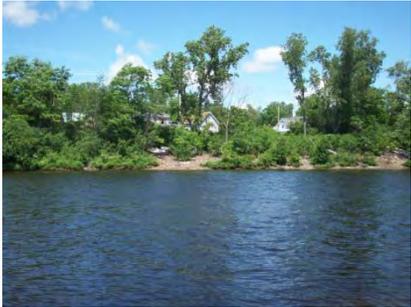
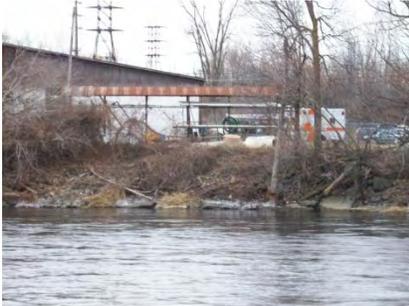
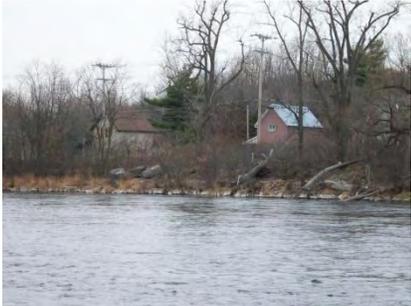
Photos 120-124 were also taken from the southern shores of the river along the western portions of the Water Works Park. These photos show the erosion that is taking place on the northern banks of the river in this area.

Looking outwards from the banks of the Water Works Park, eroding banks and retaining walls can be seen. Photos 120-124 show the erosion that is taking place along the banks opposite the Water Works Park. Photos 133 and 134 below show other areas in the vicinity. Photo 133 shows the loose material which exists in some areas. Photo 134 is within 100 feet of Photo 133, but shows how vegetation holds the bank material in place. It is recommended that these areas be planted with appropriate vegetation to prevent the earth from eroding away. They should also be inspected periodically to track the erosion. More seriously eroding areas could be considered for the use of recycled concrete.

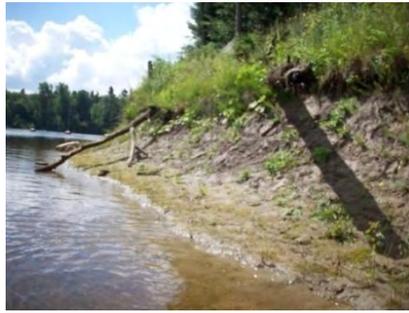
It is easy to see that when vegetation grows on the banks, it greatly mitigates the effects of erosion. This makes it logical that by planting native vegetation along eroded areas of the river would help to keep erosive forces at check. In general, the gradual eroding away of the banks in this area seems to be the most significant form of erosion. It is recommended that vegetation be planted in unstable areas to prevent this from happening. Photo 127 shows a close up shot of the upstream side of Delano Island which is eroding away. Photo 128 shows evidence of some undermining on the banks of Huntington Island which would be difficult to prevent. It has occurred even with the presence of vegetation. It is difficult to determine if this undermining is continuously eating away at the bank material or if it has reached a stable point. These undermined sections should be monitored to see the progression from year to year. If it is determined that this undermining is removing material at a substantial rate and that it needs to be prevented, it may be necessary to install structural measures such as rip-rap or even retaining wall structures. Vegetative options for stabilization are discussed in section I.F.1.

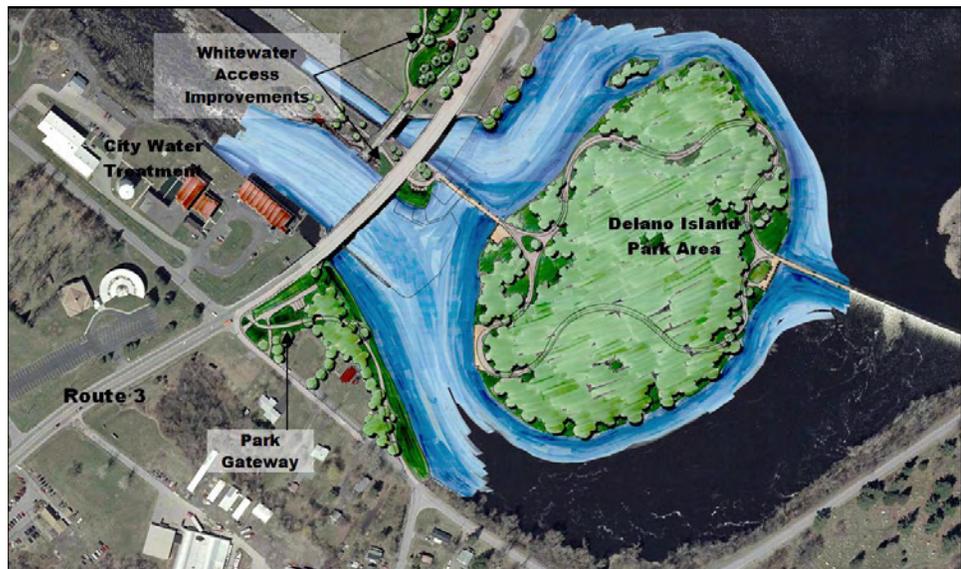
The LWRP Plans call for Delano and Huntington Islands to be converted into parks and launch areas as shown in Figure A from the LWRP plan. Knowing that these Islands could someday be developed, it is important to understand what erosion factors will need to be considered. As seen in Section II.C.1, there are slowly eroding areas which under undeveloped conditions could be mitigated through the use of vegetative measures. In most cases these vegetative measures should still be a viable option even with the islands transformed into access areas.

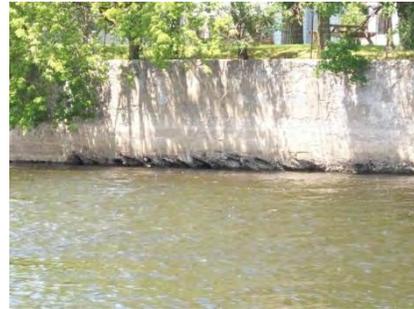
Continuing the inspection just to the northwest of Water Works Park, retaining walls in poor conditions are encountered near the Chapin Watermatics facility as seen in Photo 135. Photo 136 is a close up of the concrete retaining wall which is being eroded away at the normal water elevation.

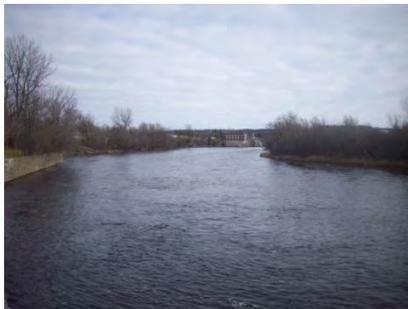
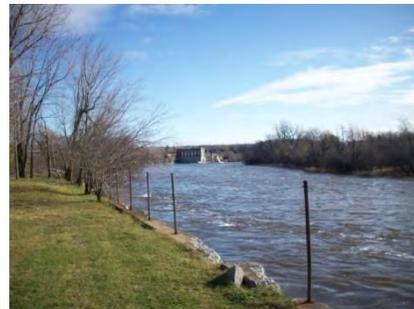
Photos 137 and 138 were taken from the parking area of Chapin Watermatics and look upstream. These two photos show the areas discussed about in the previous sub corridor.

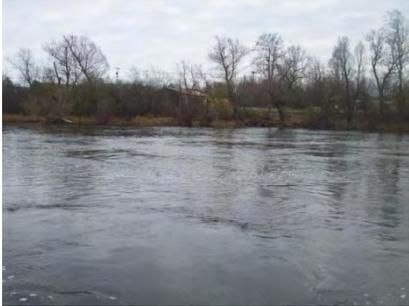
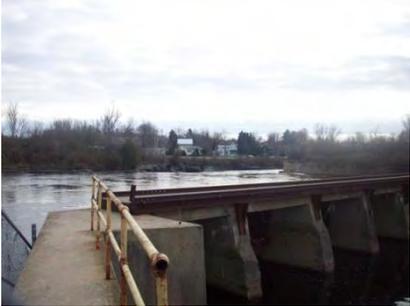
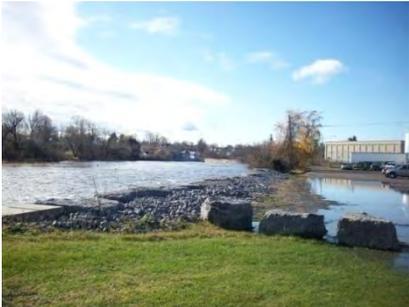
Photos 139-141 were also taken in the general vicinity of the Chapin Watermatics facility. Photo 139 shows the banks directly across the river. Photos 140 and 141 were taken looking downriver. There does not appear to be any significant erosion concerns in these photos.

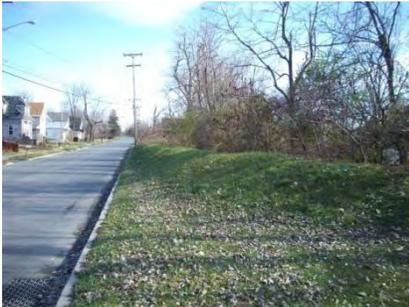
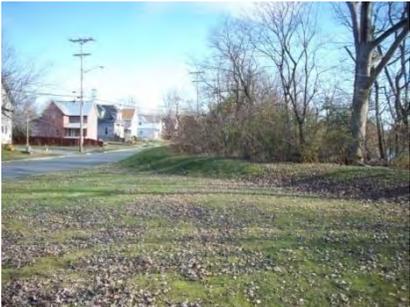
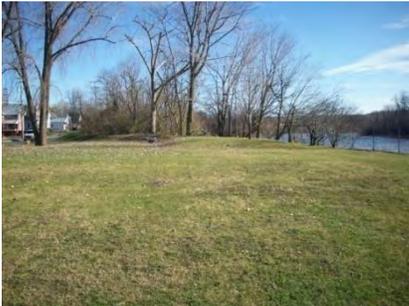
Photos 142-144 were taken to the northeast of Chapin Watermatics along Water Street. A makeshift berm which was constructed during the 1998 flooding still remains. This is a good example of controls that can be constructed in emergency situations.

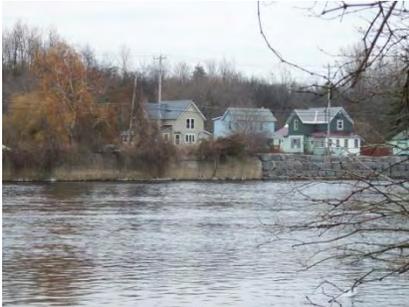
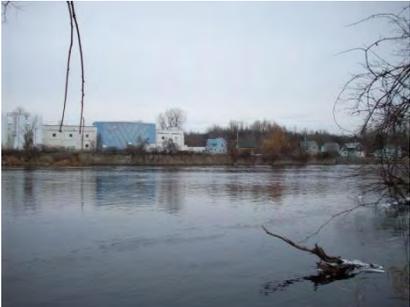
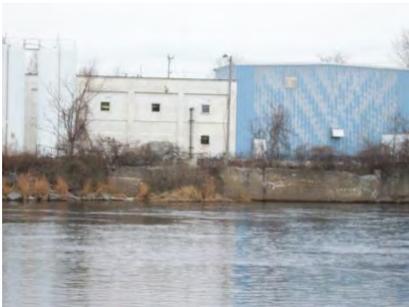
At this point in the river, it splits into two legs to get around Diamond Island. There is a privately owned hydroelectric facility at this point. The southerly leg of the river is dammed up to channel water to the northern leg and through the facility to generate power. Photos 145-158 were taken on the southern side of the river near the dam between Diamond Island and the northern bank of the river. Photos 145-148 were taken looking in the direction of the Chapin Watermatics facility. Retaining walls can be seen along the banks which seem to be in good condition.

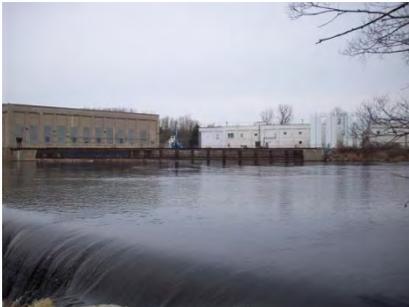
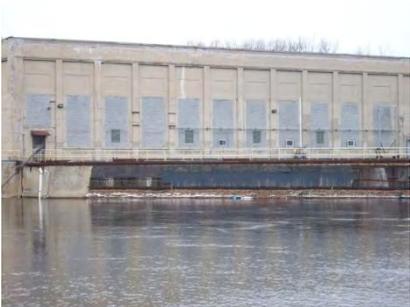
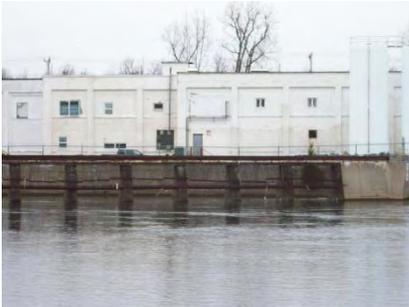
Photos 149-151 are of the hydroelectric facility. Grates are seen which filter debris out before it enters the facility for power generation.

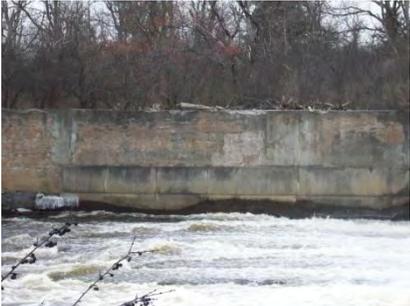
Photos 152-156 start by viewing the dam and pan to the west, ultimately looking downriver. Photo 155 shows a concrete retaining wall along Diamond Island which appears to be in good condition.

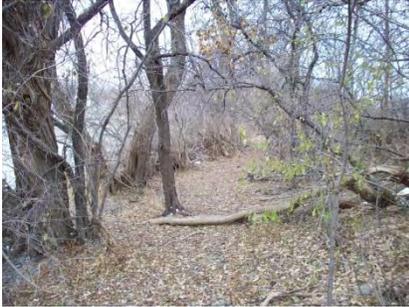
Photos 157 and 158 are taken along the southern river bank near the dam. Photo 157 shows a trail that travels along the river bank in this area. Photo 158 shows a culvert outfall from Huntington Street. It is eroding away at the outlet. The rip-rap at the outlet could be extended to be closer to the river to prevent erosion.
