EROSION MANAGEMENT PLAN FOR THE BLACK RIVER CORRIDOR

ARCHITECTURE, ENGINEERING & LAND SURVEYING, P.C.

This document was prepared for the New York State Department of State Office of Coastal, Local Government and Community Sustainability with funds provided under Title 11 of the Environmental Protection Fund.

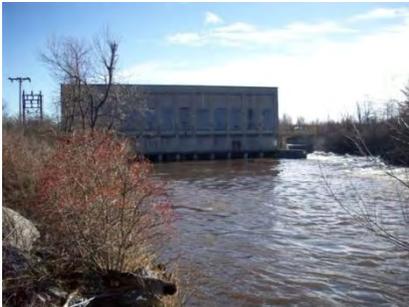
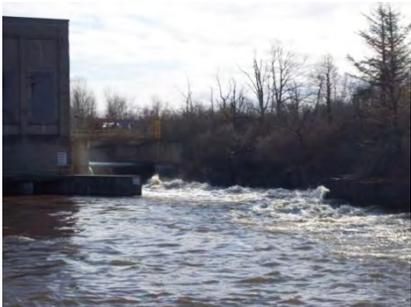
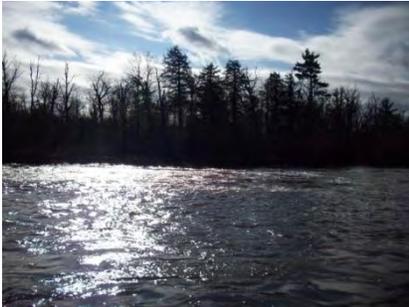
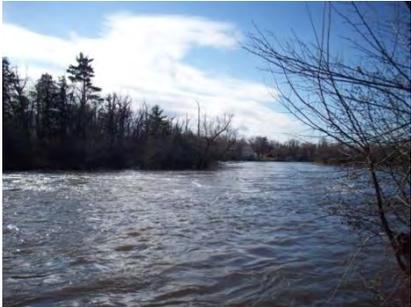
Photos 159-168 were taken downstream of the aforementioned hydroelectric facility along Water Street. This is the northern leg of the river between Diamond Island and the northern riverbank. Photo 159 and 160 are looking easterly towards the hydroelectric facility. Photo 161 is looking directly across the northerly leg at Diamond Island. Photo 162 is looking westerly down the channel towards the end of Diamond Island where the river converges back into one channel.

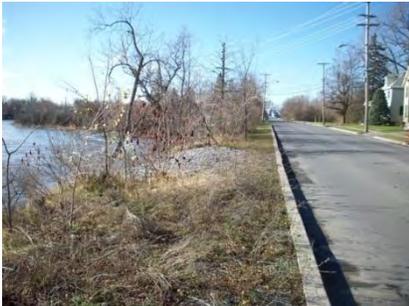
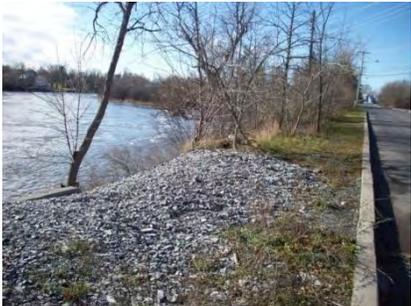
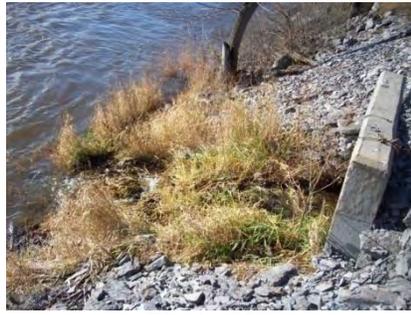
At this location, the river gets close to Water Street. The river tends to wear away at this portion of the bank as it makes a gradual left hand turn towards the downstream end of Diamond Island. These forces have caused washouts here in the past. Photos were taken of this area to record what erosion controls were in place. Photo 163 is looking in the westerly direction down Water Street and shows the area being discussed. Photo 164 is a closer view of the area. Crushed stone seems to have been placed to help prevent erosion. Photo 165 shows a drainage outlet to the river. The outlet itself doesn't seem to be causing any significant erosion. Photo 166 shows larger rip rap material just to the east of the previous three photos. This area should definitely be included in the areas to be inspected periodically. Photos 167 and 168 were taken looking downriver to the west. These bank areas appear to be stable.

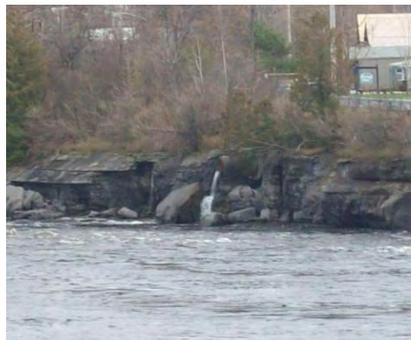
Photos 169-183 were taken in the area to the south of Diamond Island along Huntington Street. Photos 169 and 170 were taken off of Huntington Street and look easterly towards the dam between Diamond Island and the southern bank of the river. Photo 171 shows a culvert outfall to the river. It has little erosive effect because of the rock it falls onto. A makeshift access area is seen in Photo 172 which looks to be used for fishing. In general, this area appears to be stable because of the bedrock banking.

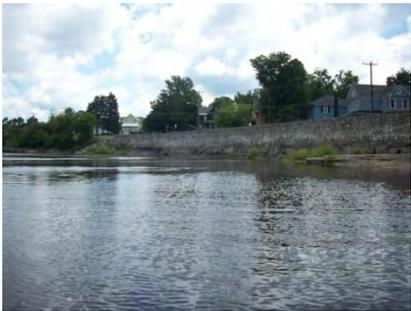
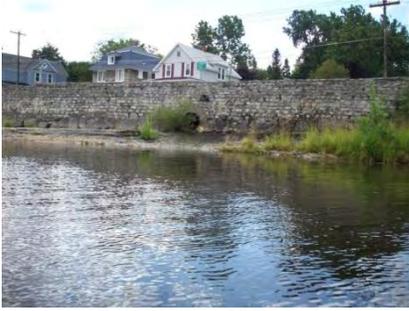
Photos 173-177 are of the southern riverbank along Huntington Street. In general, the banking closer to the dam to the east is stable due the rock material. A laid rock retaining wall exists along Huntington Street in the vicinity of Indiana Avenue North close to the water's edge and can be seen in Photos 176 and 177. This wall seems to be in good condition. It should be inspected periodically to evaluate its condition.

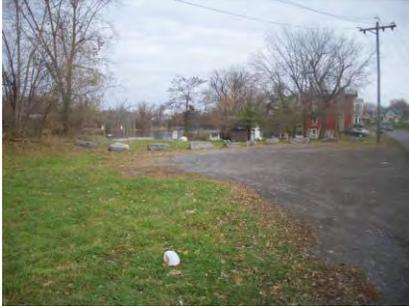
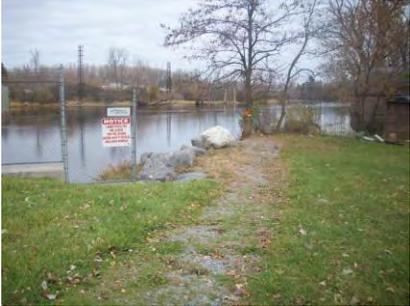
Photos 185-188 were taken from the Sewall Island Car-Top Launch near the intersection of North Hamilton and Huntington Street's. Photos 185 and 186 are of the access area itself. Some erosion from pedestrians is noticeable along the river access trail. Photos 187 and 188 are of the banks at the launch area which are stable.

This access area was in generally good condition with the exception of some minor erosion that is occurring from pedestrians accessing the water in this area as shown in Photos 185-188. It may be beneficial to install a concrete or asphalt pathway to the water's edge. Another option would be to install additional crushed stone of a larger grade.

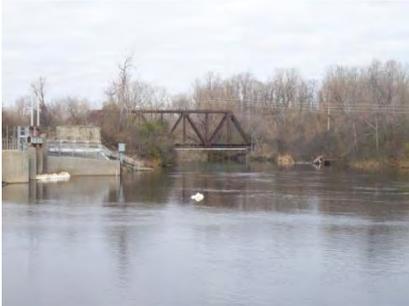
Photo 189 and 190 were taken looking to the northeast at the banks on the opposite side of the river. Photo 191 is looking north at the eastern tip of Sewall's Island where the river splits into two channels. There are no noticeable points of erosion here.

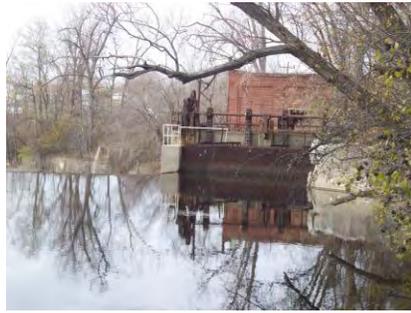
Photos 195-199 were taken around the rail road bridge which stretches from the northern bank of the river to Sewall's Island. Photo 195 looks south back towards the Sewall Island Car-Top Launch. Photo 196 is looking west down the northern leg flowing around Sewall's Island. Photo 197 is of what appears to be an abandoned hydroelectric facility to the west of the railroad bridge. Photo 198 is a show taken looking southwest along the abandoned railroad bridge. Photo 199 shows a laid rock and mortar structure that was likely used to support some sort of bridge at one time which is in poor condition. It is not supporting anything at this time but should be structurally inspected and evaluated if it going to be used for any type of access to Sewall's Island.

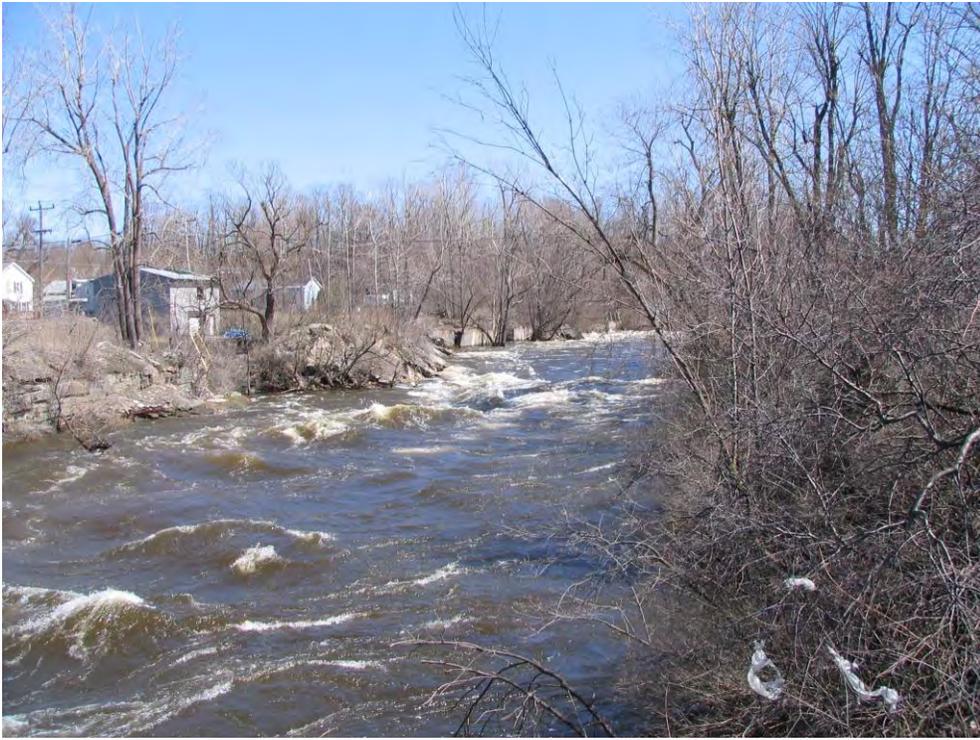
Photos 200-203 were taken from the northernmost of the two Pearl Street Bridges looking to the east. Photo 200 was taken looking to the east up the river. Retaining walls in the distance on the northern banks of the river can be seen which should be included in the periodic inspections along the river. Photos 201-203 show the banks of the river near the bridge to be of bedrock. This prevents any significant erosion from occurring in this area.

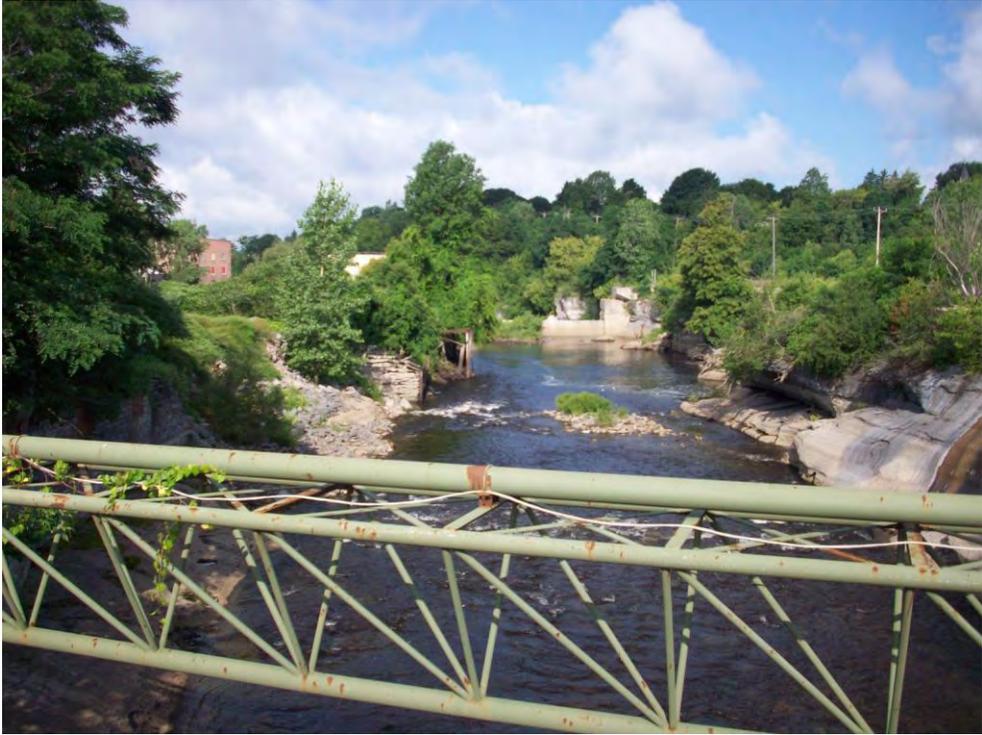
Photo 204-208 are from the northern most Pearl Street Bridge. Photo 204 is a view looking straight downriver. Erosion can be seen on the southern bank of the river. This area should be included in the periodic river inspection. Photo 205 shows a portion of the northern banks in this area, which are mostly of rock and makes for little erosion.

The banks of the river in this area are mostly of rock and are generally stable at the water's edge. The canyon like shape that is carved out by the river does make for some areas where the materials higher up the bank give way to erosion and collapse into the river. Refer to photo 204 which shows the unstable bank along the northern bank of Sewall's Island. The banking in this area has started to collapse. These upper bank areas should be studied in detail before any development to determine if stabilization is necessary. Unstable materials could be removed in these areas in some cases to solve this problem. In more severe situation where the banks could collapse, retaining structures could be designed and installed.

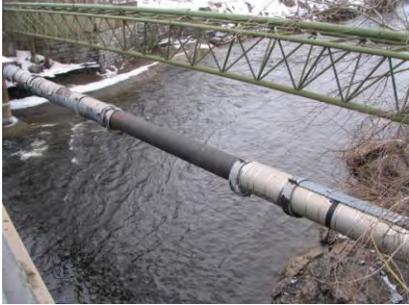
Photo 206-208 are of the piping that cross the river at the northern Pearl Street Bridge. Photo 206 shows the pipes as well as a retaining wall structure in the background which should be inspected periodically. Photo 207 shows the base of one of the support structures for the piping that is being undermined. The extent of the erosion which has taken place is uncertain. A structural inspection should be performed to assess whether or not this support needs repair. Photo 208 shows an outfall pipe to the river on the north bank in this area. It has been broken, but still could function.

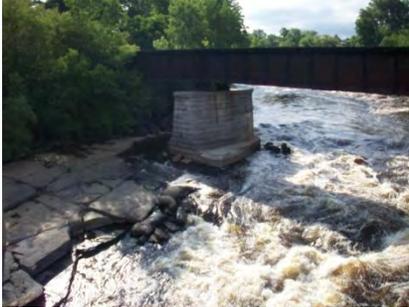
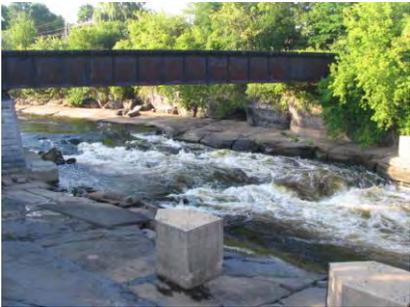
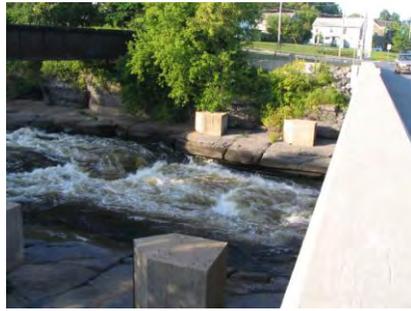
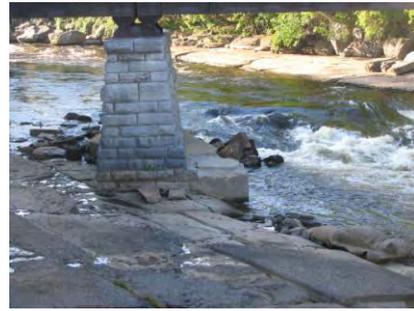
Photos 209-212 are of the southern portion of the Pearl Street Bridge, looking upstream to the east. The banks in this area are mostly of stable bedrock. An abandoned railroad bridge from Sewall's Island to the southern bank of the river is seen in the photos. This bridge may be considered for pedestrian access to Sewall's Island in the future as part of the LWRP plan. Photo 212 shows a photo of one of the supports of this bridge. It is recommended that a detailed structural inspection be performed on this prior to consideration of use as pedestrian bridge. (Note: Bridge supports are included in the NYSDOT Biennial Bridge Inspections.)

The abandoned railroad bridges which may be used for pedestrian access should also be evaluated for structural integrity and in terms of safety for use as it was revealed during the inspections that the supporting structures on these bridges are showing signs of wear and tear. Some repairs may be all that is necessary to make the bridges useable.

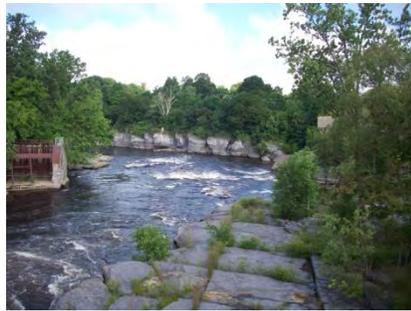
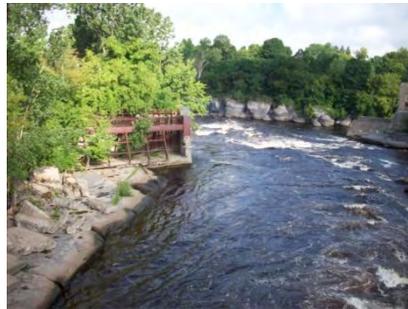
Photos 213-215 were taken from the northern Pearl Street bridge looking downstream towards the west. The banks are mostly bedrock and are stable. There are some concrete remains on the northern bank of the river which are seen in Photo 214. These remains should be removed if the riverside trail system comes through this area as they could pose a safety hazard to pedestrians.

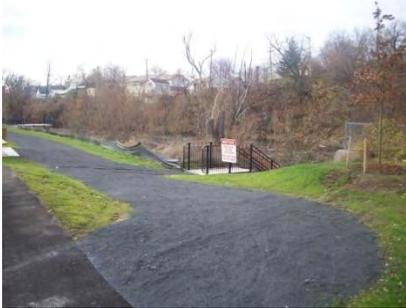
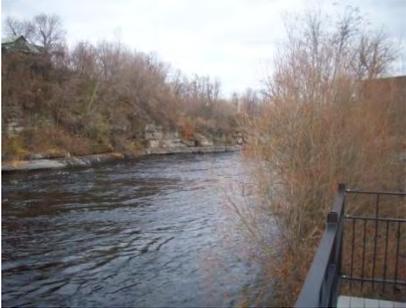
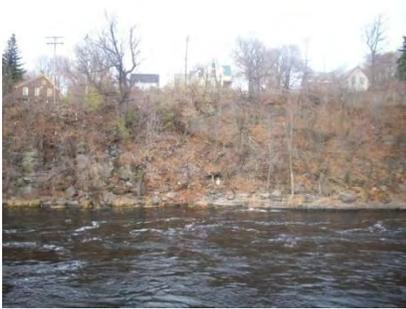
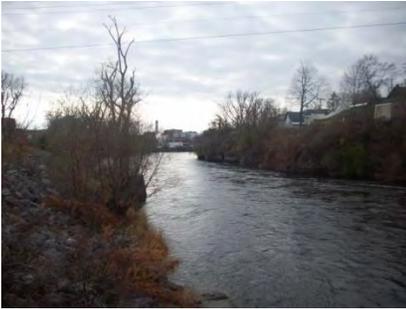
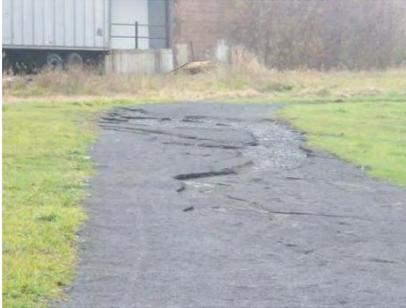
Photos 216-221 were taken from the Abe Cooper Site off of Factory Street. This site allows access down to the river's edge via a stairway as seen in Photo 216. Also in the background of Photo 216, the deck area which overlooks the river can be seen. Photos 217-219 were taken from the deck. Photo 217 is looking upriver towards the northeast. Photo 218 is looking at the river bank directly across from the deck area. Some erosion is occurring in this area. It is mainly material falling from the top of the bank down into the river. The edge of the river itself is limestone and is stable. Photo 219 is looking downriver towards the southwest. Photo 220 is a close up shot of the gravel walking trail which is eroding away. Photo 221 shows crumbling brick and mortar along the stairway down to the river's edge. There are some areas of concern at this access area which will be discussed in more detail in the recommendations section for this sub corridor.

Photos 216-221 are of the Abe Cooper site and show the general condition of it. This site and its access points were recently constructed and accomplish their general purpose. The deck area provides a great view of the river and the stairs to the river are constructed well. There are areas which are being effected by erosion.

The material that was placed for the pedestrian paths is easily washed away by water which flows to the river as shown in Photo 220 and the area at the bottom of the stairs is eroding away. The brick and mortar structures which are along the stairway are crumbling away. At the bottom of the stairway at the river's edge are abandoned industrial structures which are crumbling as well which could pose a safety hazard to pedestrians which visit. Photos 263 and 264 were taken from the bottom of the stairway and look to the north and northeast, respectively.

It is recommended that the areas at the bottom of the stairs be cleared of debris and the structures either be removed or stabilized. If necessary rip rap could be placed in this area in a strategic stepped fashion which would double as pedestrian sitting areas. These strategically stepped sitting areas could be placed inside the existing concrete remains, if a structural inspection deemed the structures to be safe to do so. If the structures are to remain as a wall along the stairs, the crumbling brick and mortar should be repaired.

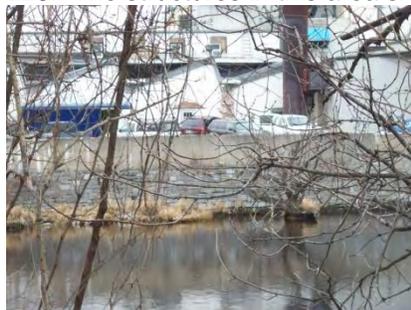
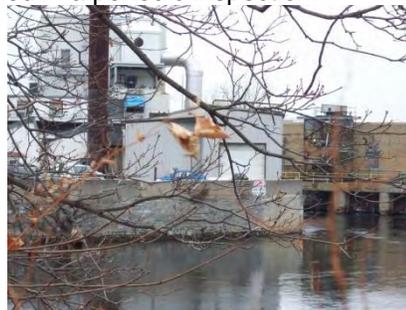
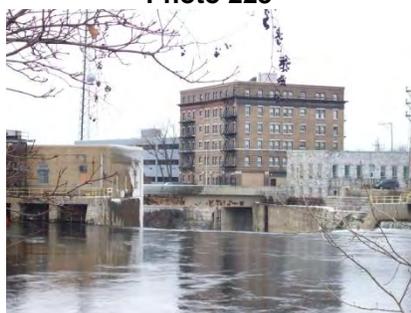
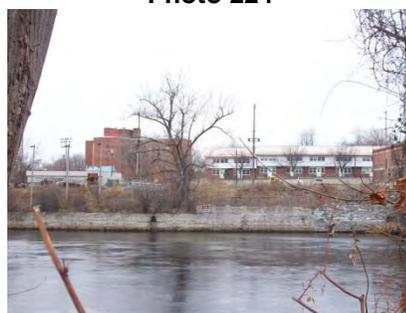
Photos 223-226 were taken from the southern banks of the river, upstream of Mill Street and show the conditions of the retaining structures near the upstream portion of the hydroelectric facility. Photos 223 and 224 are of the retaining wall on the eastern banks of Beebee Island. This retaining wall appears to be in good condition. Photo 225 shows the inlet to the hydroelectric facility and the upstream view of the dam. A retaining wall in fair condition is shown on the northern banks of the river in this area is shown in Photo 226. The structures in this area should be included in a periodic inspection.

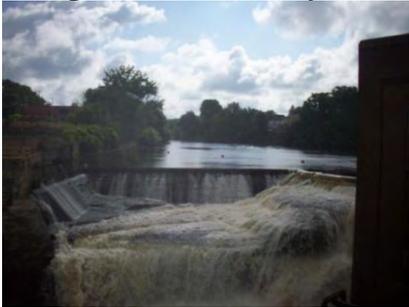
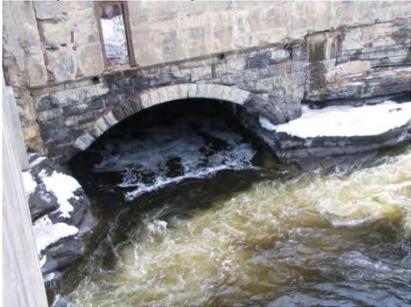
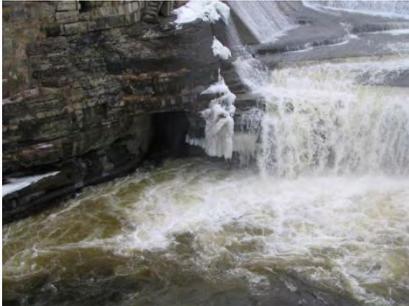
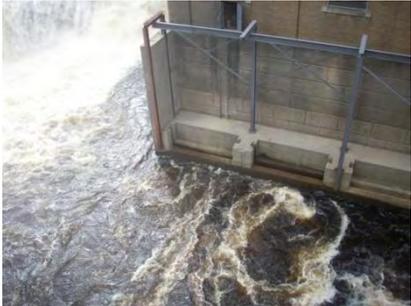
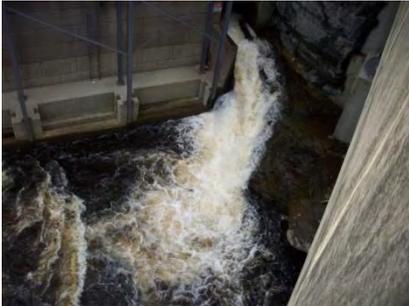
Photos 227-231 were taken from the northern portion of the Mill Street Bridge and look upstream to the northeast. Photo 227 is an overall look at the dam. Photos 228-231 pan from north to south while looking downward from the bridge. Outlet structures appear to be in good condition. They should be included in the periodic inspections recommended.

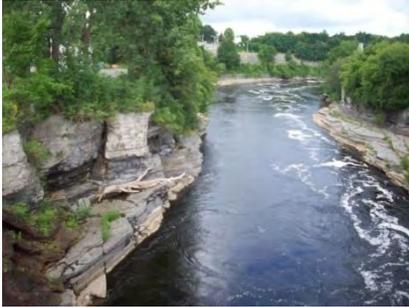
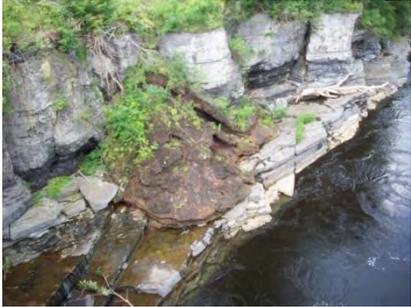
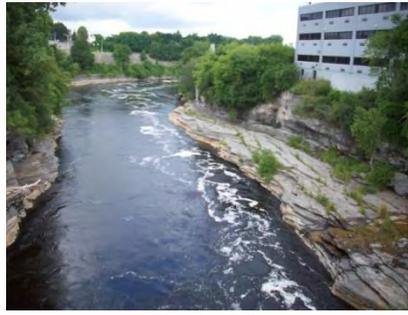
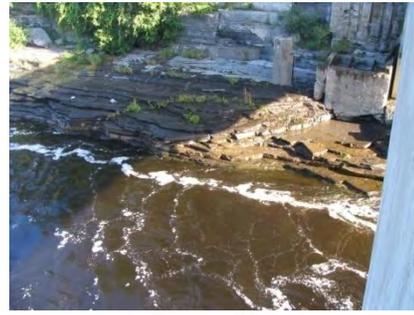
Photos 232-235 were taken from the southern portion of the Mill Street Bridge, look downstream to the west and pan from southwest to northwest. The banks close to water's edge in this area are fairly stable due to them being rock. Photo 233 shows a portion of the upper bank on the south side of the river which has collapsed. This shows how the bank can give way under erosive conditions. Although in this area it is not a threat, similar erosion could occur in other areas which might be.

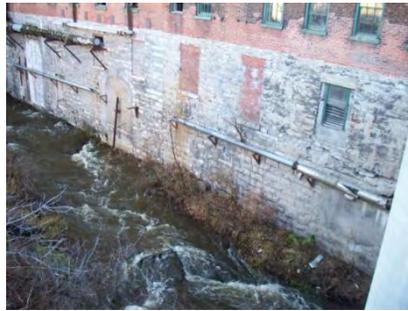
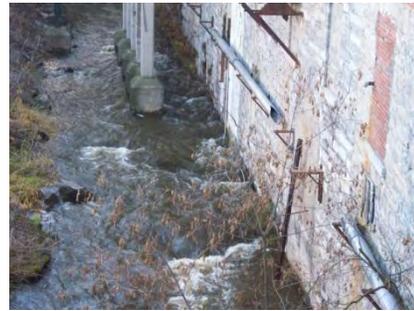
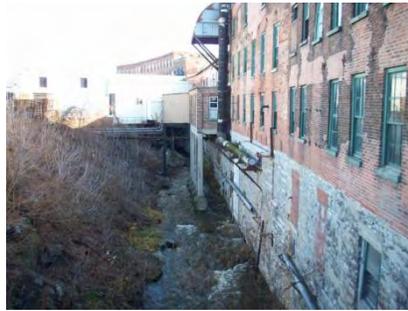
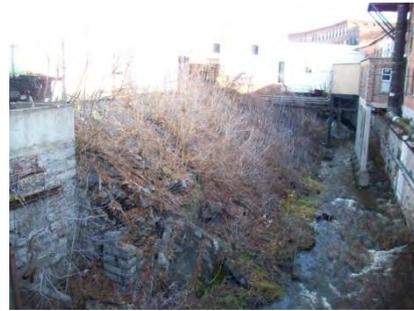
Photos 236-239 were taken from the southerly portion of Mill Street Bridge and look upstream to the east. This portion of the river channel flows between Beebee Island and the mainland to the south. This portion of the river flows along buildings as seen in Photos 236 and 237. These buildings appear to be in good condition but should be part of the periodic recommended inspections as conditions can change over time. Photos 238 and 239 show the banks of Beebee Island in this area to be steep and covered with vegetation that inhibits erosion. These banks should also be inspected periodically.

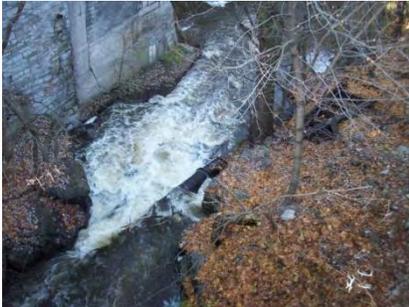
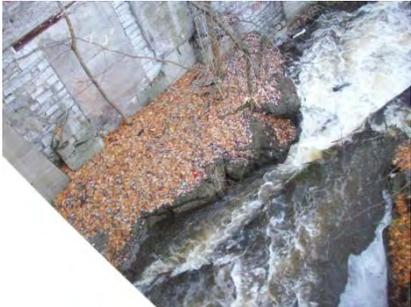
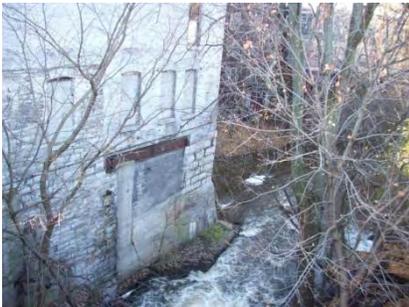
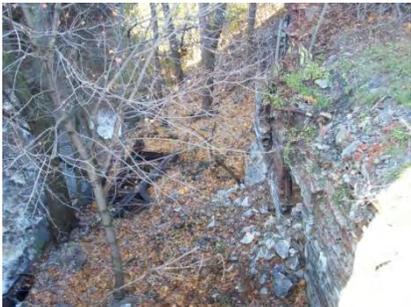
Photos 240-250 are taken in the vicinity of the southern portion of the Mill Street Bridge. These photos are of the downstream portion, west of the Mill Street Bridge, between Beebee Island and the mainland banks to the south. Photos 240-243 were taken from the bridge looking downstream. As can be seen from these photos, the water flows right up against structures in this area. Photo 243 shows the Beebee Island banks which are very steep and are held back by ageing and crumbling retaining structures. The Beebee Island banks should be inspected periodically for erosion.

As seen in photos 240-250, the areas around the southerly Mill Street Bridge flow along buildings and very steep banks. Some of these banks have buildings very close to the top which are supported by deteriorating retaining wall systems such as the southerly bank of Sewall's Island, downstream of the Bridge. The buildings along the southern banks of the river at the water's level near Beebee Island are also susceptible to erosive forces of the water and do show deterioration in some areas. These retaining structures and buildings should be structurally inspected thoroughly to determine if the buildings along the top of the banks are properly supported.

As discussed in the various sections of this report, and seen in photos 240-250, the areas downstream of the southern Mill Street Bridge are in need of attention. The existing structures along the southern bank of the river in this area look to be deteriorating. Before any development is considered for these structures, the structural and safety concerns should be addressed.

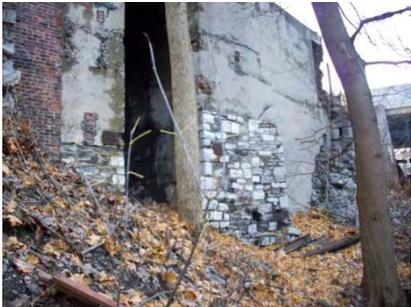
Photo 245

Photos 244-246 are of the deteriorating structures along the southern banks of Beebee Island downstream of the Mill Street Bridge. As can be seen from the site plans, there are buildings which sit very close to the banks in this area. These buildings look to be supported or partially supported by retaining structures which are in questionable condition. Photo 244 was taken from the bottom of the southern Beebee Island bank and shows the structure. Photos 245 and 246 are more detailed photos of these structures. Photo 246 especially shows the deteriorating condition of the retaining structures, as the stones are slowly falling out of the wall.

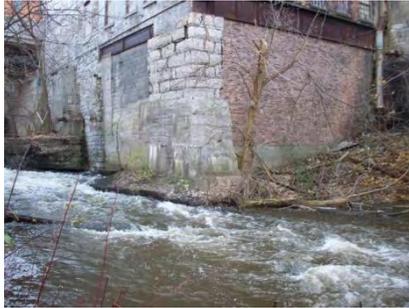
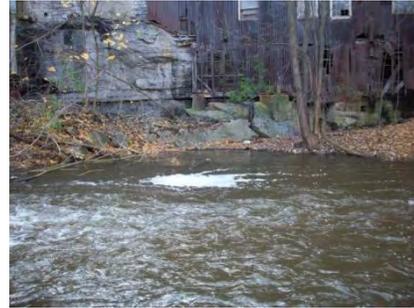
Photos 247-250 were taken from the lower southern banks of Beebee Island of the northern banks of the river. Photos 247-249 pan from southeast to southwest and show the building structures which are right on the bank in this area and are in questionable condition.

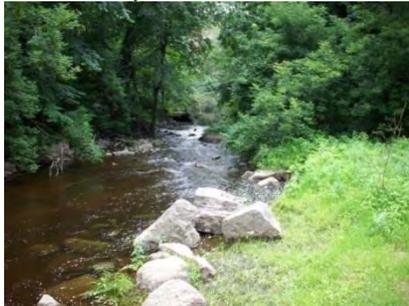
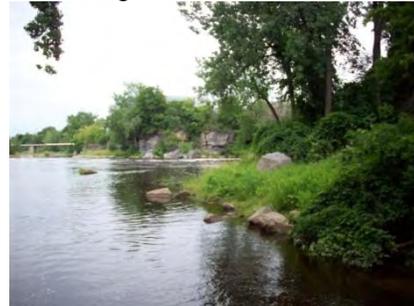
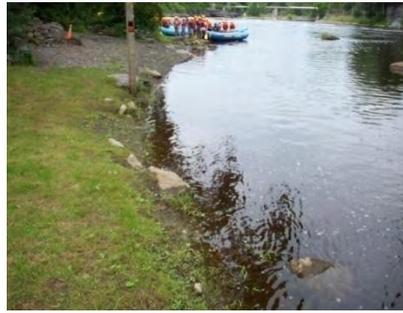
Photos 251-253 were taken near the Adirondack River Outfitters private river launch area west of the Mill Street Bridge on the southern banks of the river. Photo 251 is looking upstream to the east. Photo 252 is looking downstream to the northwest. Photo 253 is a shot of a launch in progress looking to the west down the river bank. This launch area seems fairly stable as there is crushed stone in place along the bank.

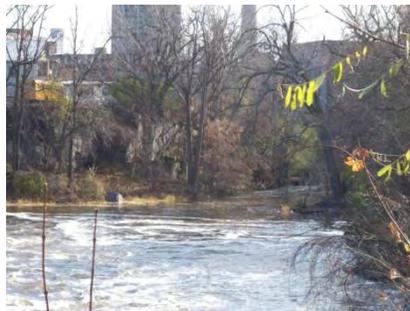
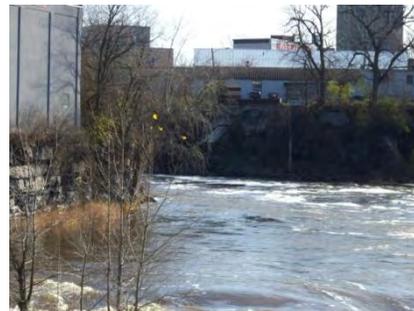
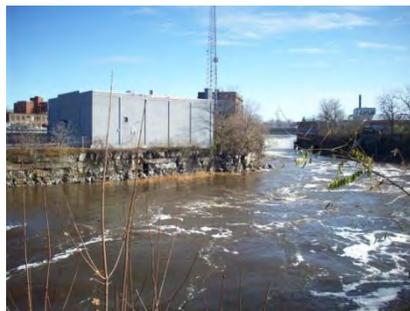
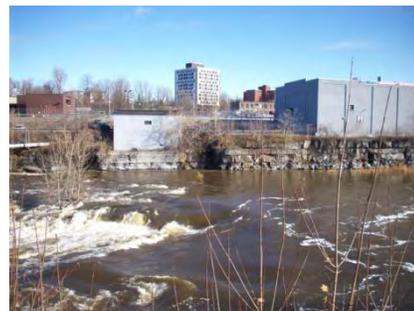
Photos 254-259 were taken from the southern banks of the river near the Veterans Memorial Riverwalk Park. Photo 254 is looking to the southeast towards Beebee Island. Photo 255 is looking to the east at Beebee Island and the outlet from the Mill Street Bridge. The steep banks of Beebee Island can be viewed from here. Vegetation currently holds material in place along these banks. Photos 256 and 257 look to the generally northeastern direction at the northern banks of the river. Buildings sit close to the river in this area on bedrock. Photo 258 looks in the northerly direction at the banks directly across the river. An outlet pipe can be seen which likely drains the Dealmaker facility parking area off of Main Avenue. This outlet pipe seems to be eroding the lower loose materials away under it. Photo 259 is a cropped close up of the previous photo which shows the chain link fencing concrete foundations exposed along the parking area across the road. Employees at the corporate office of Dealmaker on Main Avenue have been informed of this eroded area.

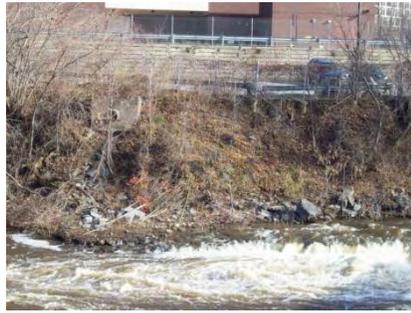
Photo 258

As seen in photos 258 and 259, a portion of the bank near this facility is eroding away to the point where the chain link fencing around the perimeter of the northern most parking area has the post foundations exposed. These foundations of course, are very close to the pavement where vehicles are driven and parked. At this point, the pavement in this area does not seem to be in danger of collapsing. Although, this is a possibility. The corporate office at the Dealmaker Body Shop facility was notified of this eroding area.

In the future, it is recommended that when site plans are reviewed, a setback be required from the top of very steep river banks such as this. Exceptions could be made, as conditions allow. This is discussed in more detail in the recommendations section of this report.

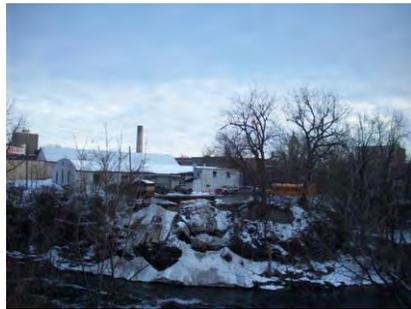
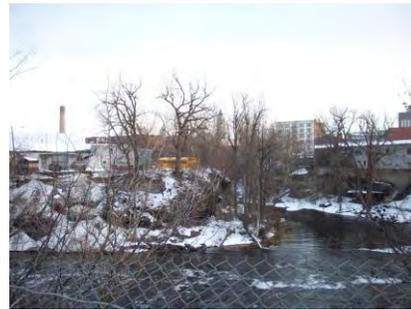
Photos 260-262 were taken on the northern banks of the river from the Dealmaker Body Shop parking area. Portions of the western Beebee’s Island bank can be seen from Photos 260 and 261. These steep banks appear to be limestone bedrock at the edge of the water, but up higher loose materials are held in place by vegetation. Photo 262 shows the Adirondack River Outfitters private launch area.

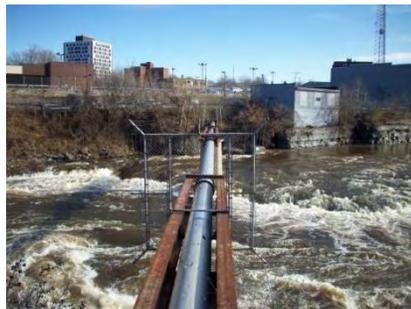
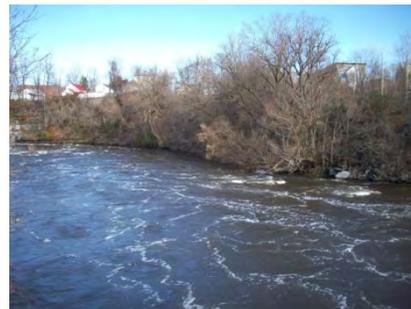
The walkthrough inspection continues in the vicinity of the Veterans' Memorial Riverwalk. Photos 265 and 266 were taken from the high southern banks of the river at the pipeline that crosses the river and capture the northern banks of the river. Photo 265 was taken in the eastern direction. Photo 266 looks to the northeast. The banks in this area are steep but appear stable likely because of the vegetation holding the loose materials in place. They should be included in the periodic inspections.

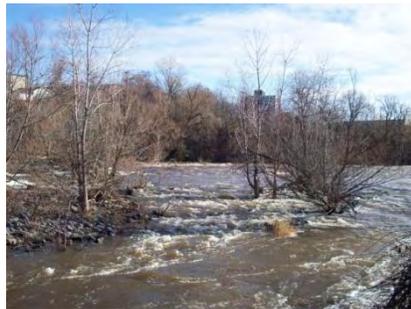
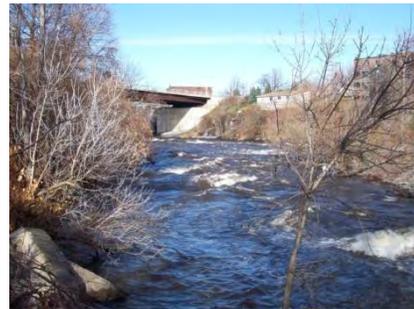
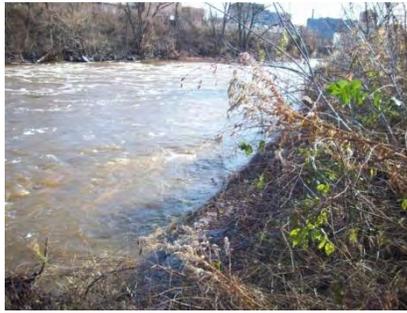
Photos 273-275 were taken from the lower southern banks of the river near Veterans' Memorial Riverwalk. Photo 273 is looking in the northeastern direction and shows how the small islands in the middle of the river are being inundated with water in several areas. It is likely that if this vegetation were not in this area, a lot of the materials would wash away. The trees within this island illustrate the ability of vegetation to prevent erosion. Photo 275 is a shot of the southern bank of the river at the water's edge. These steep banks are held in place by limestone bedrock near the bottom and vegetation on the higher portions of the bank. These banks should be inspected periodically.

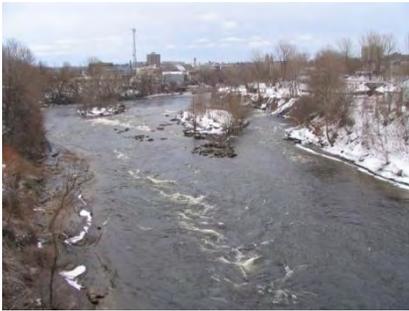
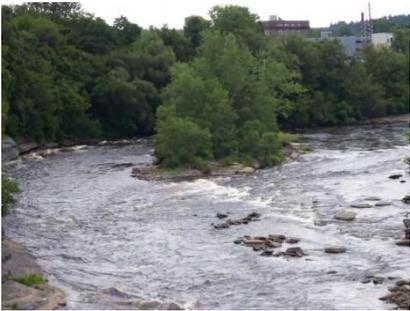
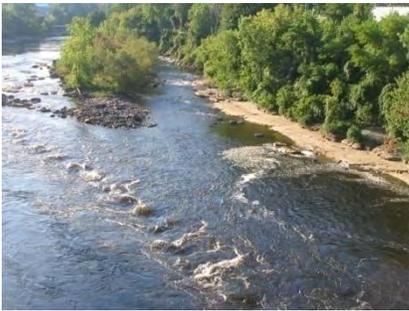
Photos 280-282 were taken from the Court Street Bridge looking upstream to the southeast. The steep banks in this area are shown on both sides of the river. As indicated previously, these banks are stable on the bottom as they are comprised of limestone bedrock. The middle and upper banks soil materials are held in place by vegetation. The vegetated islands mentioned in the previous sections are shown from afar.

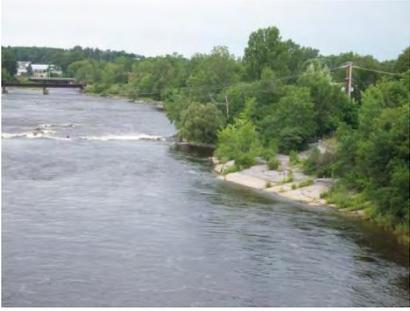
Photos 283-285 were taken from Court Street Bridge and look downstream to the northwest. Hole Brothers Wave can be seen from here. Photo 284 shows a launch area that is used for rafters on the northern bank. Portions of the launch area and Hole Brothers Park can be seen from Photos 283 and 285.

These two private launch areas are located across from one another, downstream of the Court Street Bridge. They are shown on the Overall Plan included in Appendix A. The B.O.B. Rafting Launch Area located on the northern bank of the river is mainly bedrock and there are no obvious signs of erosion. This launch area is shown from a distance in Photo 284.

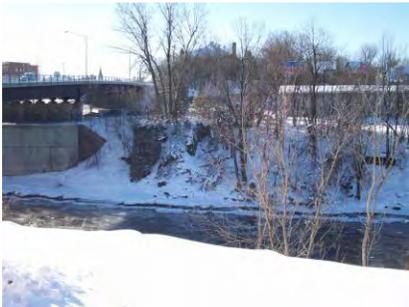
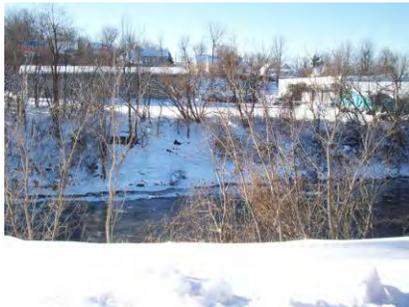
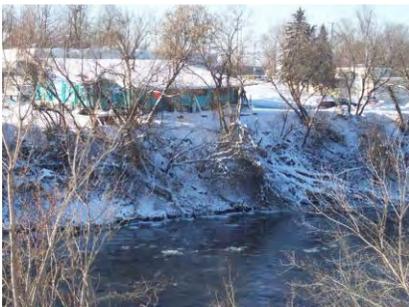
Photos 286-290 were taken in the winter, from the northern banks of the river, just downstream of the Court Street Bridge. The photos pan from the east to west and show the steep, heavily vegetated banks in this area.

The Hudson River Rafting launch area is located in the same general vicinity of the B.O.B. Rafting launch area, on the opposite side of the river. This launch area and the banks in the vicinity can be seen in Photos 286-290. The approach to this launch area is a lot steeper than the B.O.B. Rafting launch area. According to a representative from Hudson River Rafting, the remains of the old Court Street Bridge abutment are close to this launch area and are crumbling apart slowly. The new Court Street Bridge has an area to watch the river from which is fenced off. Due to this, rafters periodically make their way past the crumbling bridge abutment to the viewing area and vice versa. This makes for an unsafe situation when rafters are traversing the bank near this. This existing structure should be removed.

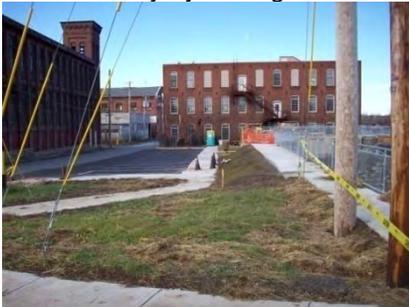
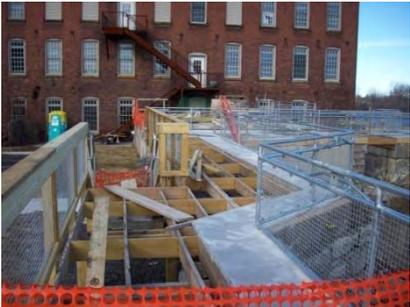
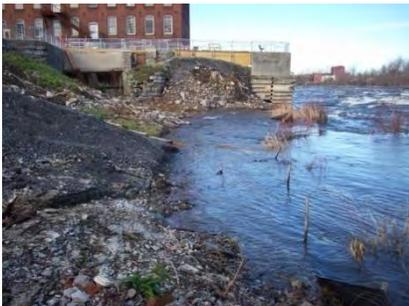
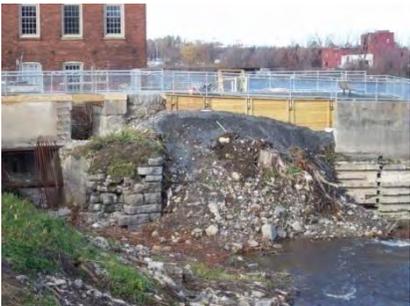
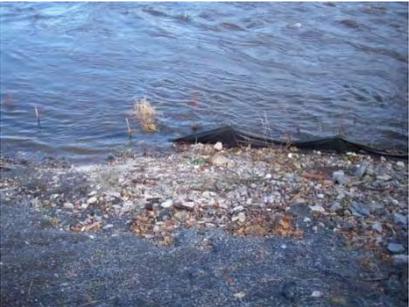
Photos 291-295 were taken at the Hole Brothers Park which is under construction, but shut down for the winter season. Photo 291 is a view just off of Newell Street which looks down to the west at the former Black River Brewery and the recently constructed parking area. Photo 292 is of the decking area which is under construction. Photos 293-295 were taken at the upstream end of Hole Brothers Park and look to the west at the eroded banks in this area. Photo 294 is a close up shot of the erosion that is occurring on the bank adjacent to the deck area that is being constructed. Photo 295 shows silt fencing that was installed as part of the summer construction project which has nearly been washed away by the higher fall water levels.

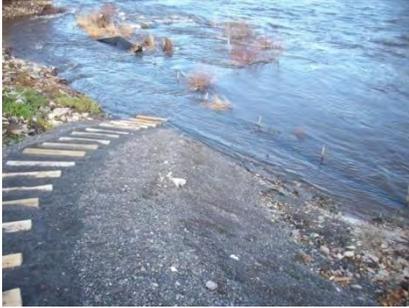
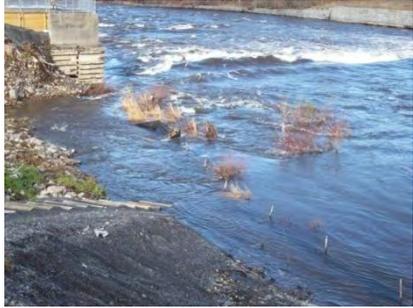
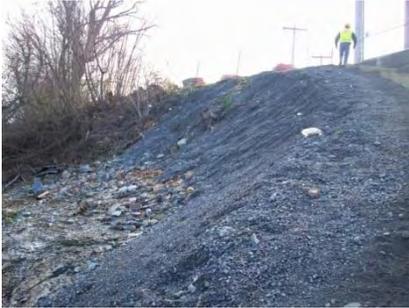
Photos 296-298 were taken of stairs that were constructed on the eastern portion of Hole Brothers Park. Photo 296 and 297 show a view of the stairs from the top. The bottom portion of the stairs is washing away due to the erosive effects of the river. Photo 298 is from the bottom of the stairs looking up towards the top. The newly graded, steep bank can be seen in this photo.

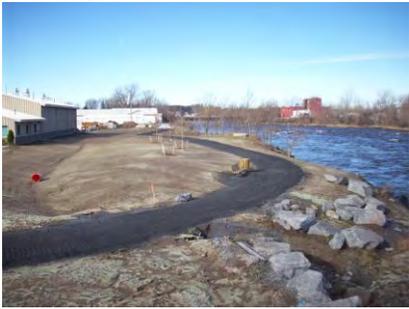
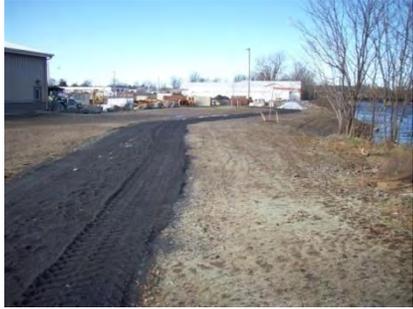
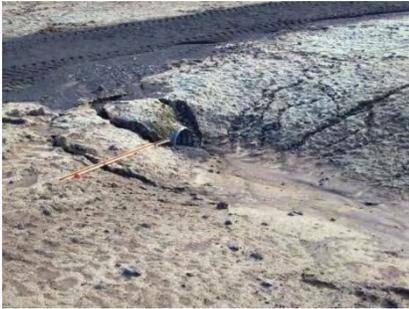
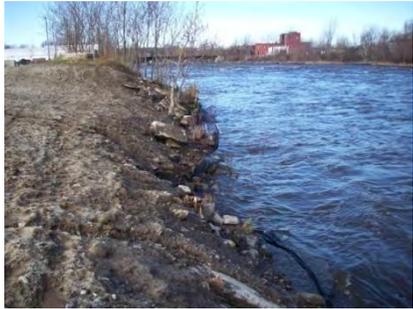
Photos 299-302 were taken at the Hole Brothers Park, west of the former Black River Brewery. Photo 299 is of the pedestrian path in this area taken from the deck area of the former Black River Brewery in the northwesterly direction. Photo 300 is from the pedestrian path looking in the western direction. Photo 301 is of a culvert under the pedestrian path which is eroding away at the inlet and outlet. Photo 302 is of the riverbank near the pedestrian path which has been subject to severe erosion. The silt fencing which was installed during construction has been inundated and soils are entering the river.

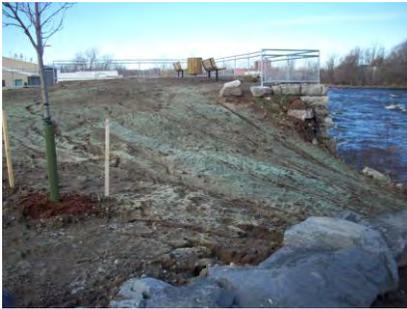
Photos 303-305 were taken to the northwest of the former Black River Brewery near the access to the Black River. Photo 303 shows the banks in this area eroding away. Photo 304 is taken looking in the westerly direction and shows the lookout area in the distance. Banks in need of erosion protection are shown in Photo 305 adjacent to the deck area which is being added onto the former Black River Brewery.

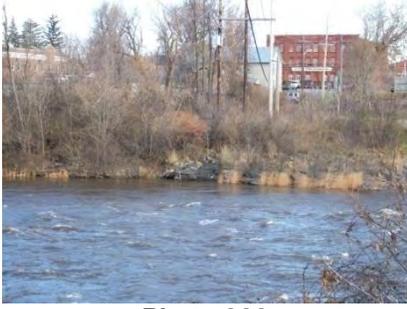
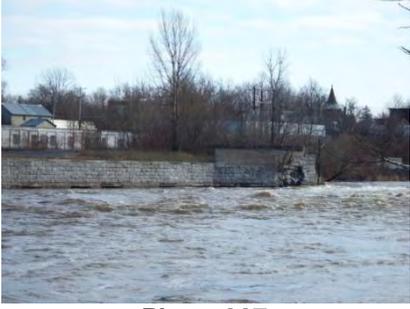
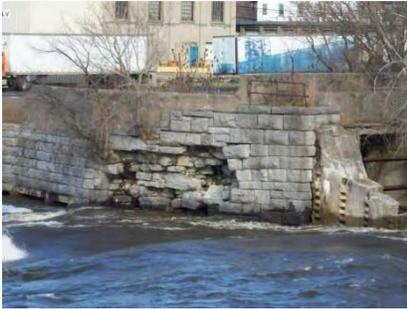
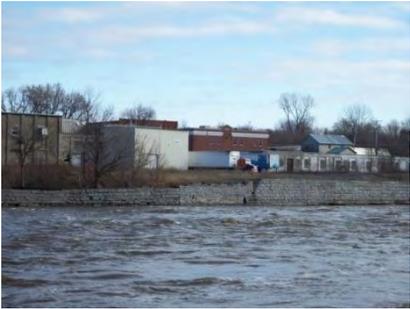
Photos 306-313 are of the northern banks of the river, across from Hole Brothers Park. Photo 306 was taken in the northeastern direction. Photo 307 is looking to the northeast at an abandoned structure which looks to have been used for power generation at one time. The retaining wall that is part of this structure is beginning to fail. Photo 308 is a close up shot of the failing eastern portion of the wall. Photo 309 is another shot of the wall farther downriver to the west.

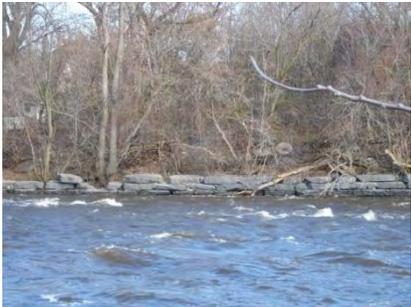
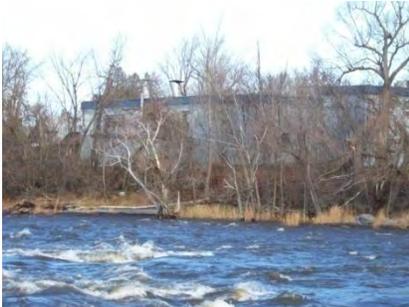
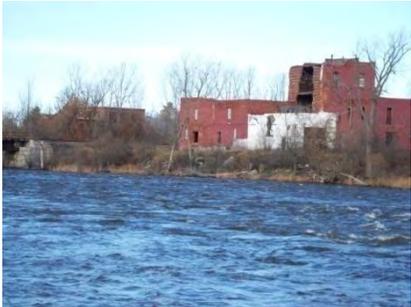
Photos 310-313 pan downriver from the failing retaining wall to the west along the northern banks. Photos 310 and 311 are of smaller rock wall retaining structures which are also failing. Vegetation exists along the banks behind the rock wall. Photos 312 and 313 are of the northern banks of the river upstream of the railroad bridge. Abandoned, crumbling structures are seen in the background. The banks along this area seem to be stabilized by the native vegetation.

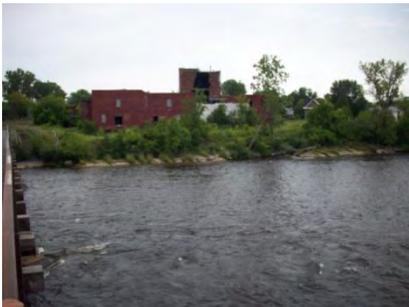
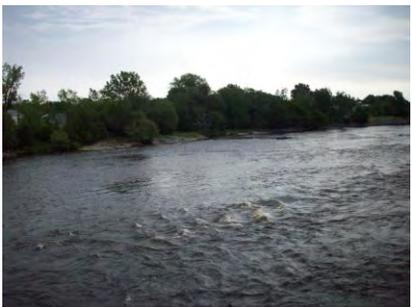
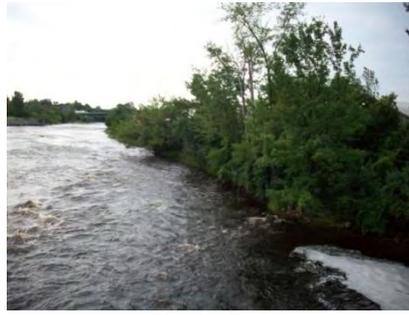
Photos 314-320 were taken from the railroad bridge east of the Vanduzee Street Bridge. Photos 314-316 were taken from the eastern side of the railroad bridge and show some of the banks upstream. Photo 314 and 315 are of the northern banks of the river, upstream from the railroad bridge. Photo 316 shows a portion of the southern bank of the river in this area. The banks shown in these photos seem to be the typical lower limestone bedrock and the upper soil materials held in place with vegetation. The railroad bridge itself didn't show any obvious damage from erosion. It should still be included in the periodic inspections.

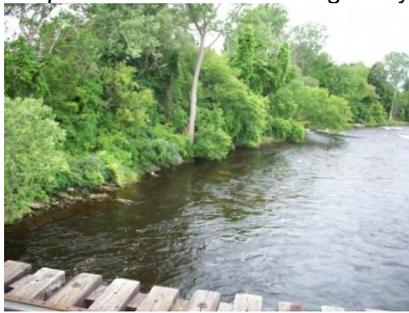
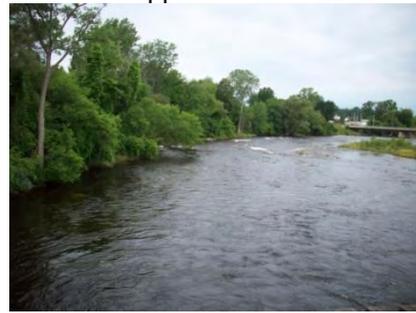
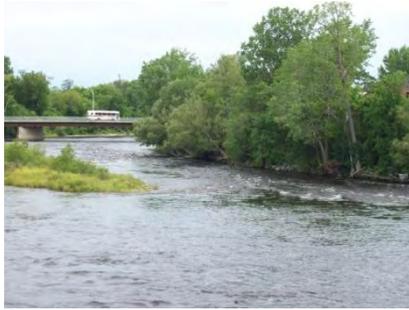
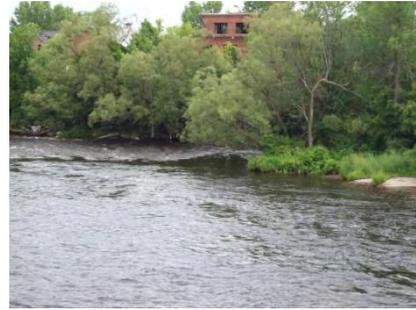
Photos 317-320 were taken from the western side of the railroad bridge. Photos 317 and 318 were taken in the western direction along the southern banks of the river. Photo 319 and 320 are taken in the northeastern direction along the northern banks. A small island exists downstream of the railroad bridge and is another example of how vegetation can keep materials from washing away. The banks in this area appear to be stable.

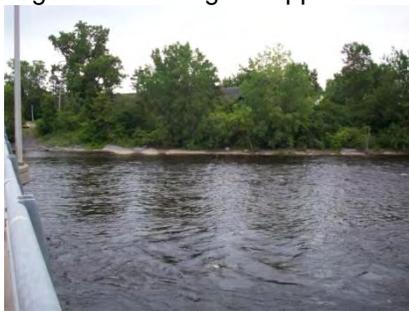
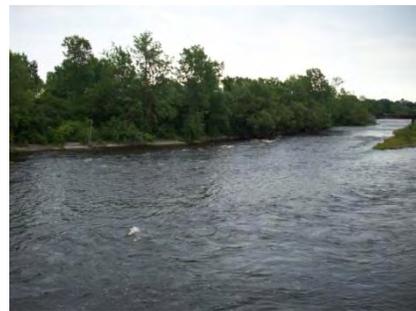
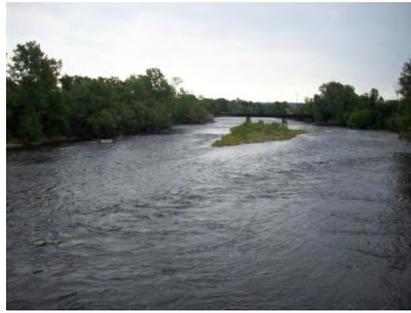
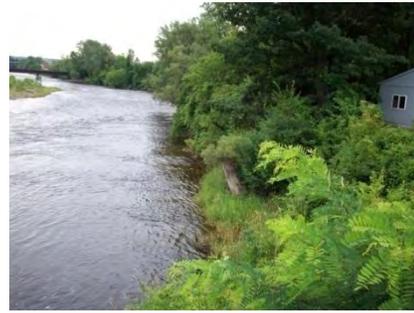
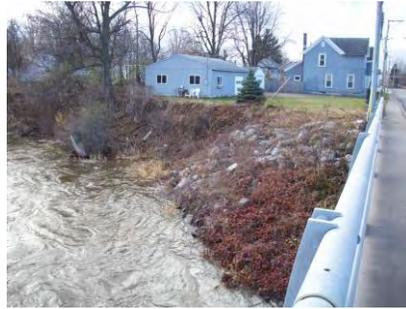
Photos 321-325 were taken on the upstream side of Vanduzee Street Bridge. Starting with Photo 321 and ending with Photo 325, views pan from northeast to southeast. Both the northern and southern banks of the river can be seen from here. As mentioned previously, the banks in this area appear to be in stable condition because of the ample vegetation holding the upper soil material in place.

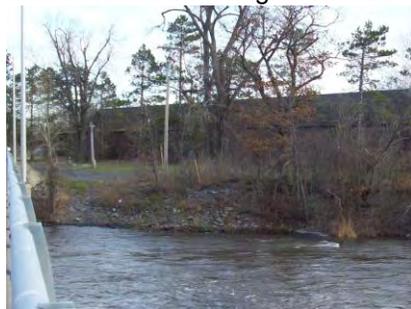
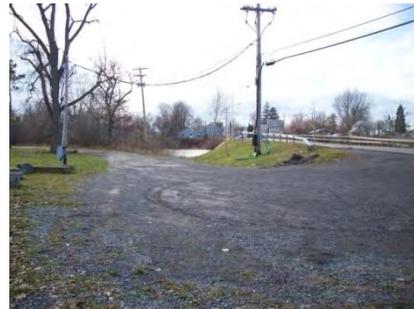
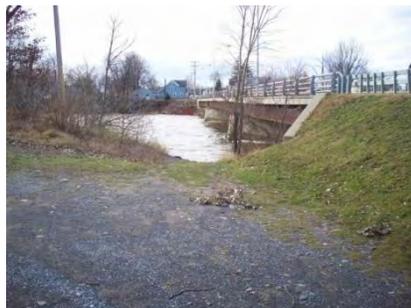
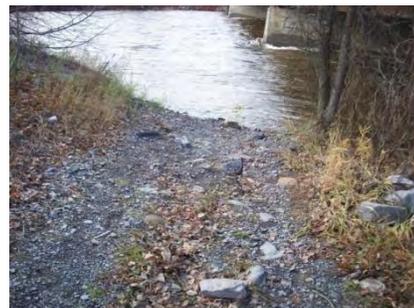
Photos 326-331 were taken at the Vanduzee Street DEC Fishing Access Area, just to the northeast of the Vanduzee Street Bridge. Photo 326 is looking in the northern direction at the access area from the bridge. The steep banks of the access area can be seen in this photo. Photo 327 was taken near the parking lot of the access area and looks towards the south. Photo 328 was a similar photo taken closer to the river banks. Photo 329 is a close up shot of the path down to the river's edge. Photo 330 is from the pedestrian path looking upstream to the southeast at the nearby banks. Some erosion is occurring along these banks from pedestrian as well as river erosion. Photo 331 was also taken from the pedestrian path and looks to the south at rip rap that has been placed near the foundation of the bridge structure to protect it.
