EROSION MANAGEMENT PLAN FOR THE BLACK RIVER CORRIDOR

ARCHITECTURE, ENGINEERING & LAND SURVEYING, P.C.

This document was prepared for the New York State Department of State Office of Coastal, Local Government and Community Sustainability with funds provided under Title 11 of the Environmental Protection Fund.

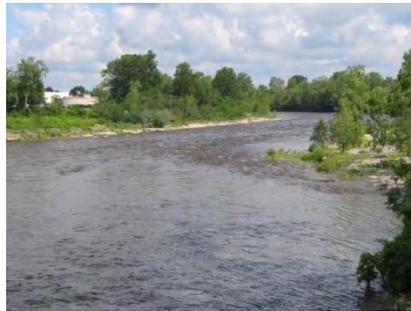
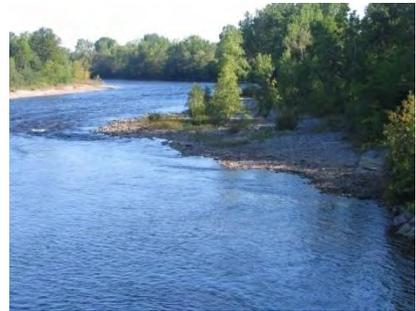
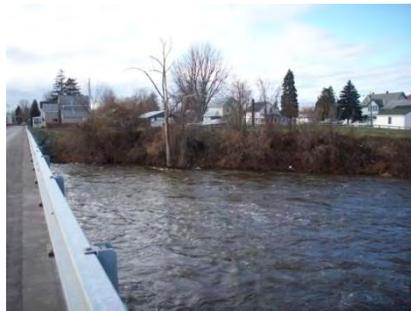
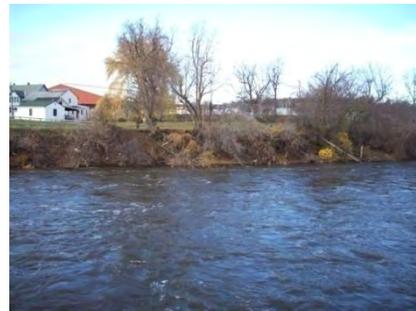
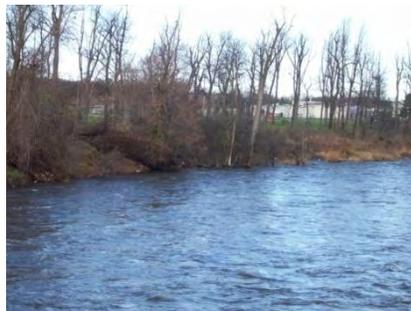
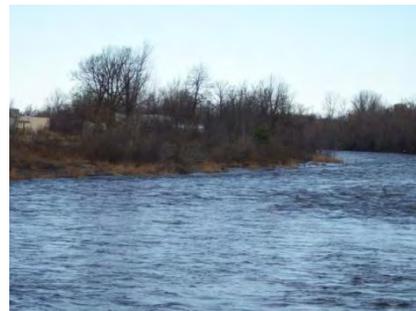
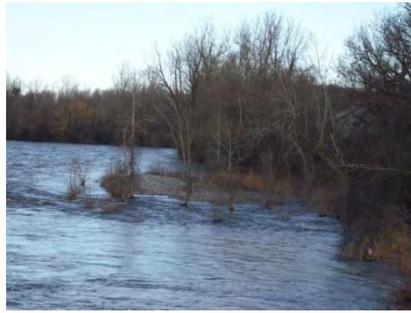
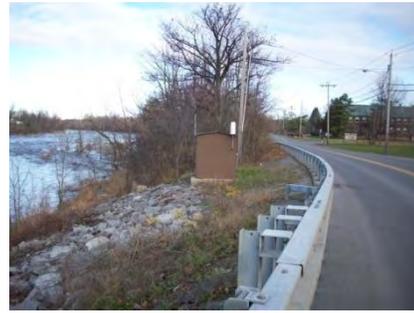
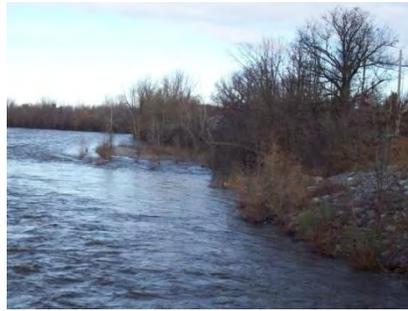
Photos 332-341 were taken from the western side of Vanduzee Street Bridge. Photos 332 and 333 provide an overall view looking to the northwest. Photos 334-340 are more detailed views of the banks and pan from the south to the north. The lower banks in this area are bedrock while the upper banks are of soil which is held in place by vegetation. Photos 339 and 340 show how rip rap has been placed near the bridge to protect it from erosion.

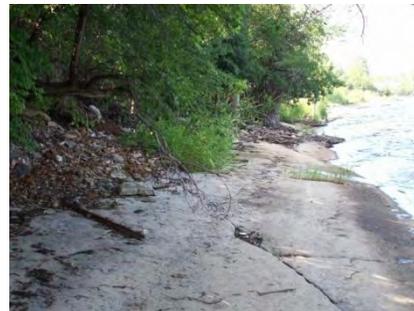
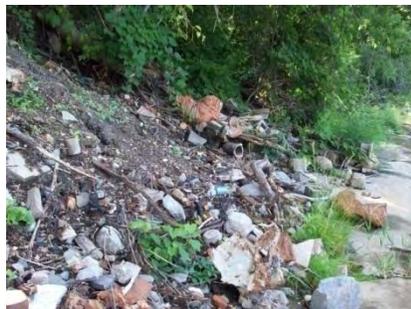
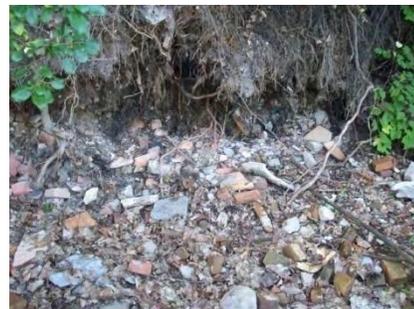
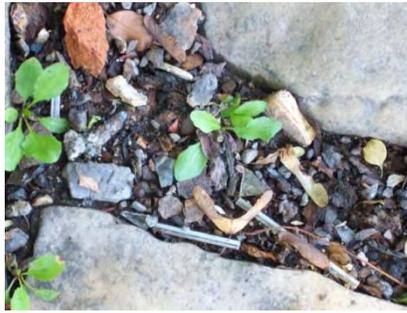
Photos 341-345 are of the waste site that exists on the southern banks of the river, to the northwest of Vanduzee Street Bridge. This area is labeled on the Overall Plan in Appendix A. Photo 341 and 342 show the lower bedrock banks in the area with debris on the higher banks which is washing away during higher flows. Photos 343-345 show closer views of the materials, including broken thermometers.

In addition to hurdles that must be overcome as part of the construction process, existing areas near Bicentennial Park should be considered for additional improvements. Just upstream from the proposed Bicentennial Park is a small waste site which should be cleaned up as shown in Photos 341-345. Erosion has gradually undermined the upper banks in this area during high flows and has unearthed a dump site from the past. Especially with a newly improved park nearby, pedestrians are bound to venture into this area where unsafe materials were discovered, including broken thermometers. Once this site is environmentally cleaned, it should be considered for erosion control. Note that not all of this waste site is on City of Watertown property. (See Overall Map 1 in Appendix A)

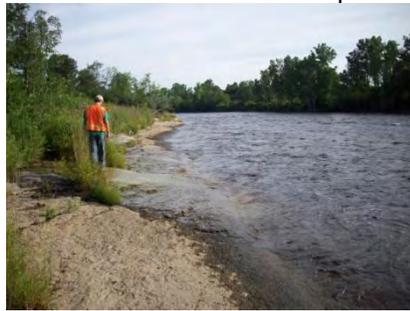
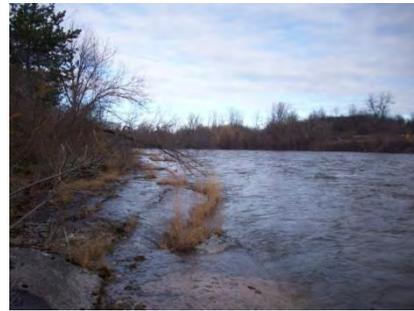
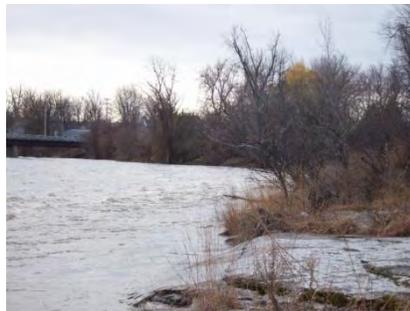
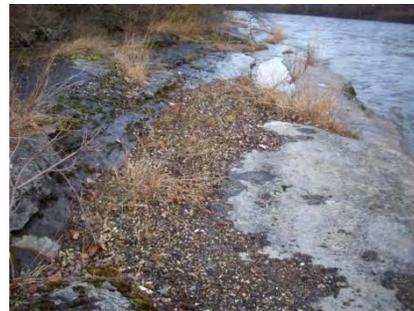
Photos 346-349 were taken from the southern banks of the river, east of the Bicentennial Park Area. In general, the banks in this area are bedrock and fairly resistant to erosion. Photo 346 and 347 look downstream in the northwesterly direction. Photo 348 is from the same area and looks upstream to the southeast along the southern river banks. Photo 349 shows some debris which was found in this area which seems to be similar to the aforementioned waste site upstream.

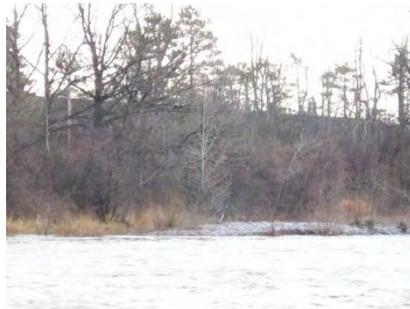
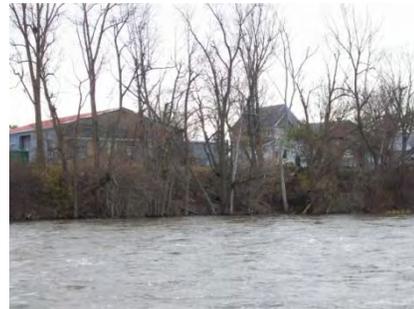
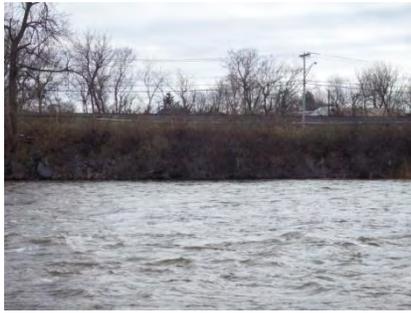
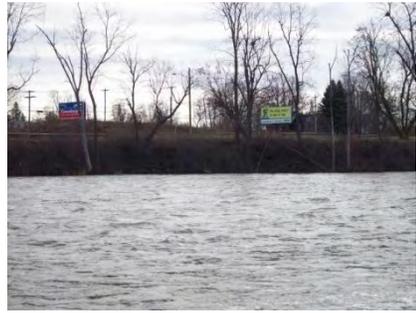
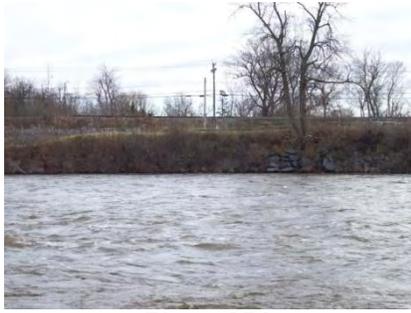
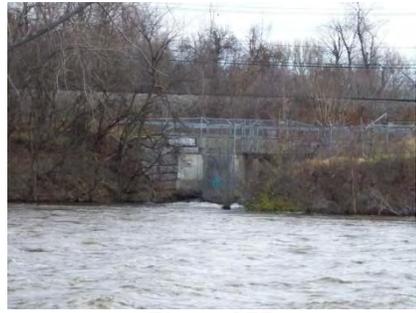
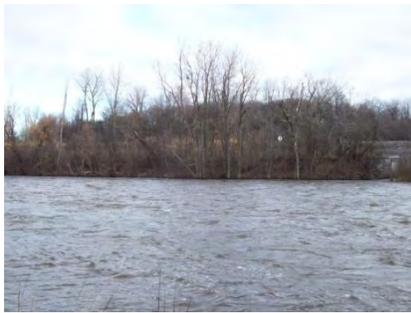
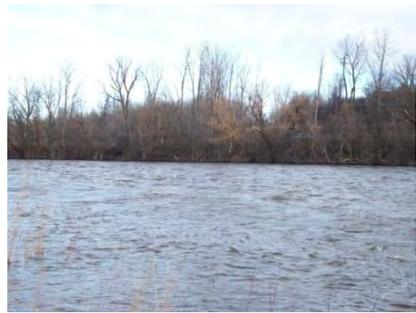
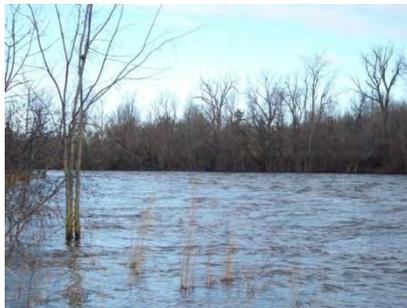
Photos 350-358 were taken from the southern banks of the river, east of the Bicentennial Park and offer views to the northern banks in this area. Starting with Photo 350 and ending with Photo 358, the view pans from upstream to downstream. The steep banks in this area are protected from erosion in most places by thick vegetation. Bedrock lines the lower banks.

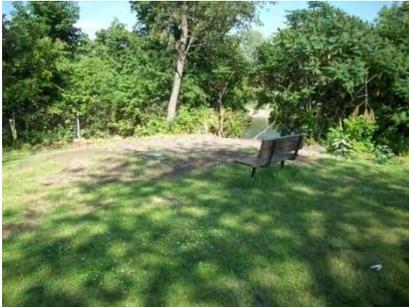
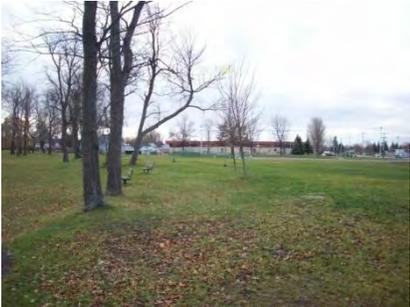
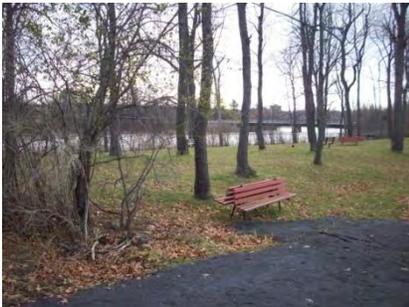
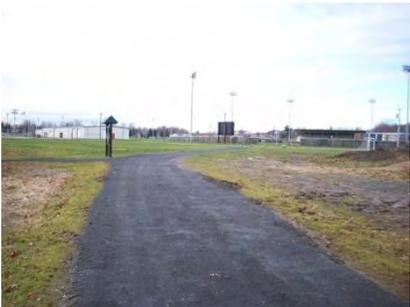
Photos 359-362 were taken of the Bicentennial Park and Waterfront Trail System along the southern banks of the river. Bicentennial Park is to be further developed in the upcoming years. Photo 359 was taken on the downstream side of Bicentennial Park looking in the northeastern direction at an access point to the river. Erosion is visible in the path from pedestrians. Photos 360-362 were taken on the northern side of the park. Photo 360 is looking south towards the Ice Arena. Photo 361 is looking southeast towards the river from the park. Photo 362 is looking southwest.

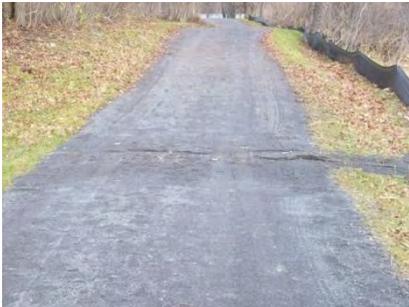
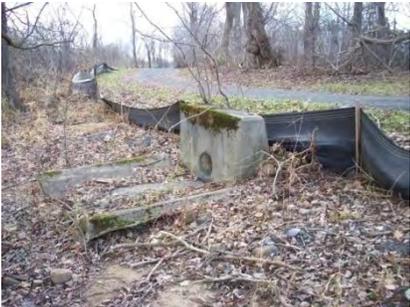
Photos 363-367 were taken along the Waterfront trails that traverse the southern banks of the river from Bicentennial Park to Jefferson Community College. Photo 363 is of an eroding section of one of the trails along the river in the vicinity of the Pollution Control Plant and looks northwest. Note that the erosion in Photo 363 has been repaired at the completion of this report, but still serves to show the general erosion susceptible state of the paths. Photo 364 is of a culvert outfall near the same trail. Concrete outfalls like this prevent erosion. Culverts which discharge significant amounts of water could have rip rap installed to extend closer to the edge of the river.

The trails in the vicinity of Jefferson Community College and the Pollution Control Plant provide a great way for pedestrians to enjoy the river area. This trail system varies from several hundred feet to right up to the banks. Some minor erosion was witnessed in the trails themselves at low points where there were no culverts under the trail. See photo 363, which shows a portion of the gravel trail which has washed out in a low spot. For future trails, asphalt or larger crushed stone should be considered as a base. This would help to prevent washouts.

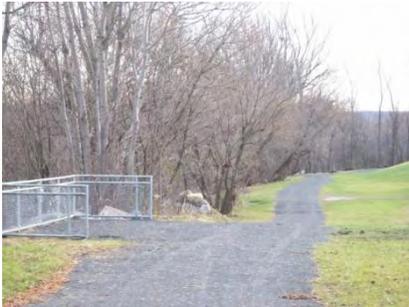
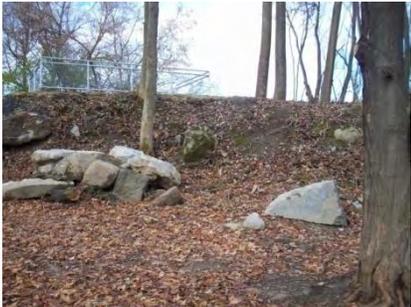
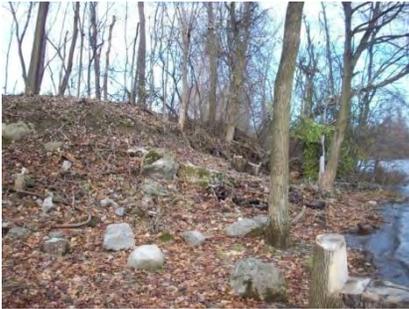
Photo 365 is a view of a portion of the trail system between the Pollution Control Plant and Jefferson Community College looking in the southeastern direction. A lookout area can be seen in this photo. Photo 366 and 367 were taken along the banks of the river, near a separate lookout from the one in Photo 365. These photos show the general configuration of riverbanks in this area. The lower banks consist of bedrock and the upper banks are of different soil materials which are held in place by vegetation in many areas. Some areas, such as here where there is a lack of vegetation, are more susceptible to erosion during high flow events than vegetated areas.

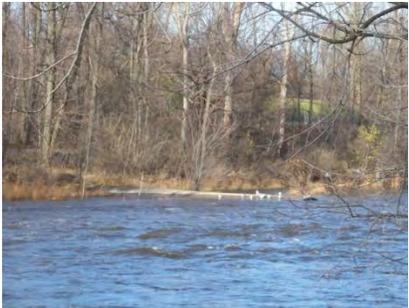
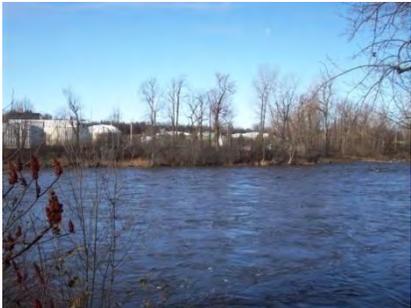
Photos 368 and 369 were taken near the Kelsey Creek Outlet to the Black River on the northern banks and are looking at the southern banks near the Pollution Control Plant.

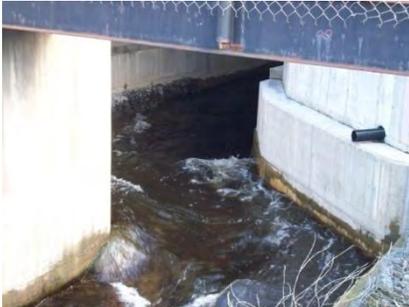
Photos 370-374 were taken of the Kelsey Creek outlet to the river. Photo 370 shows the concrete channels which the water flows through. Photos 371 and 372 are also at the outlet of Kelsey Creek and show the gabion baskets and retaining walls that are used to channel water to the river. Photo 373 and 374 are of the northern banks of the river upstream and downstream of the inlet, respectively. This outlet to the river and the nearby banks seems to be in stable condition. This inlet area should be included as part of the periodic inspections.

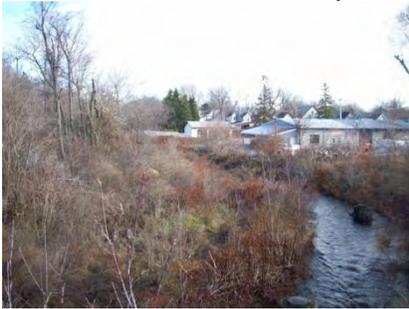
Photo 375

Photos 375 and 376 were taken from the train tracks near the Kelsey Creek outlet to the river and look in the northern direction. This area is part of the 100 year flood plain. The banks of this stream are fairly stable because of the thick vegetation.

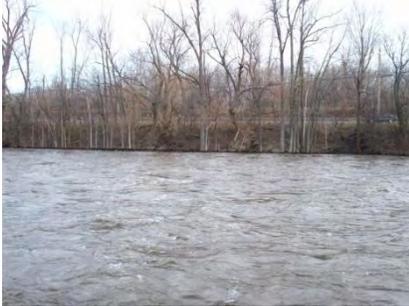
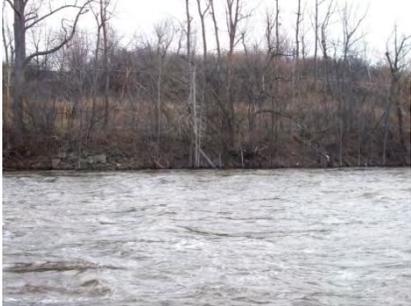
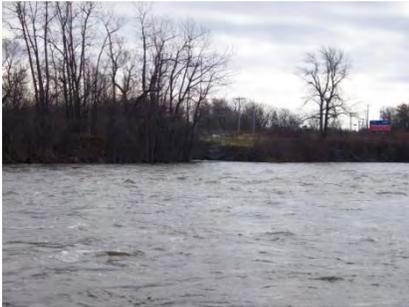
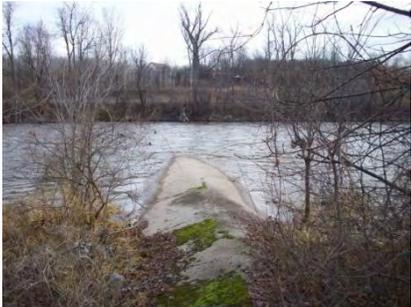
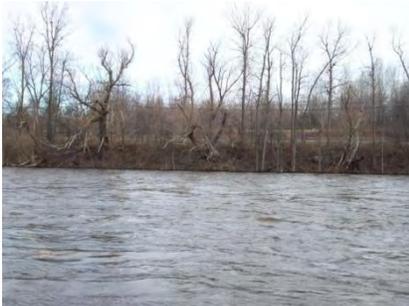
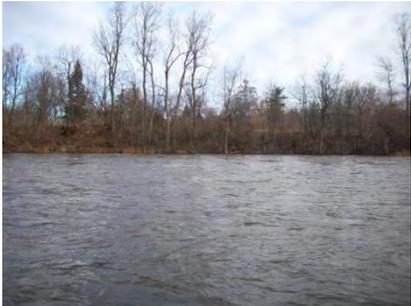
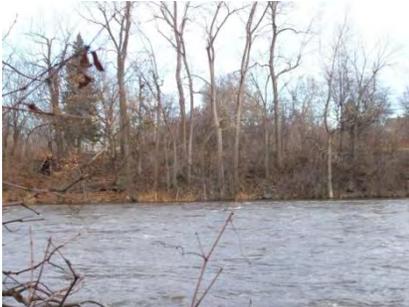
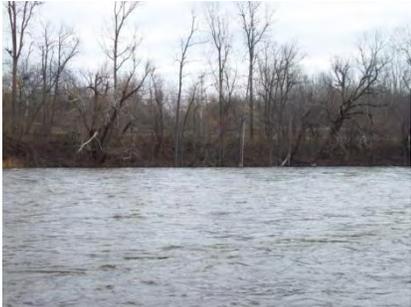
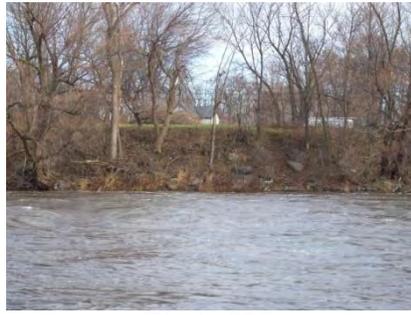
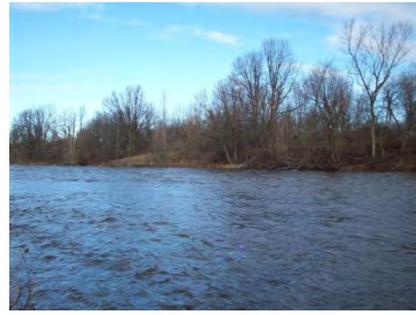
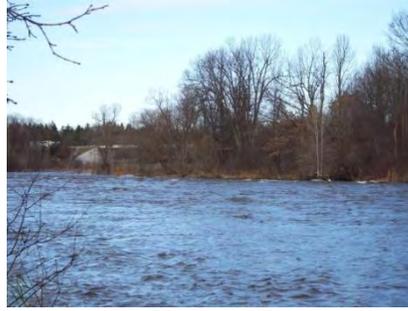
Photos 377-387 offer views of the northern banks of the river, stretching from areas across from the Pollution Control Plant to areas across from the Waterfront Trails at Jefferson Community College. The banks along this area are the lower bedrock river edge and the upper soil materials held in place by vegetation.

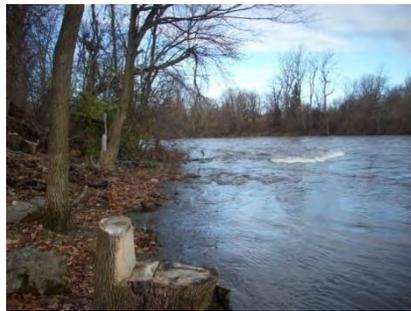
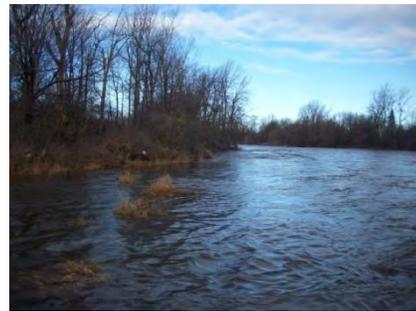
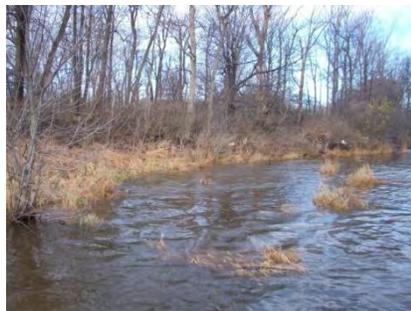
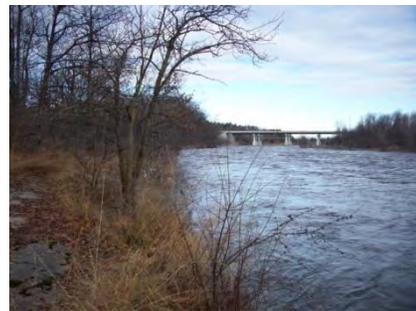
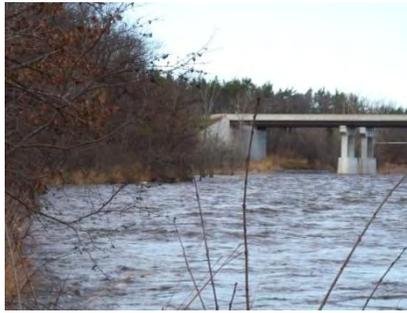
Photos 388-392 were taken along the southern banks of the river between the Pollution Control Plant and Jefferson Community College. Photos are generally looking downstream. Most areas are heavily vegetated which prevents significant erosion from occurring.

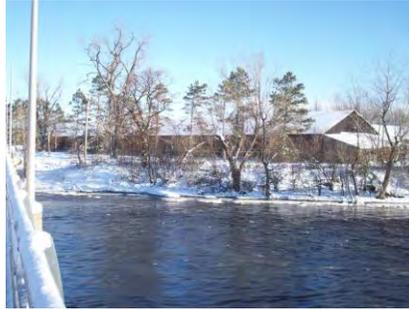
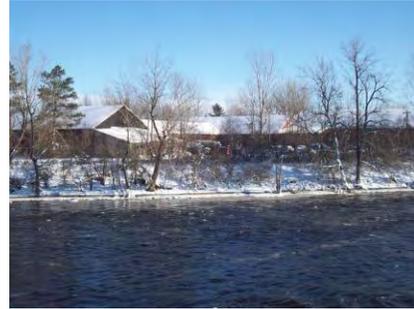
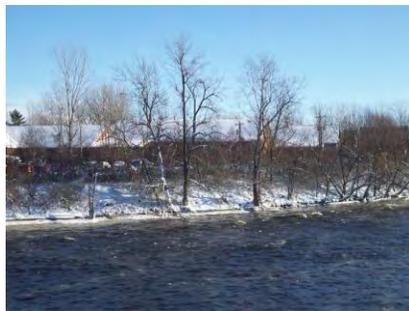
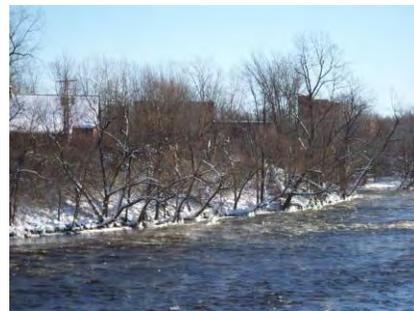
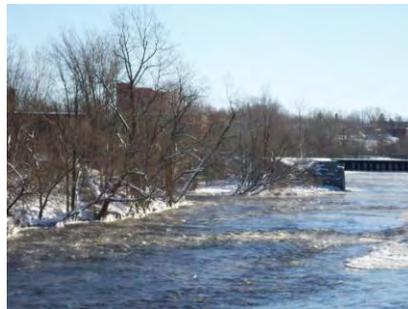
Photos 316-318 are of the northern banks in the vicinity of the proposed Vanduzee Barns Residential Community. These photos were taken during the summer. Photos 393-397 were taken in the winter months from the upstream side of Vanduzee Street Bridge and show the grades of the banks better, as the view is better without foliage. The photos pan from west near the fishing access area to the east near the railroad bridge.

The photos above show how vegetation can prevent banks from eroding away. It will be important when developing this site, to maintain as much of the existing vegetation as possible. If vegetation needs to be removed along the banks to provide for trail and viewing areas, erosion controls may be necessary. The lower banks are of bedrock, but the upper banks are soils which are erosion susceptible without appropriate vegetation. This area may be a good candidate for the use of the stepped rip rap which doubles as pedestrian seating areas as shown in the LWRP plan.

As discussed in other sections, the recommended pedestrian path material is asphalt, as it is resistant to erosion. If this is not an economical feasibility, a larger sized crushed stone than was used on other City access areas should be considered. This material may not provide the ideal walking surface, but it will resist erosion much better than pea gravel, which was used in other pedestrian pathways and eroded away.

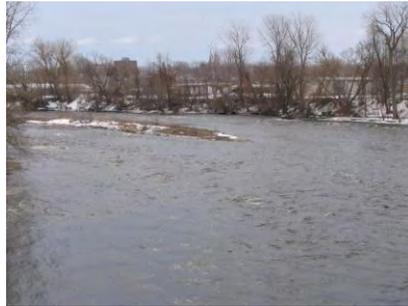
CVP 15A

CVP's 15 and 16 are taken from the Vanduzee Street Bridge. CVP 15 includes views of the upstream to the southeast. CVP 16 looks downstream to the northwest.
