FCS
FRANKLIN CONSULTING SERVICES

INSPECTION REPORT

PROJECT: WATERTOWN MUNICIPAL ICE ARENA

INSPECTION #: 3

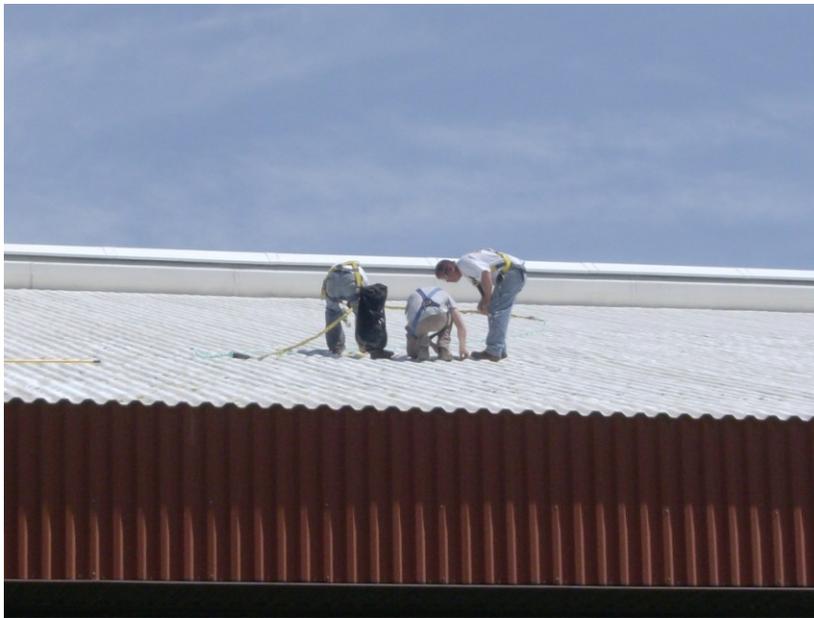
- **PREP WORK OF ROOF SURFACES REQUIRED PEELING BACK CURLED AND DELAMINATED COATING.**
- **EQUIPMENT READIED FOR SPRAY APPLICATION.**

MONOLITHIC HAD BEGUN HIS PREP OF THE SOUTHEAST CORNER OF THE BUILDING PARKING LOT SIDE. IT WAS NOTED THAT REPAIRS COMPLETED DURING LAST YEARS EFFORTS BEFORE BEING SHUT DOWN DUE TO WEATHER CONSTRAINTS WERE ONCE AGAIN FAILING. THOSE AREAS COULD BE PEELED BACK UP ONCE AGAIN. FURTHER REVIEW OF THE PEELED BACK AREAS NOTED EXCESSIVE SPIDER CRACKING OF THE PREVIOUSLY INSTALLED TRUCO COATING THE NOW HAD EXTENDED DOWN AND INTO THE FIRST LAYER OF THE SPRAY FOAM INSULATION.
